# ***FINAL*** **FIVE-YEAR REVIEW** **Fourth Five-Year Review Report**

Former Castle Air Force Base,  
California

Contract No. FA8903-08-D-8777  
Task Order 0144

March 2014

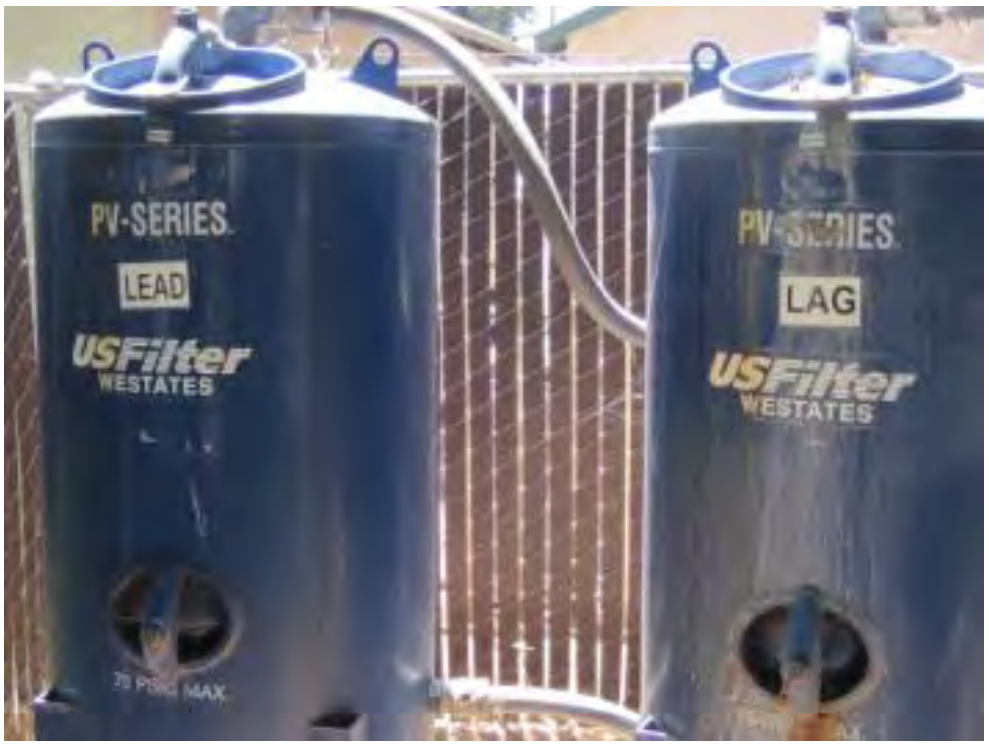
<b>Photograph ID: 1</b>

<b>Survey Date:</b> 6/18/2013	
<b>Comments:</b> D5766 utilizes two granular activated carbon vessels in series.

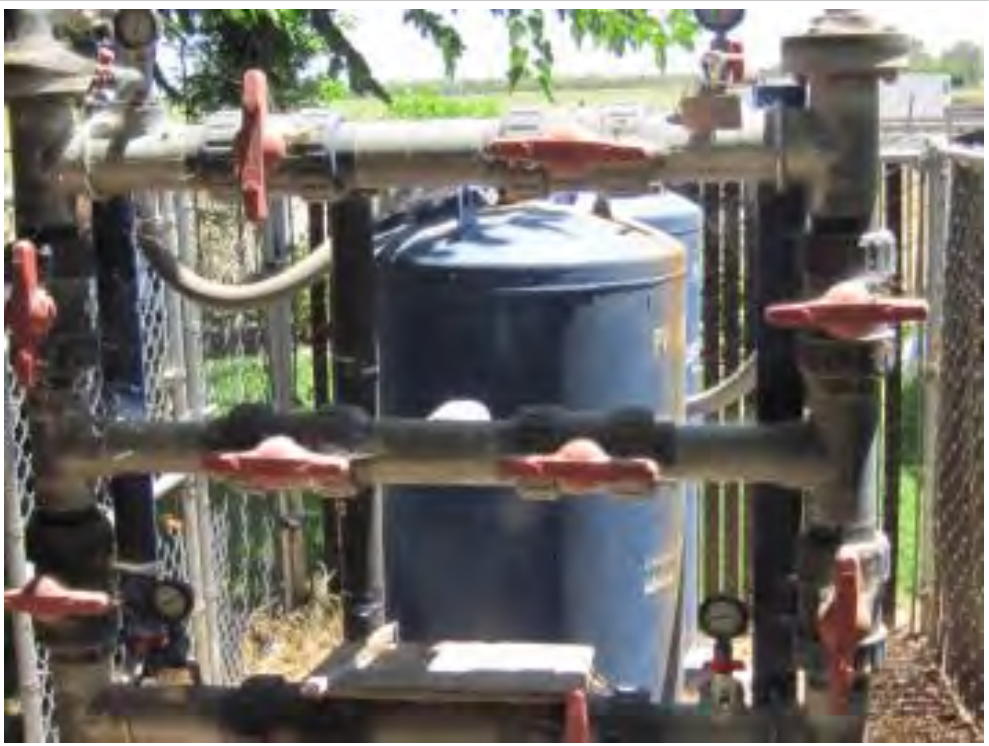
<b>Photograph ID: 2</b>

<b>Survey Date:</b> 6/18/2013	
<b>Comments:</b> The D5766 wellhead treatment system.

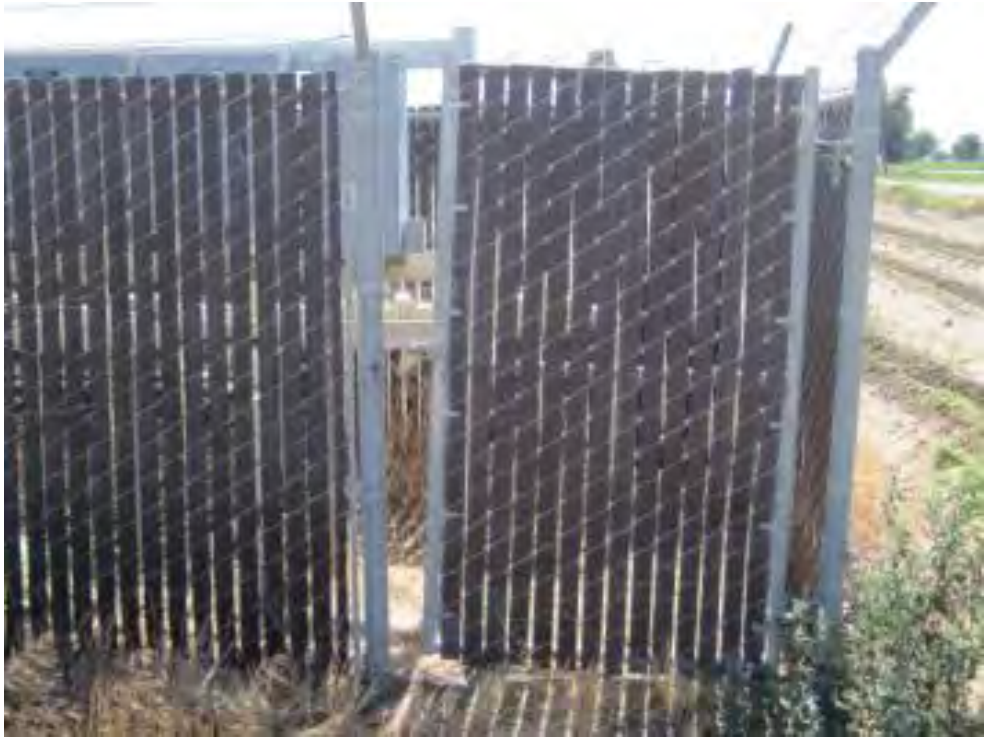
<b>Photograph ID: 5</b>

<b>Survey Date:</b> 6/18/2013	
<b>Comments:</b> Fencing at IW-2 is in good condition.

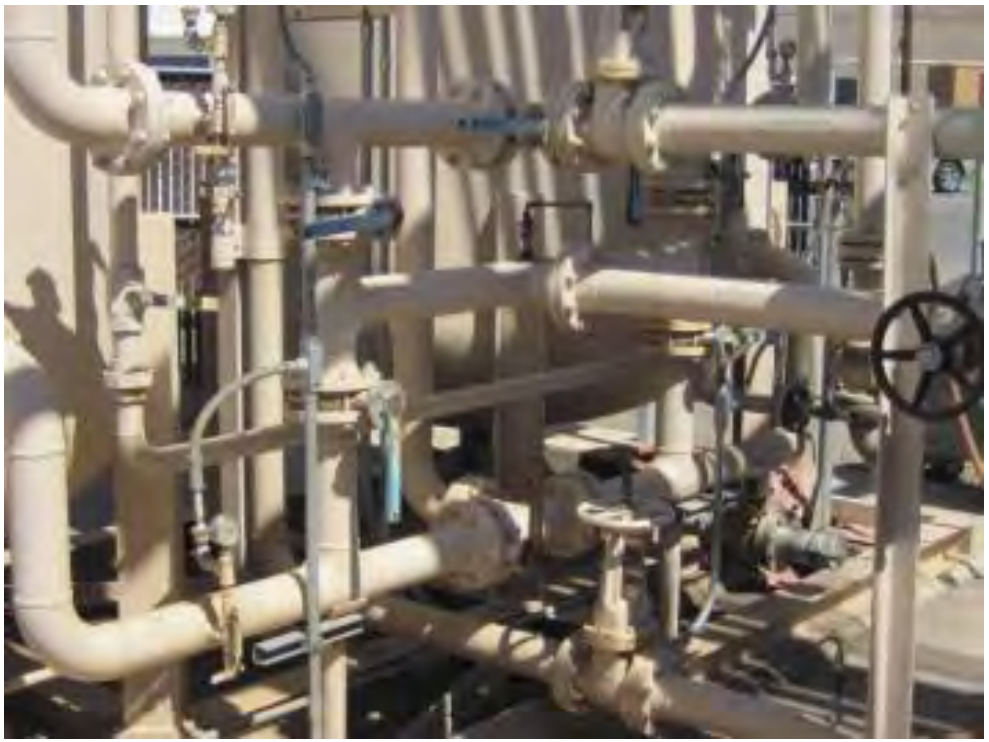
<b>Photograph ID: 6</b>

<b>Survey Date:</b> 6/18/2013	
<b>Comments:</b> Piping for the Main Base treatment system.

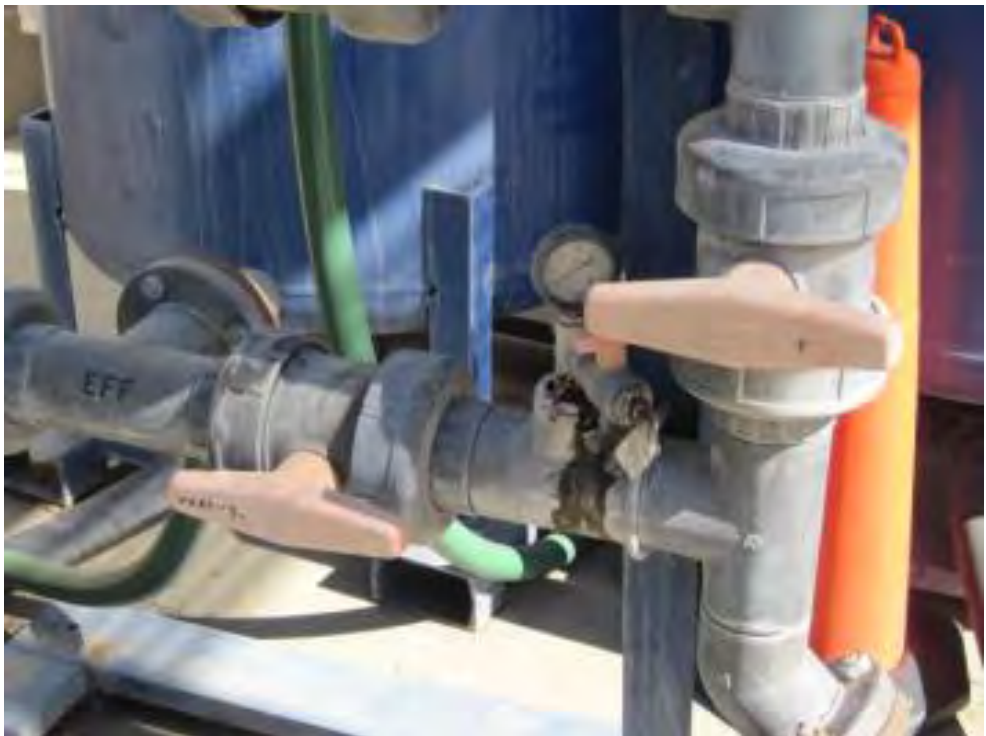
<b>Photograph ID:</b> 14

<b>Survey Date:</b> 6/18/2013	
<b>Comments:</b> The OU-2 treatment system valves and piping; there are some minor leaks from the piping.

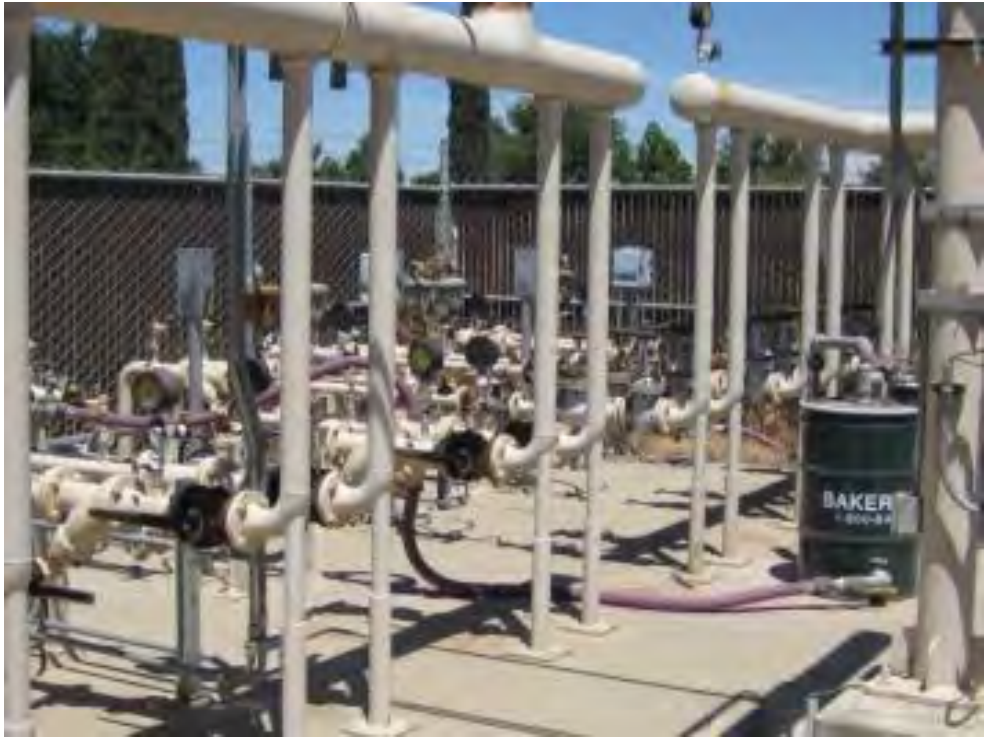
<b>Survey Date:</b> 6/18/2013			
<b>Comments:</b> The treatment system piping.

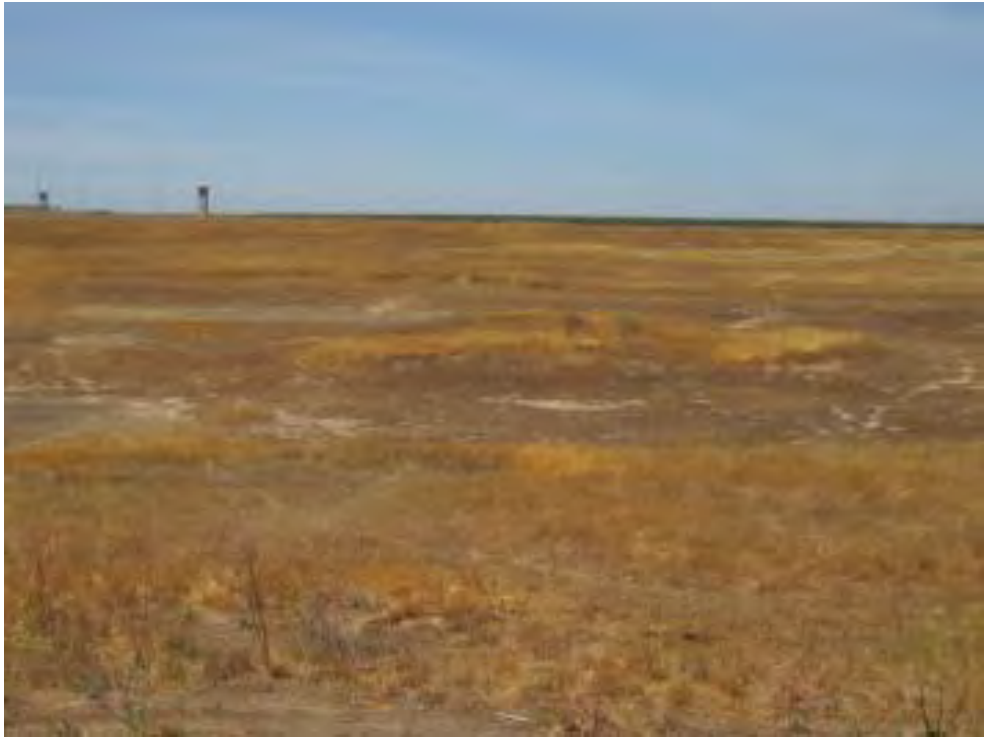
<b>Survey Date:</b> 6/18/2013			
<b>Comments:</b> The wetland at ETC-10.

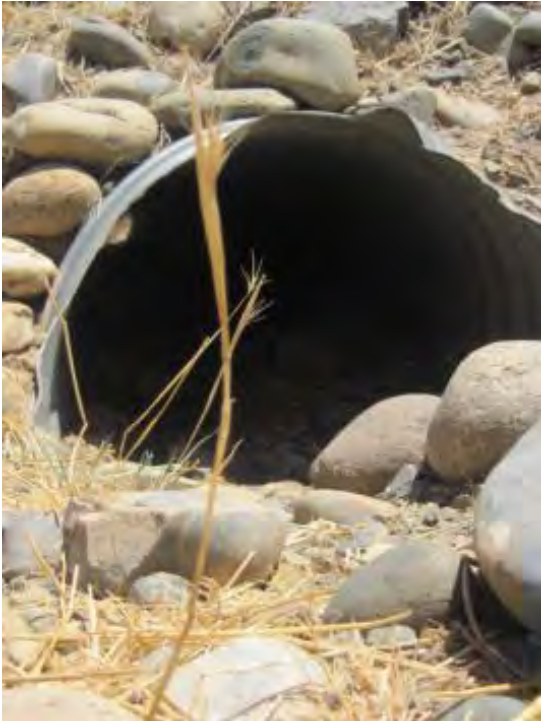
<b>Photograph ID: 2</b>

<b>Survey Date:</b> 6/18/2013	
<b>Comments:</b> One of the culverts on the southeastern part of the Site that transfer drainage water from the landfill and off site. They are partially filled with rock. Transfer and drainage of water can still take place, however.

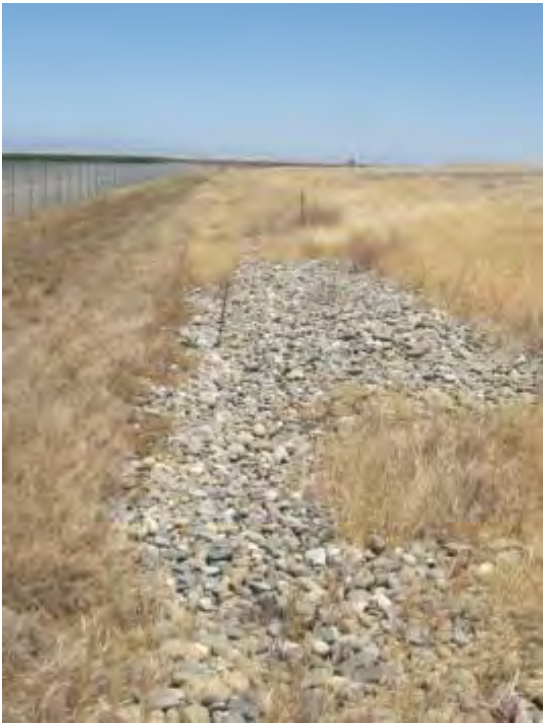
<b>Survey Date:</b> 6/18/2013			
<b>Comments:</b> Drainage ditch at LF-5. Some vegetation is present in the ditch.
