**Former Castle Air Force Base
Atwater, California**

**Fifth Five-Year Review Report for
Former Castle Air Force Base
Merced County, California**

Final

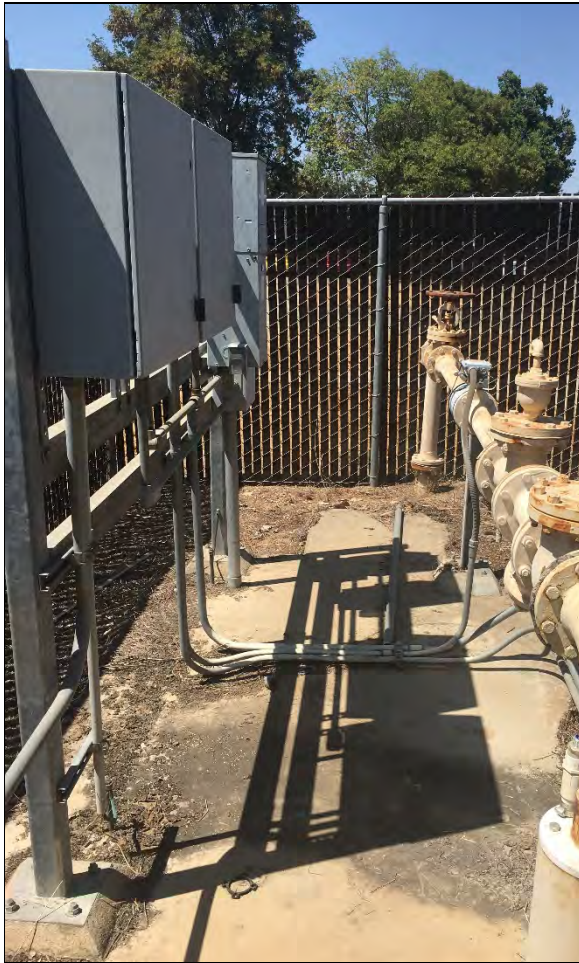
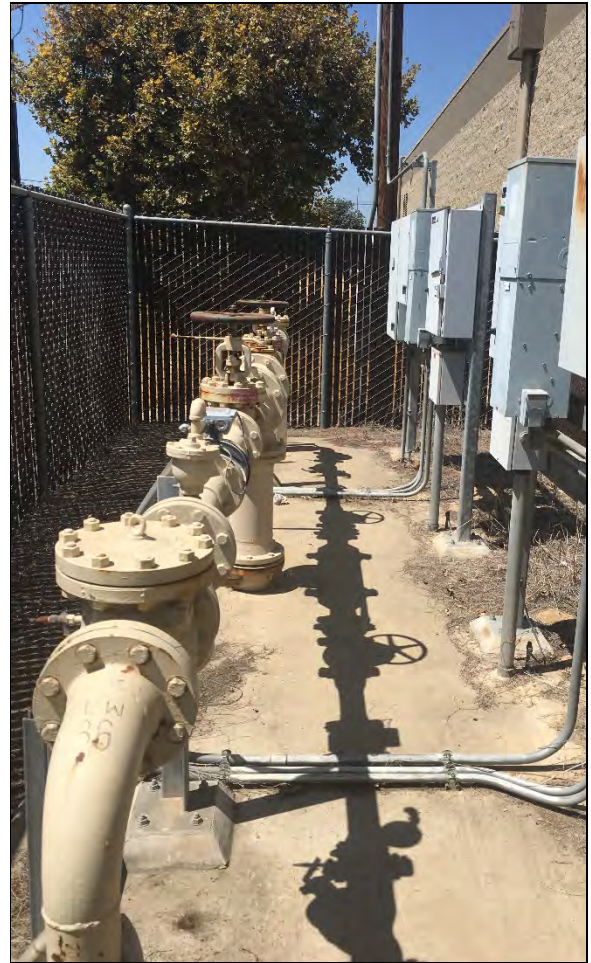
- **Main Base Plume:** EW34 and EW36 valves were found to have minor drips; therefore, the valves were sealed.
- **FTA-1:** Burrows were evident over the surface of the vegetative surface cover; however, the burrows were mostly inactive and do not appear to have negatively impacted the HDPE liner or the stability of the soil cover. While this site inspection did not directly identify issues with implementation of the ICs, on 16 February 2018, the USAF was notified by its support contractor that portions of the fencing and HDPE liner material within drainage swales near FTA-1 had been disturbed by BoP Atwater inmate work crews. According to the BoP Atwater Facilities Manager, their work crews mistakenly removed several fence posts and fencing, and disturbed soils and the margin of the HDPE liner material within drainage swales to gather stones from the swales to construct improvements to the entrance of the prison. The HDPE material is part of the cap liner that originally extended from the cap into the swale as a continuous unit. Despite the disturbance of the swales, the FTA-1 cap does not appear to have been significantly damaged. Based on a review of where the contaminants were located beneath the cap, no risk to human health or the environment is anticipated to have occurred due to the incident. BoP will restore the disturbed portion of the liner and protective soil layer.

EW-34

EW-36

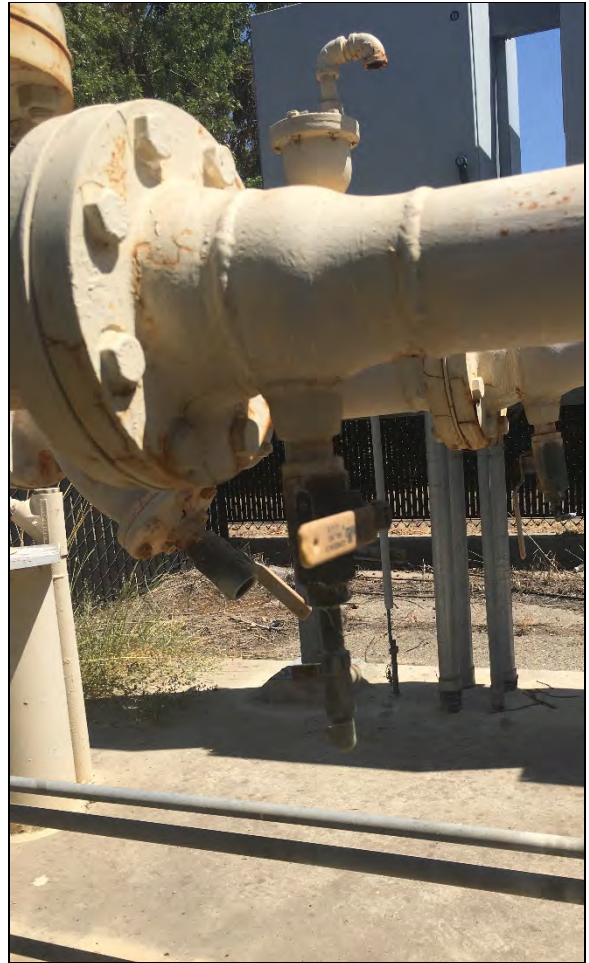
MW-918 Drip Fix
