Air Force Real Property Agency

Kelly Restoration Advisory Board

April 13, 2010

Semiannual Compliance Plan Report June through December 2009 Former Kelly Air Force Base

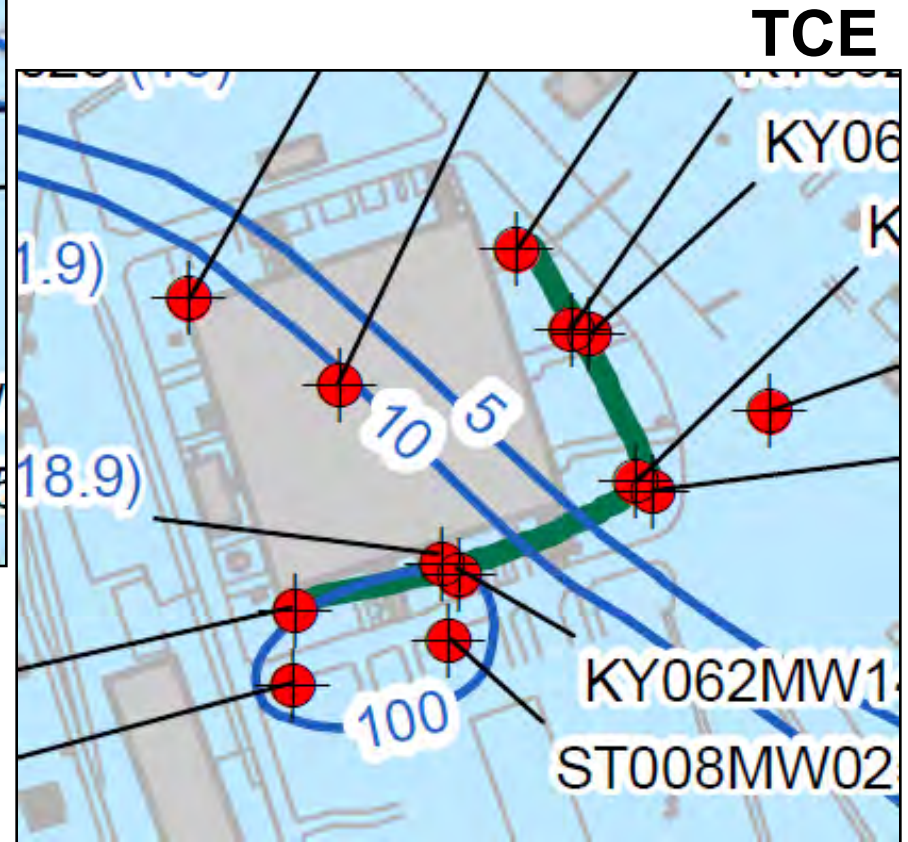
PCE and TCE Isoconcentration Maps, Building 301

PCE

TCE

- Higher PCE concentrations in the immediate vicinity of the ERH system are believed to be a temporary, localized effect resulting from operation of the ERH system.
- Groundwater appears to be moving parallel to the eastern wing wall of the PRB, instead of perpendicular and through the wall.

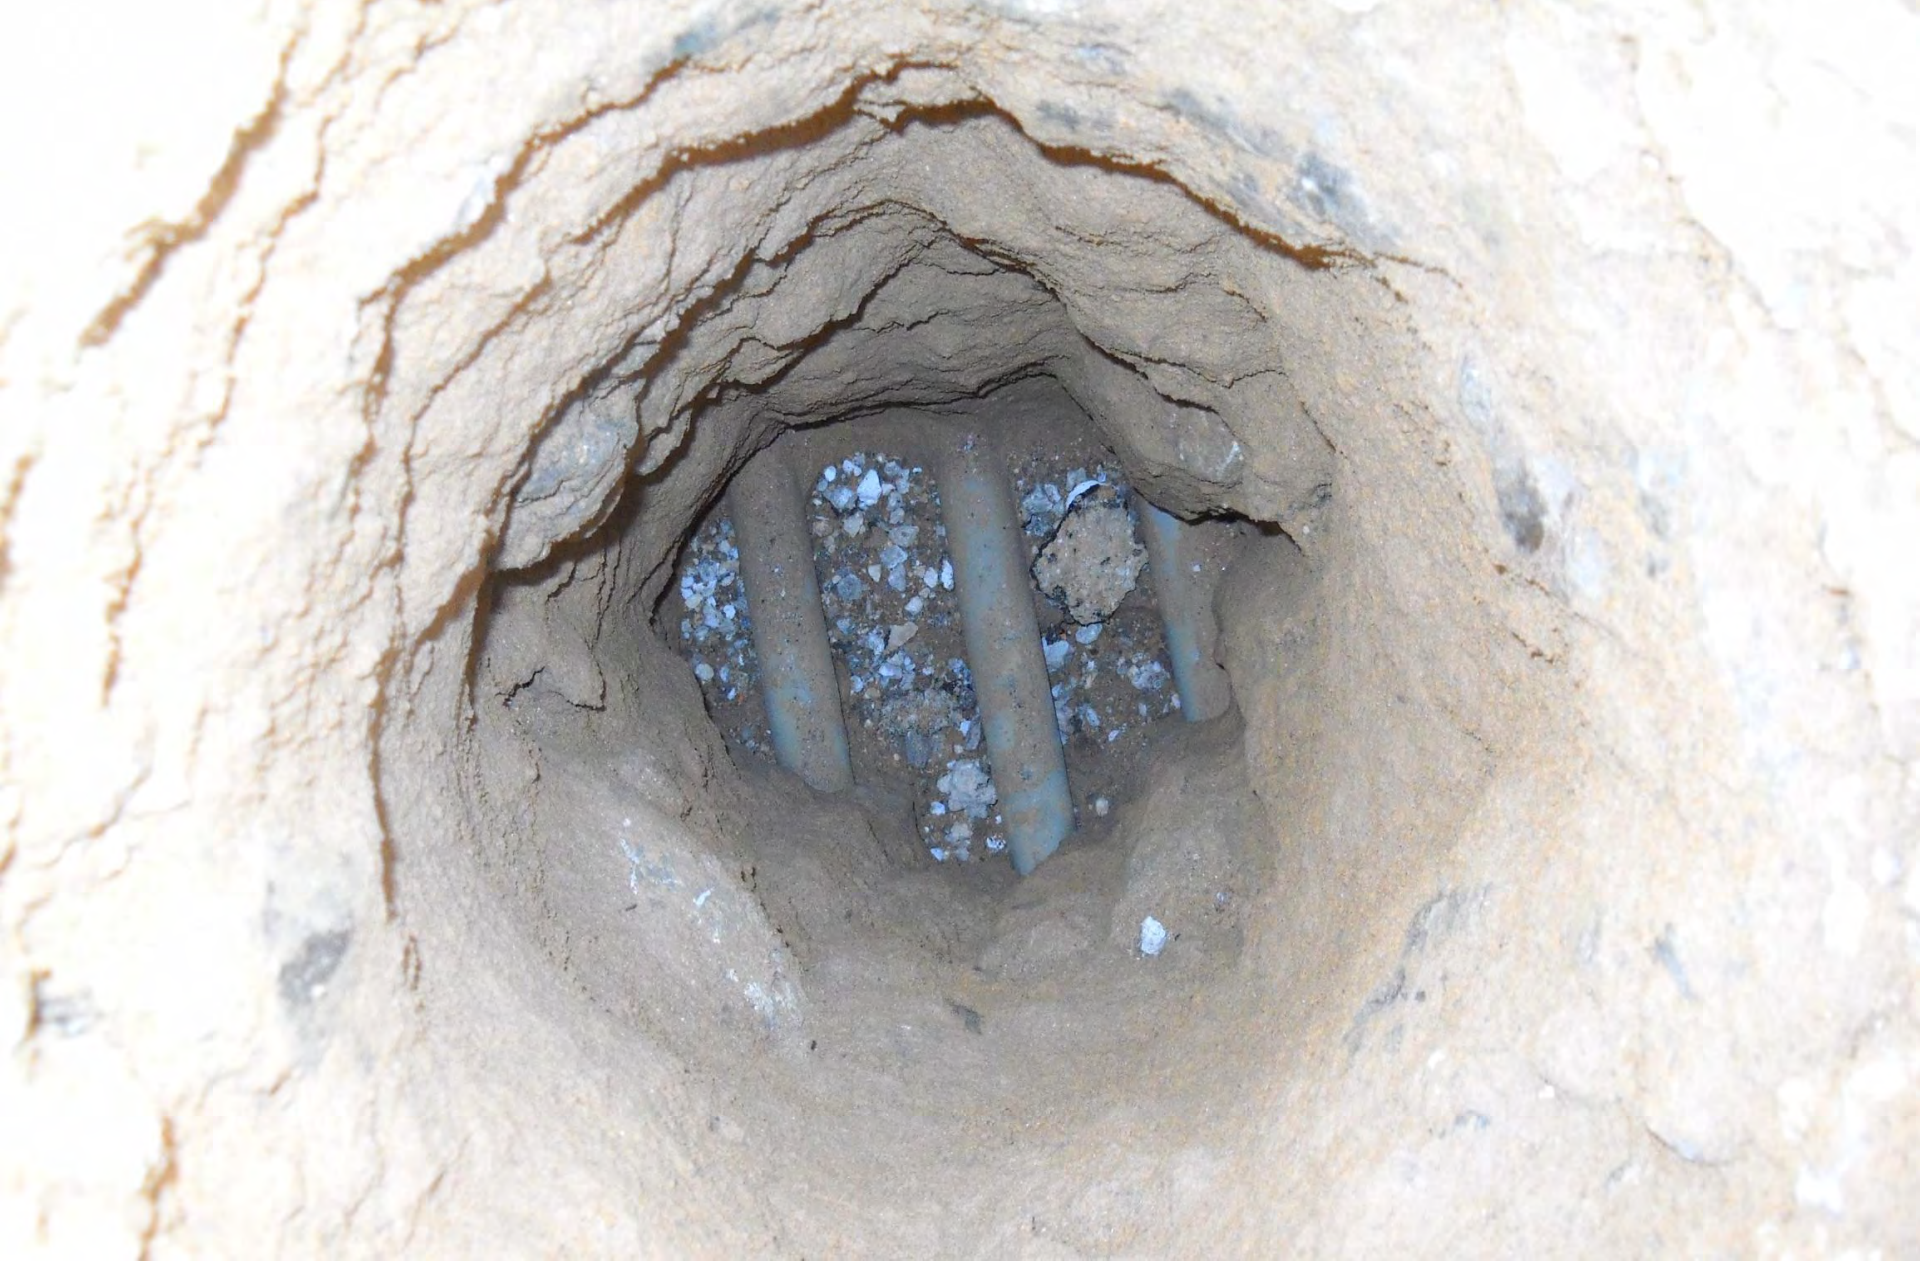
Utilities Located utilizing Air Knife

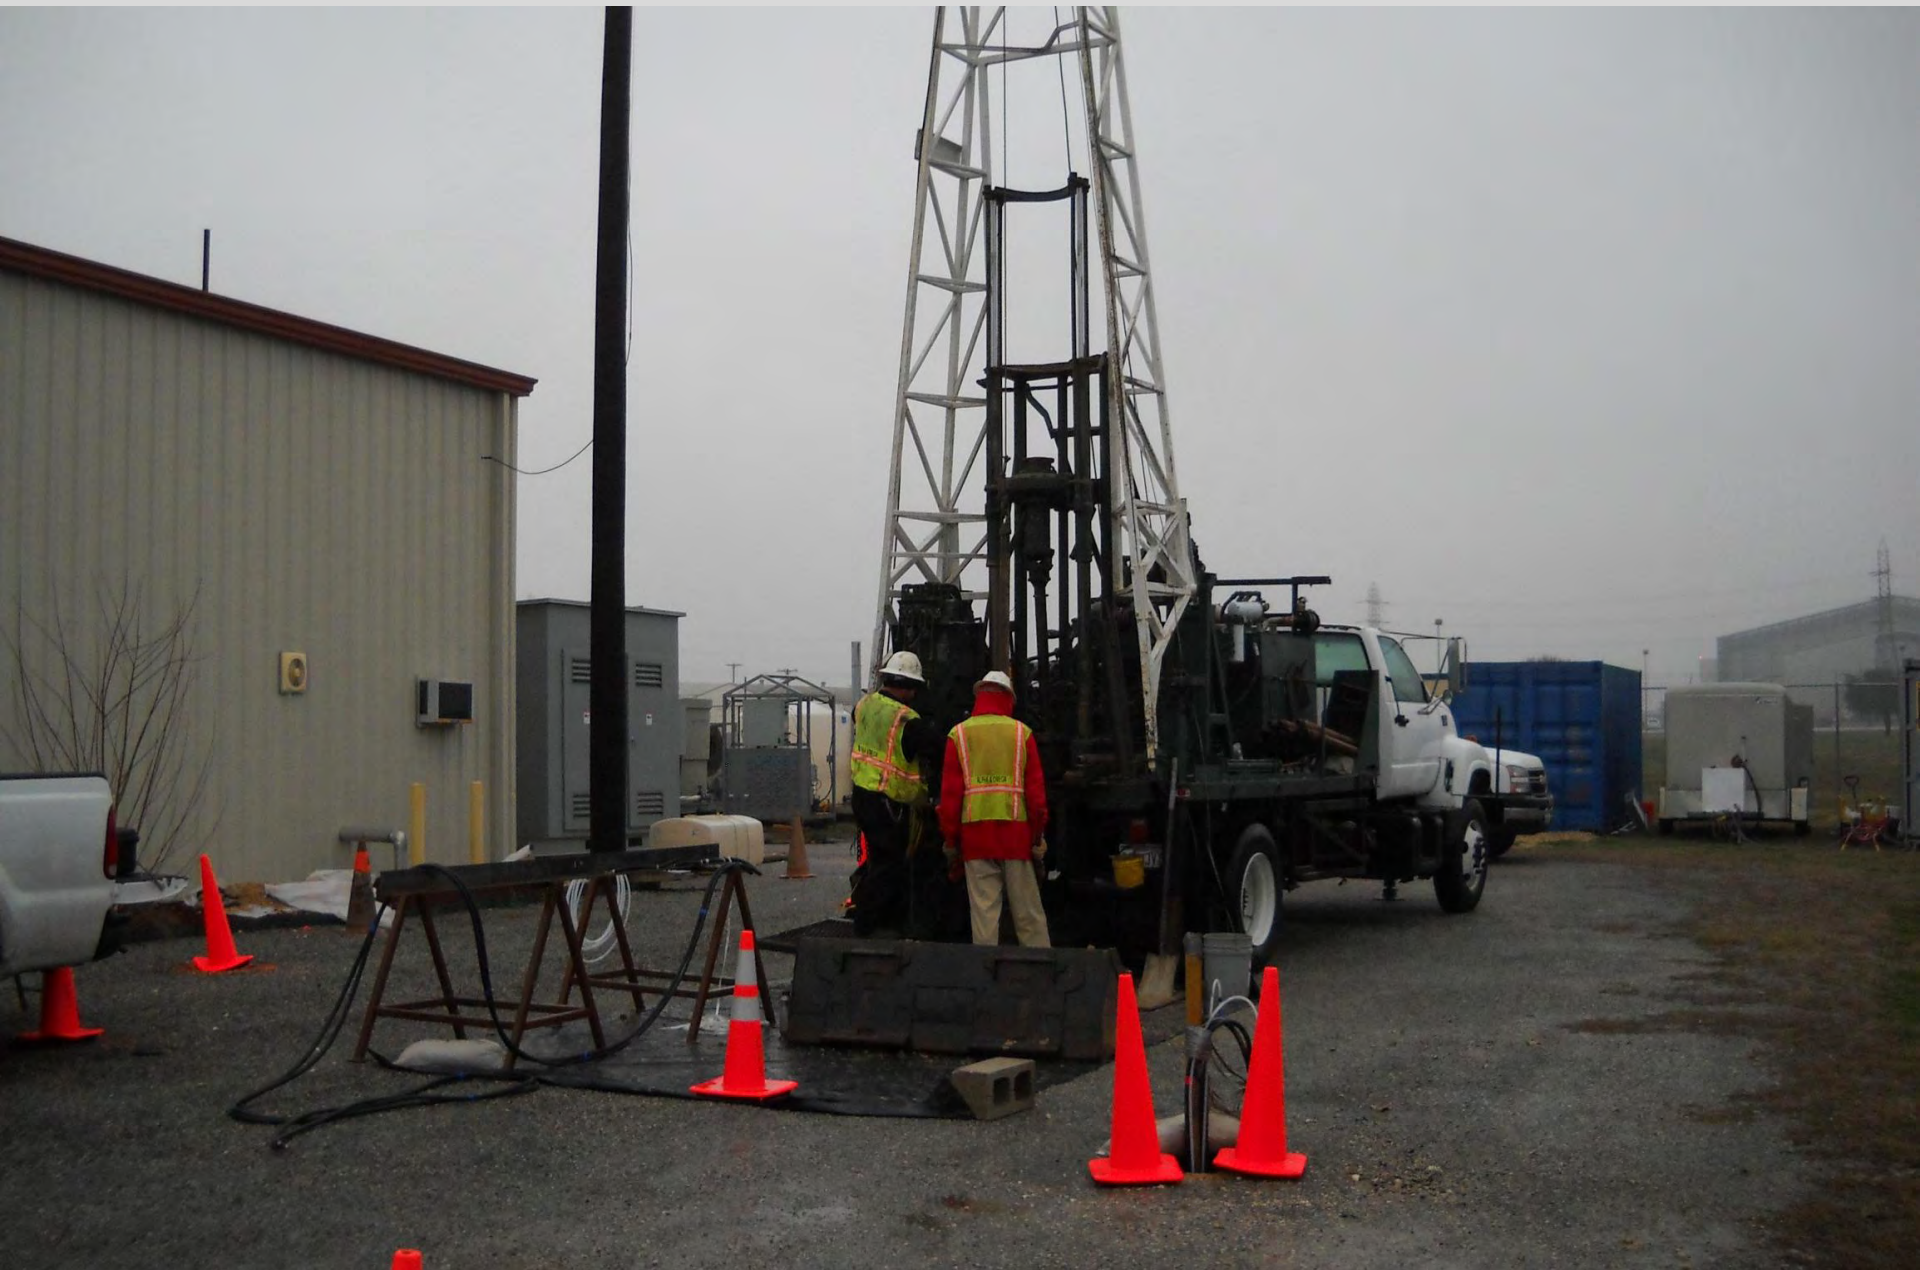
Site S-1 Drilling

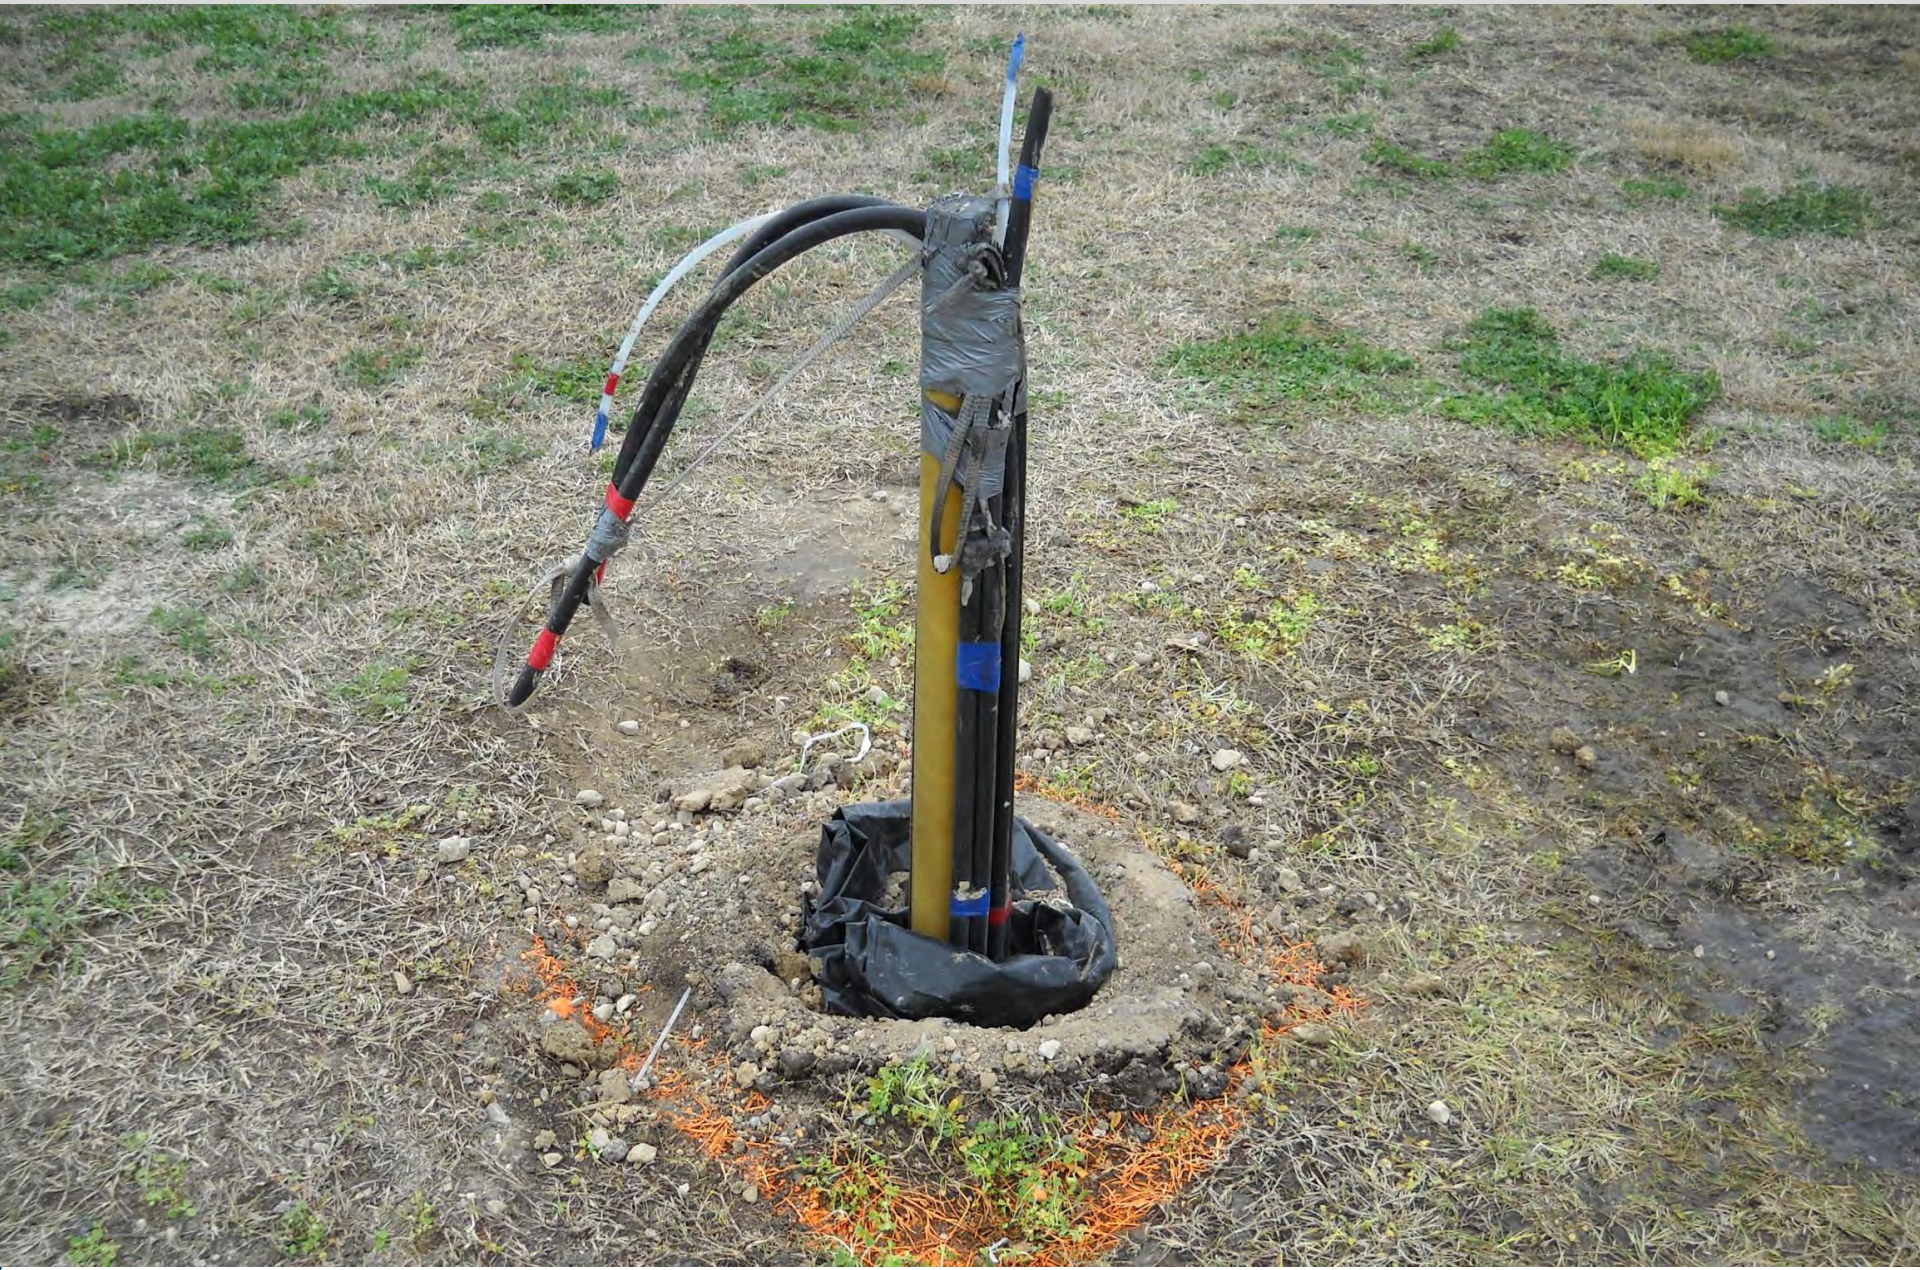
Site S-1 Electrode Installation

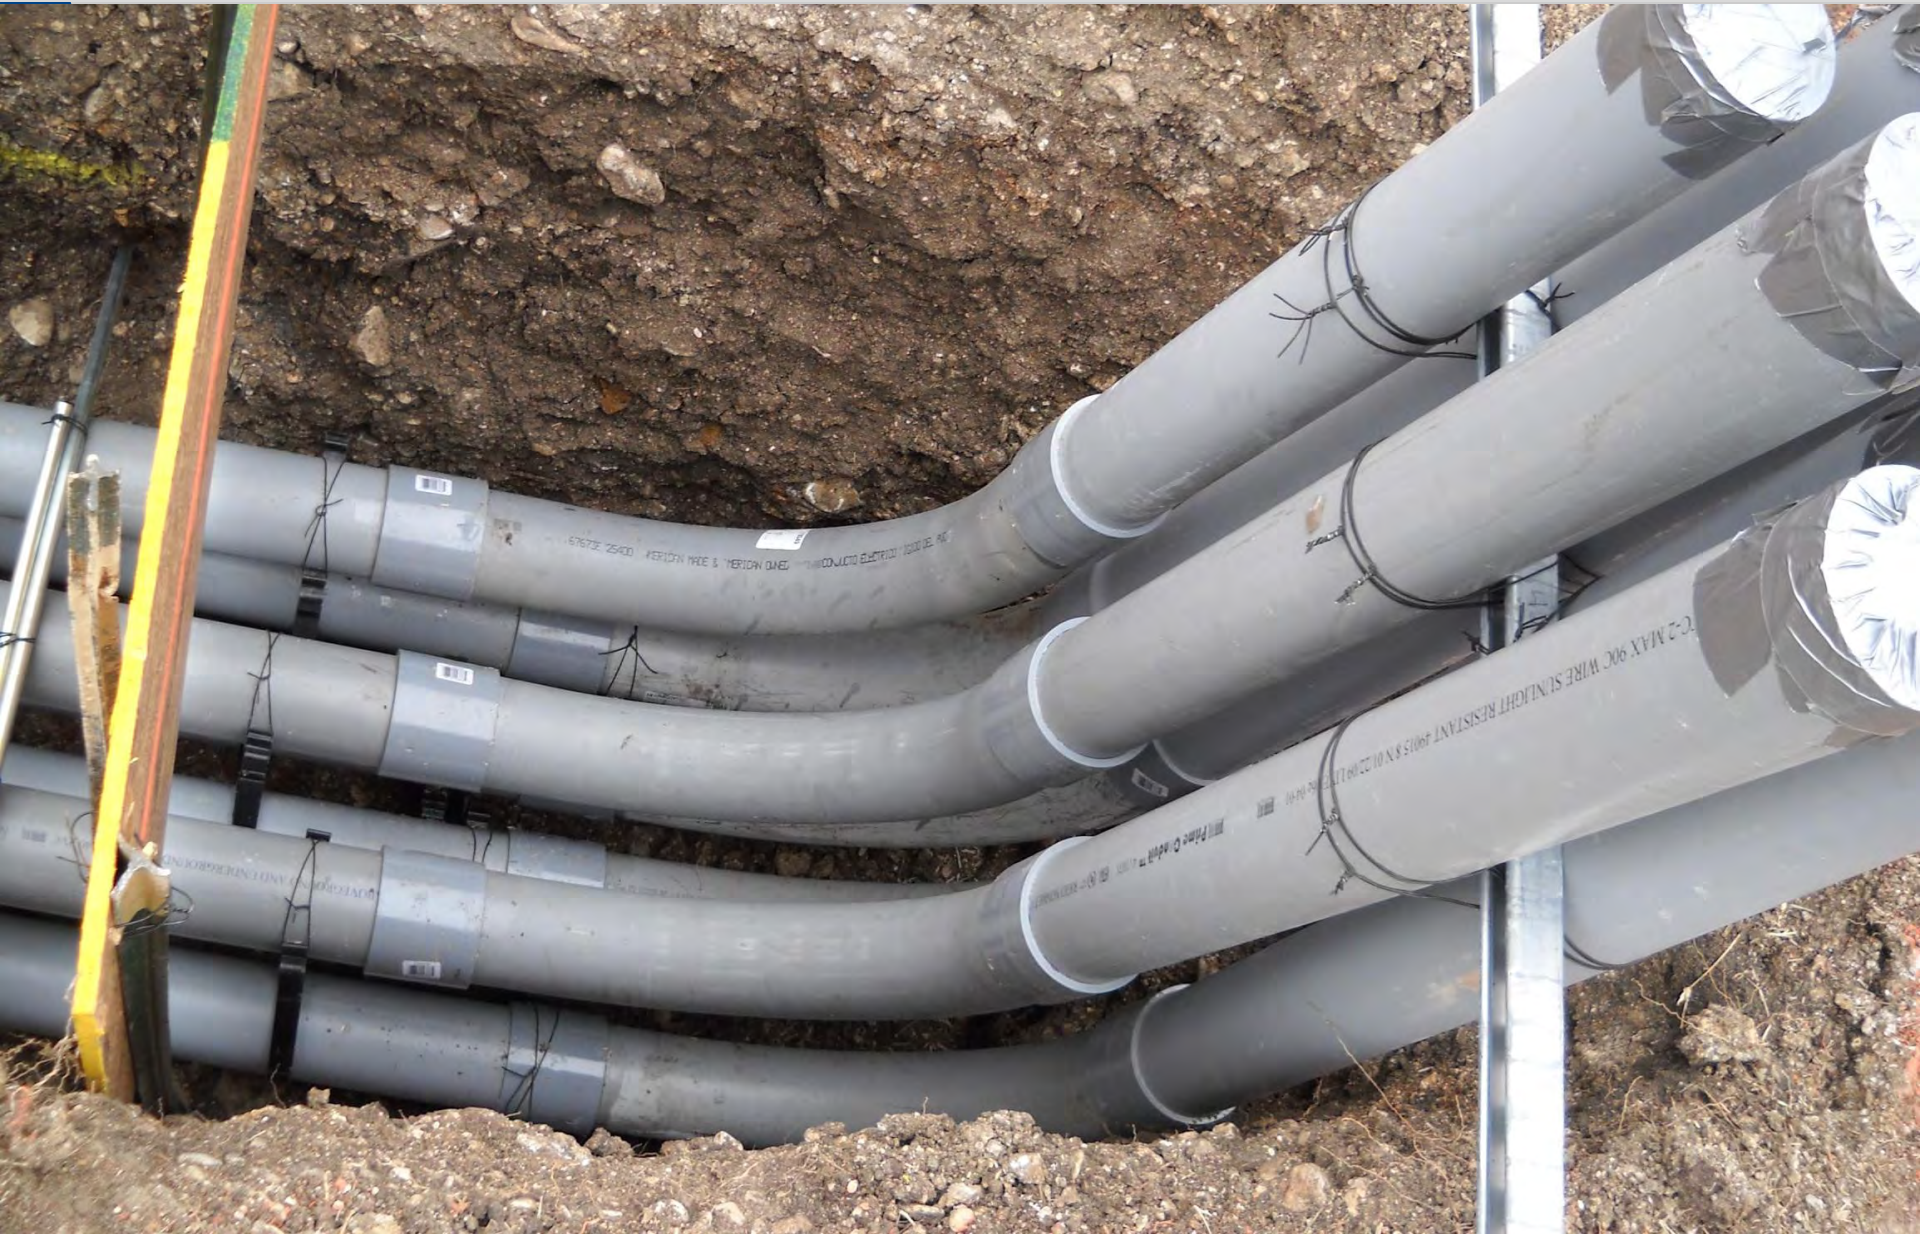
Installation of conduit for CPS Energy transformer and electrical switchgear

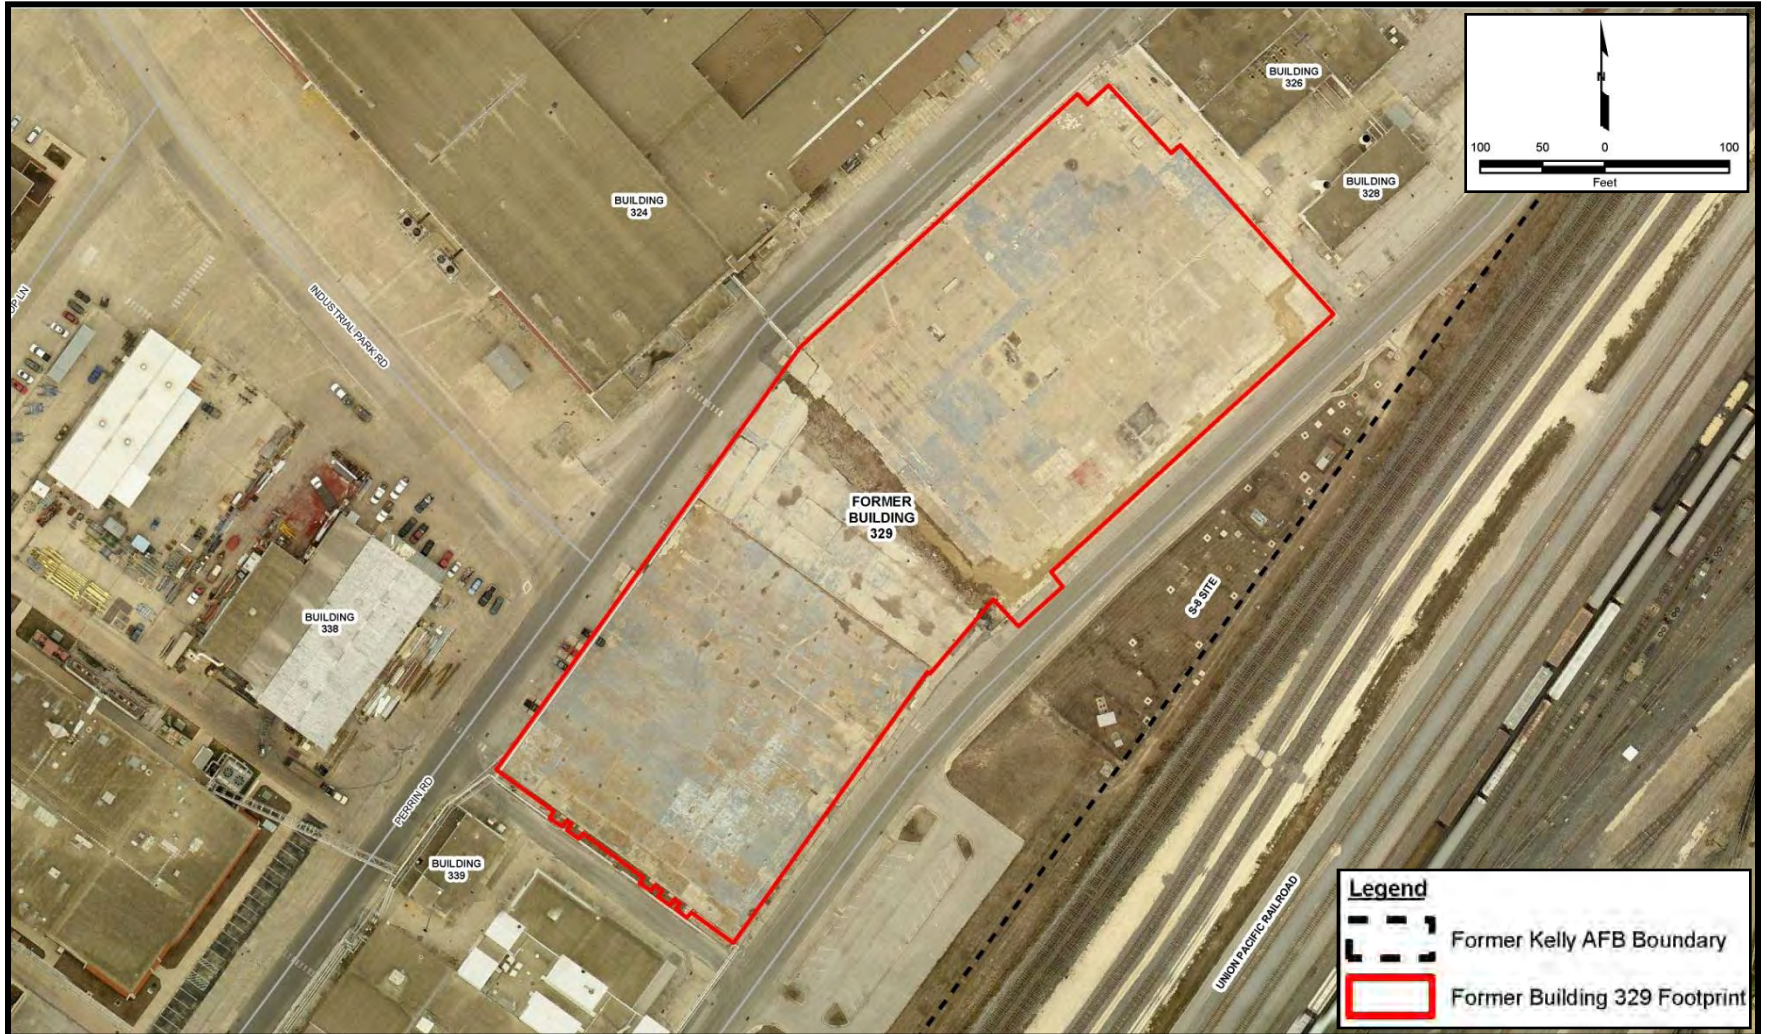
2009 Aerial Photo Former Building 329 Footprint

- **Operations began in 1917 with construction of two hangars**
- **Original Bldg. 329 constructed in 1942 on northern portion of site**
- **By 1956, the two hangars and original Bldg. 329 combined into one building**
- **Uses included aircraft parts maintenance, repair, and cleaning**
- **Automated Engine Parts Cleaning Facility (“Green Worm”) moved outside in 1950s**
