Galena Restoration Advisory Board

Mr. AL Weilbacher
BRAC Environmental Coordinator
AFCEC/CZ
10 October 2012

Former Galena Forward Operating Location

***LANDFARM
CONSTRUCTION/OPERATION
& ROAD RECONSTRUCTION***

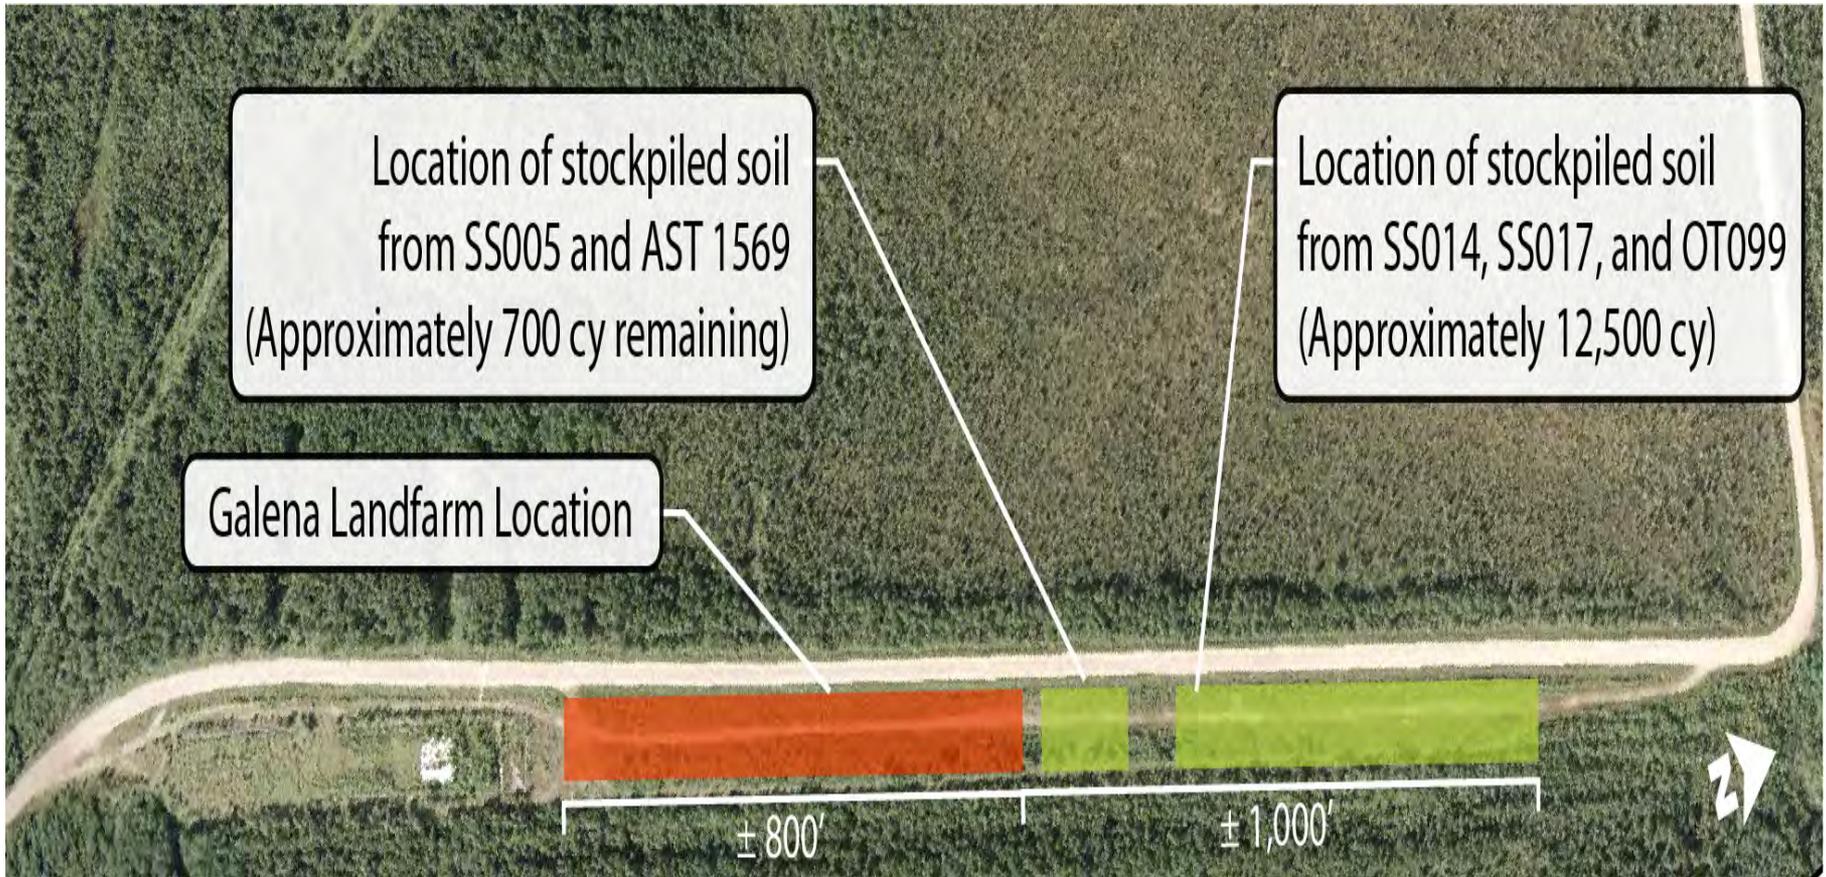
Landfarm and Stockpile Location

- **Landfarm treatment area approx. 760' x 55'**
- **3' high berms constructed with soil screened from former Campion airstrip grubblings**
- **12' wide gravel access road on west side**
- **Gravel decon area in southwest corner**
- **2,100 cy of contaminated soil placed 18" deep in landfarm**
- **All disturbed areas re-seeded**

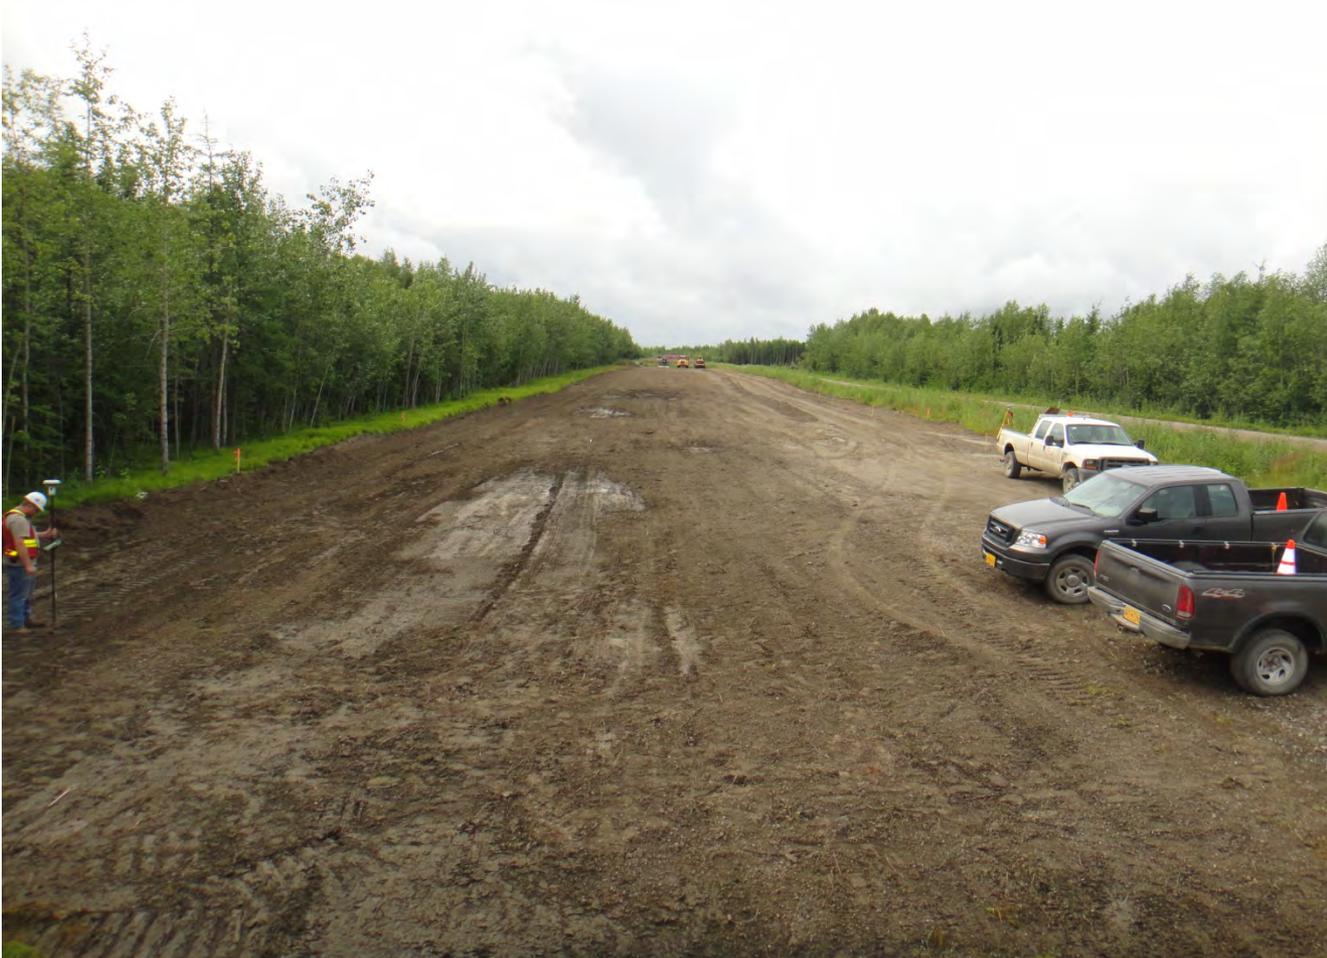
Landfarm Area after Grubbing (looking south)

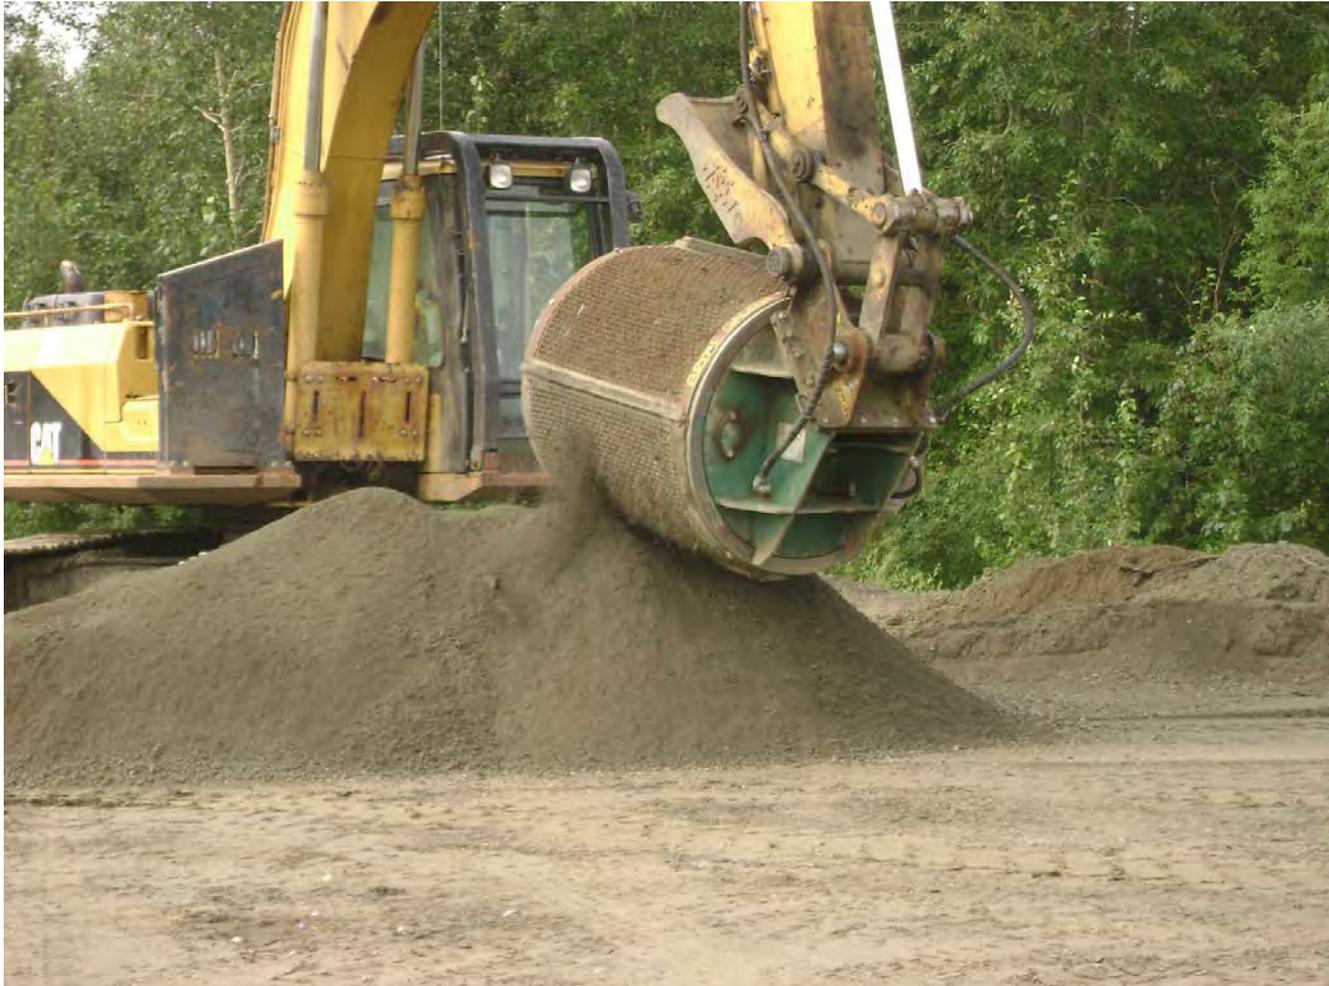
Screening Stockpiled Soil for Berm Construction

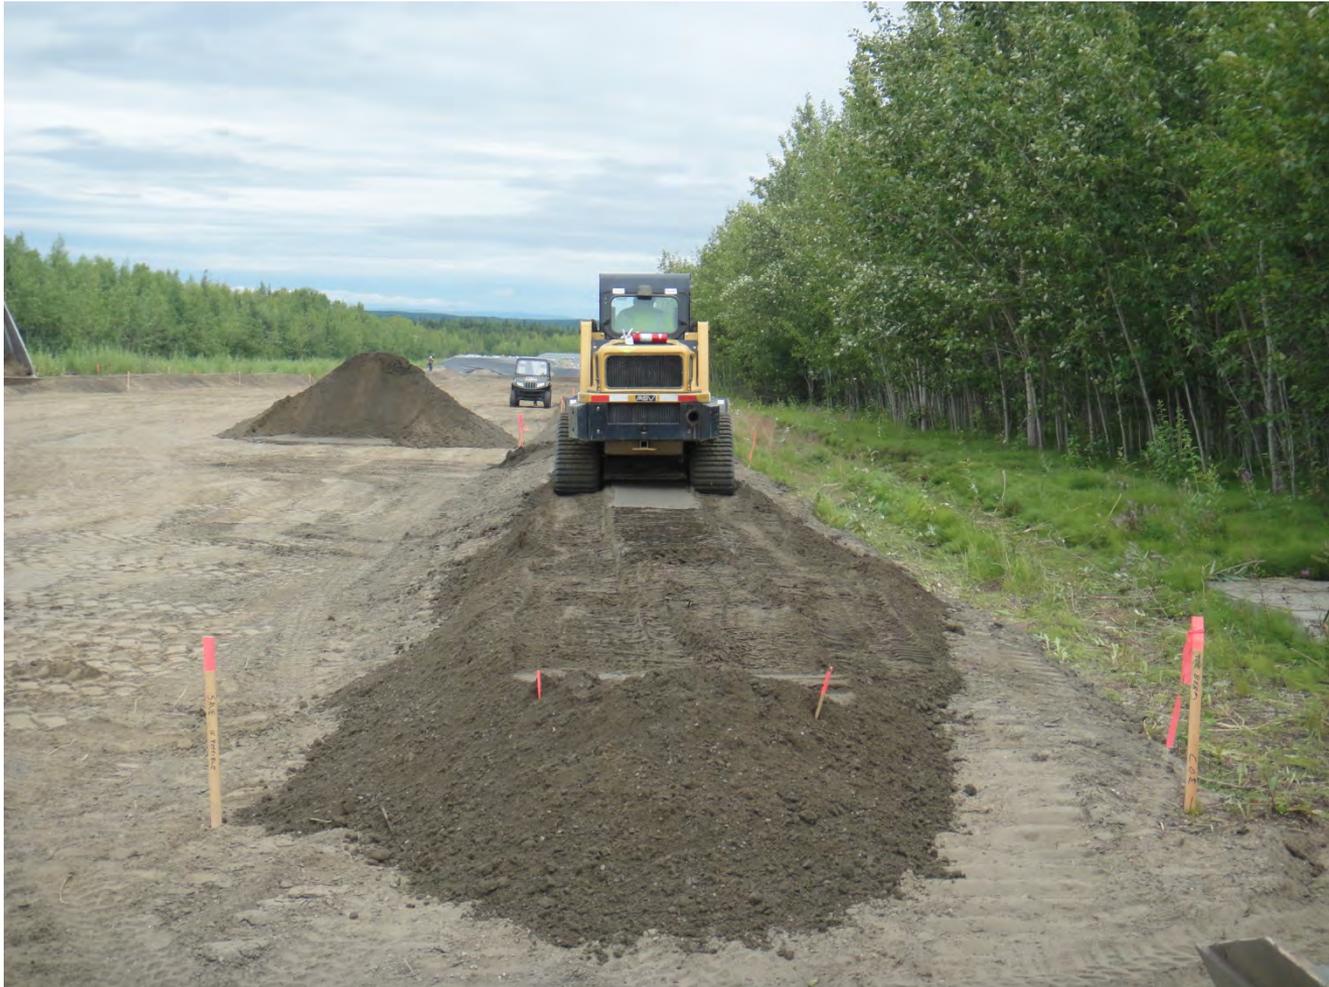
Landfarm Berm Construction (looking north)

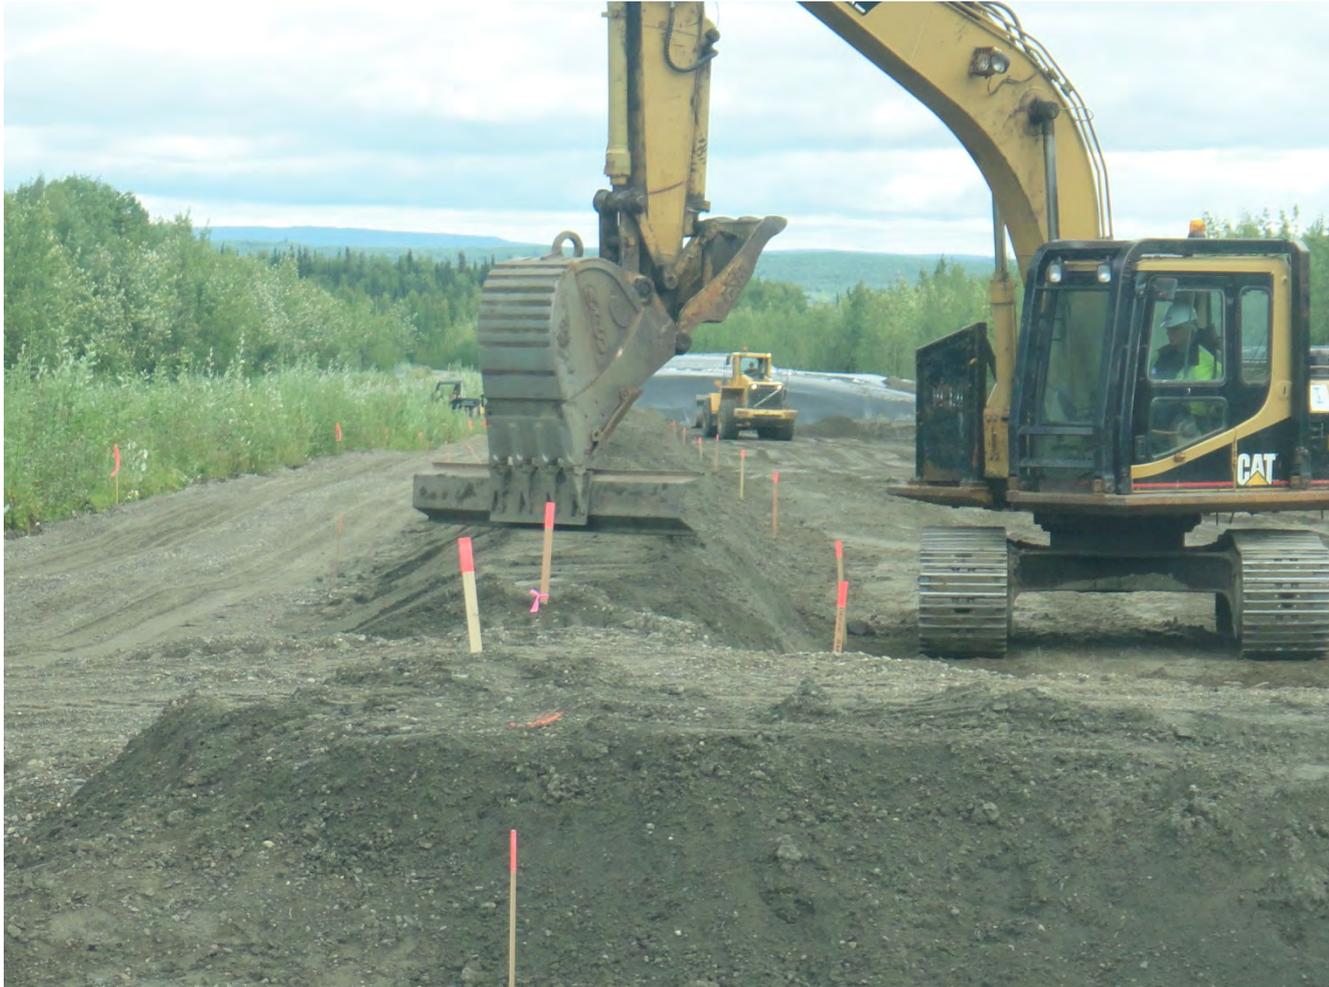
Shaping Southwest Corner of Landfarm Berm

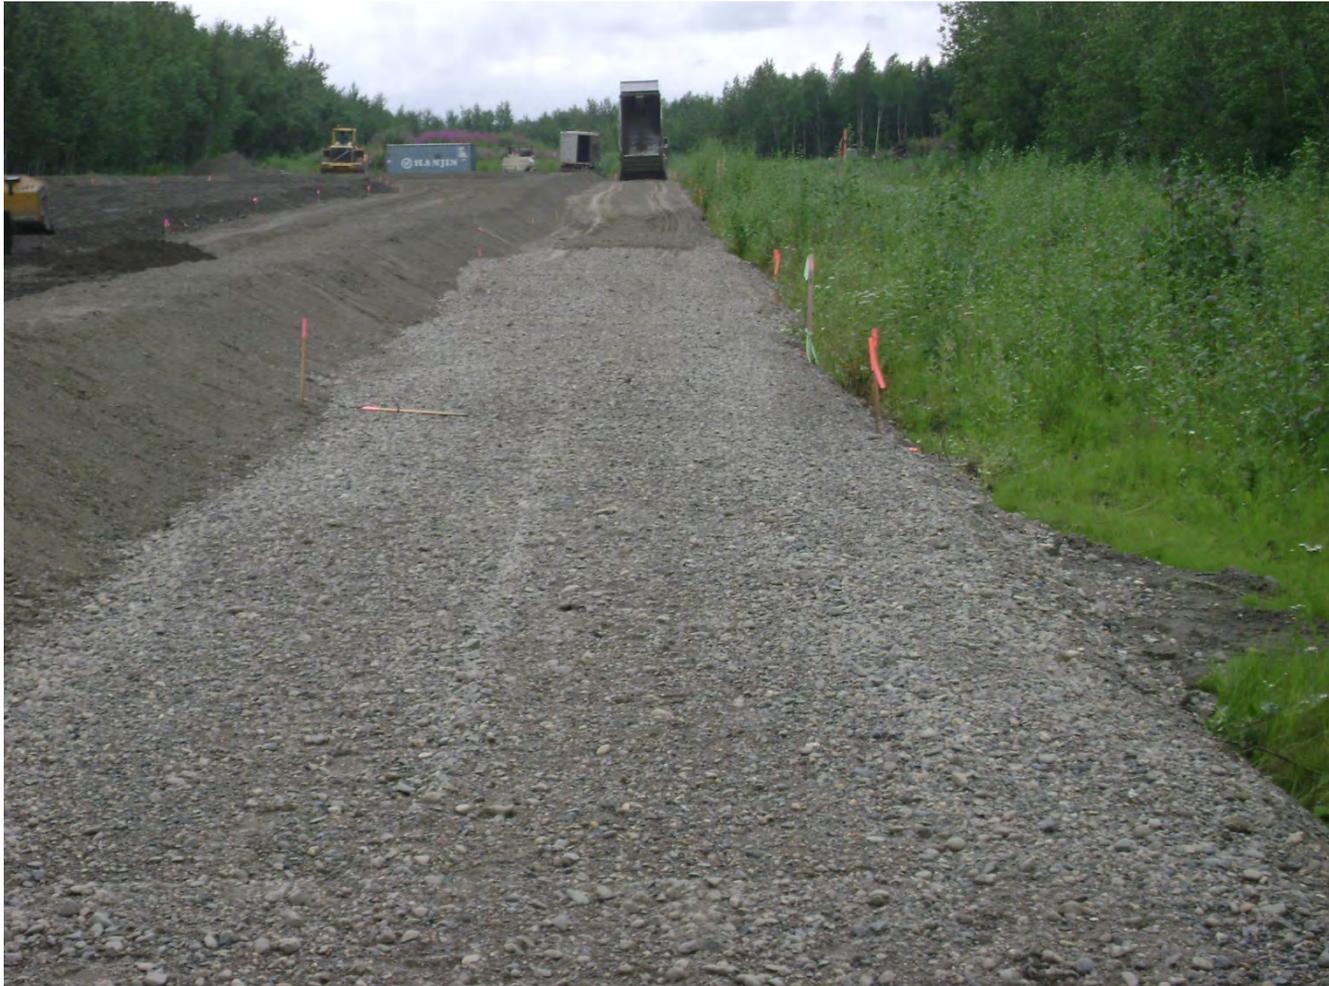
Constructing Gravel Access Pad (looking south)

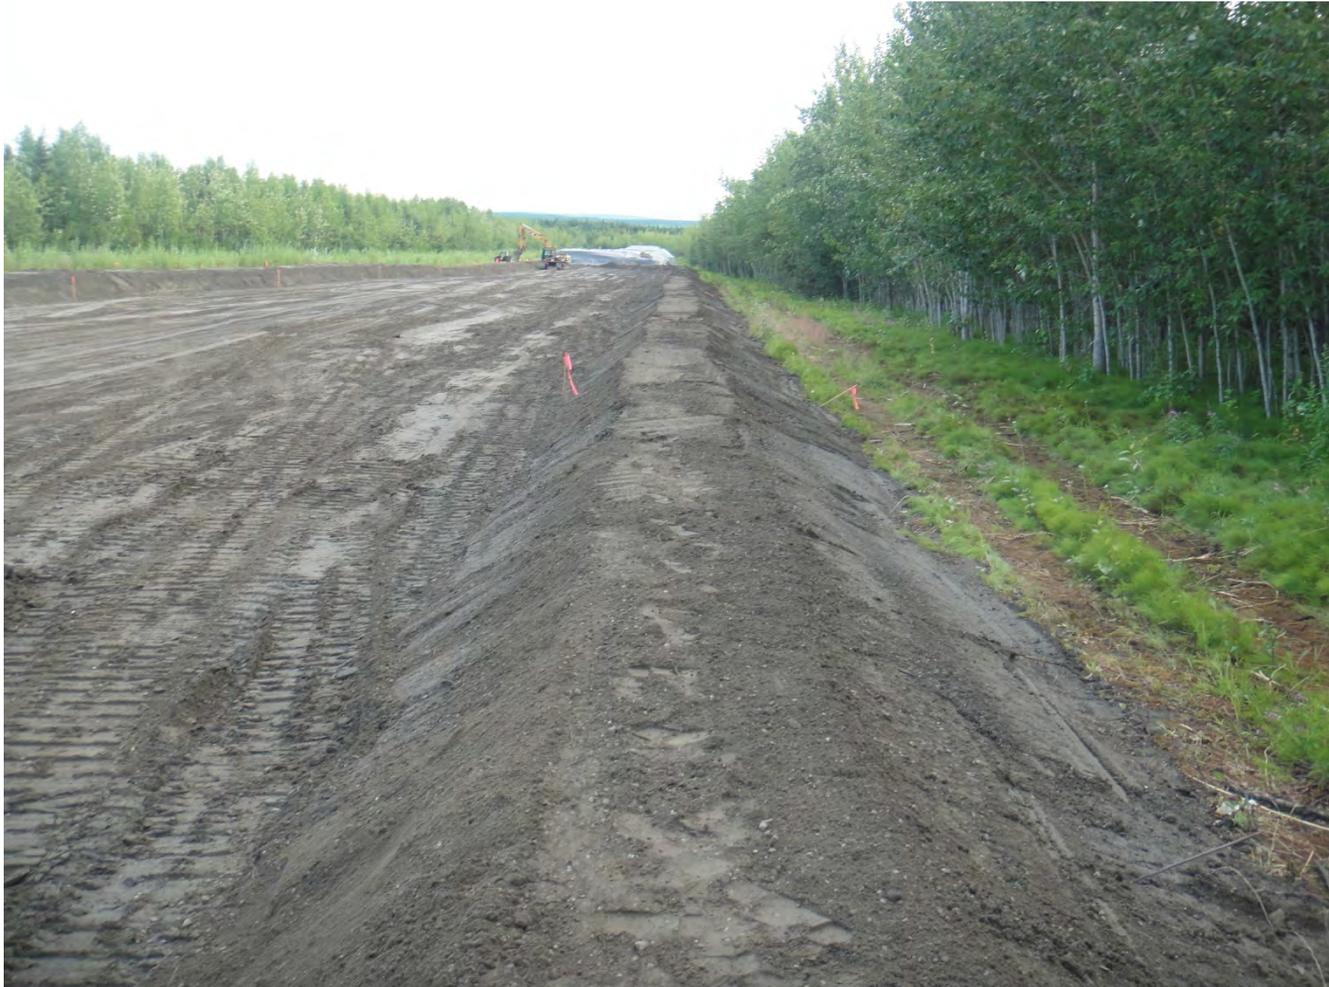
Completed East Berm (looking north)

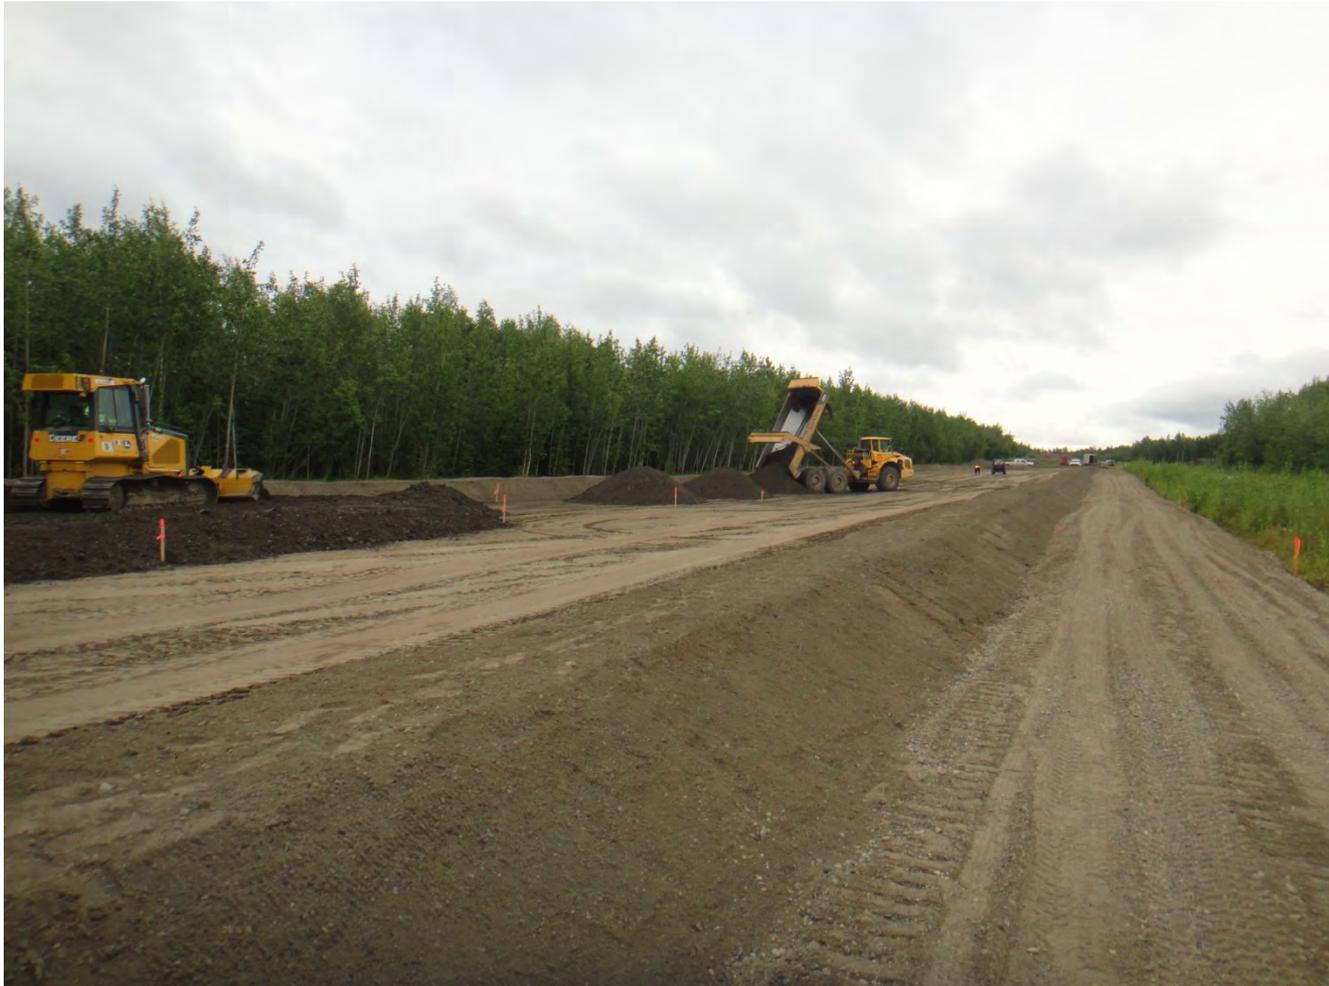
Placing Contaminated Soil in the Landfarm (looking south)

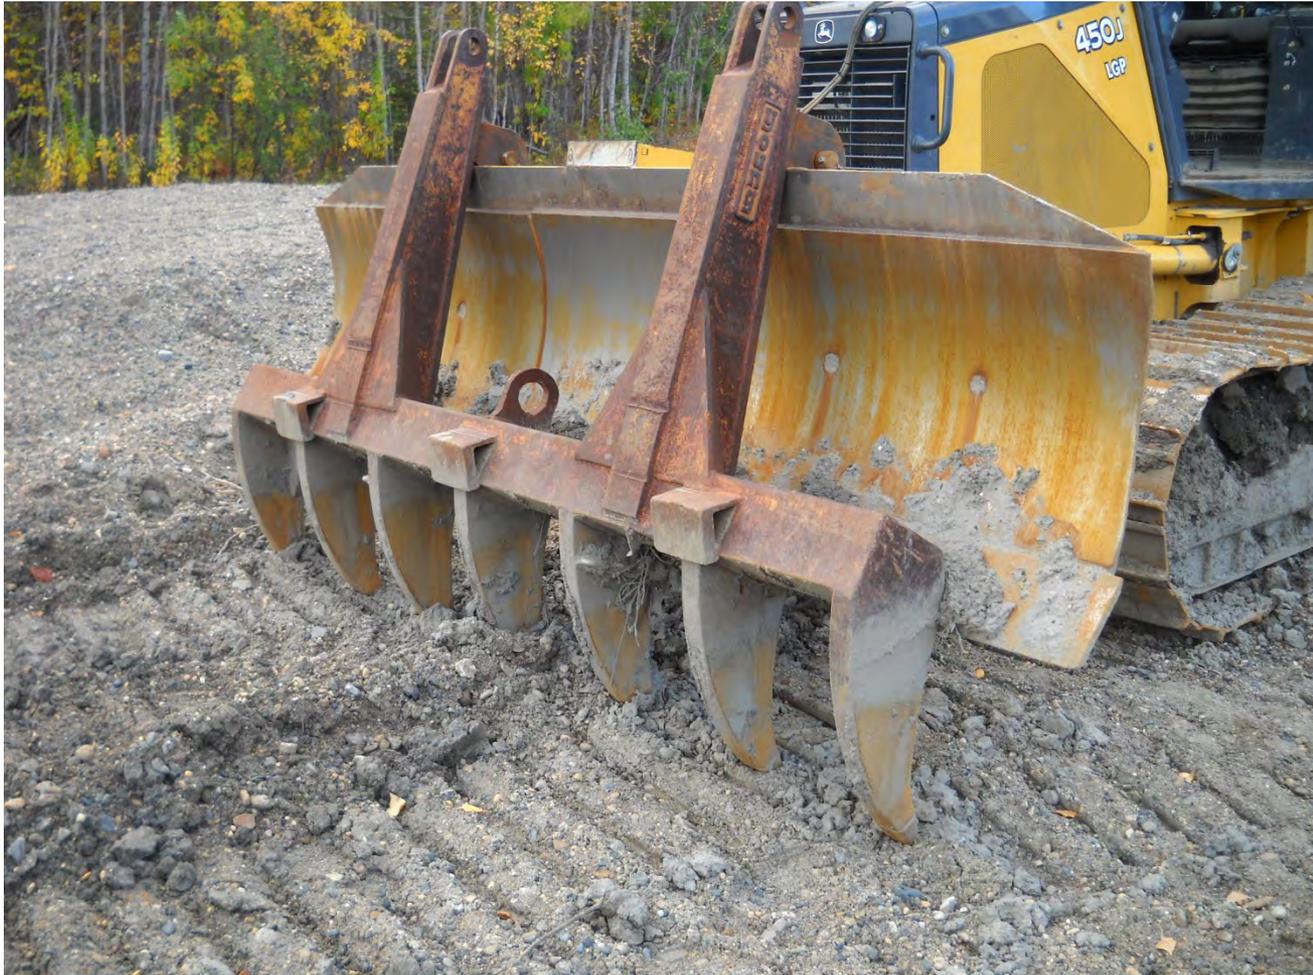
Tilling Equipment

- **Landfarm tilled once/week with dozer equipped with multi-shank ripper**
- **7 weekly tilling events occurred in 2012 -- Aug 6th through September 21st**
- **Fertilizer spread on landfarm prior to 1st tilling to aid in biodegradation**
- **Landfarm winterized in October**
 - **North berm reduced in height**
 - **Polyethylene cover/sandbags placed over entire landfarm area**

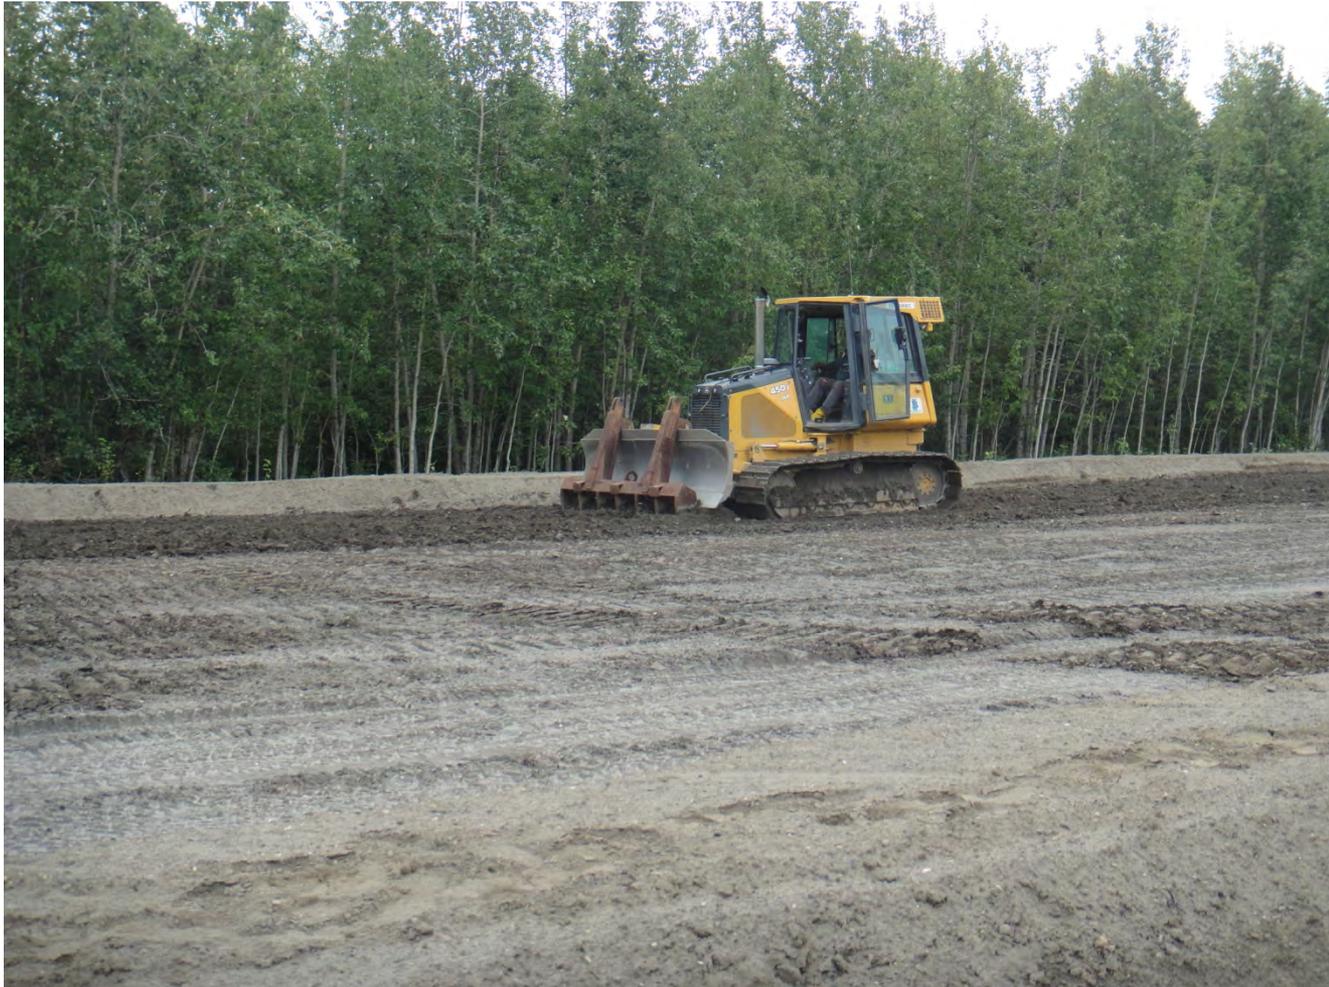
Landfarm Tilling

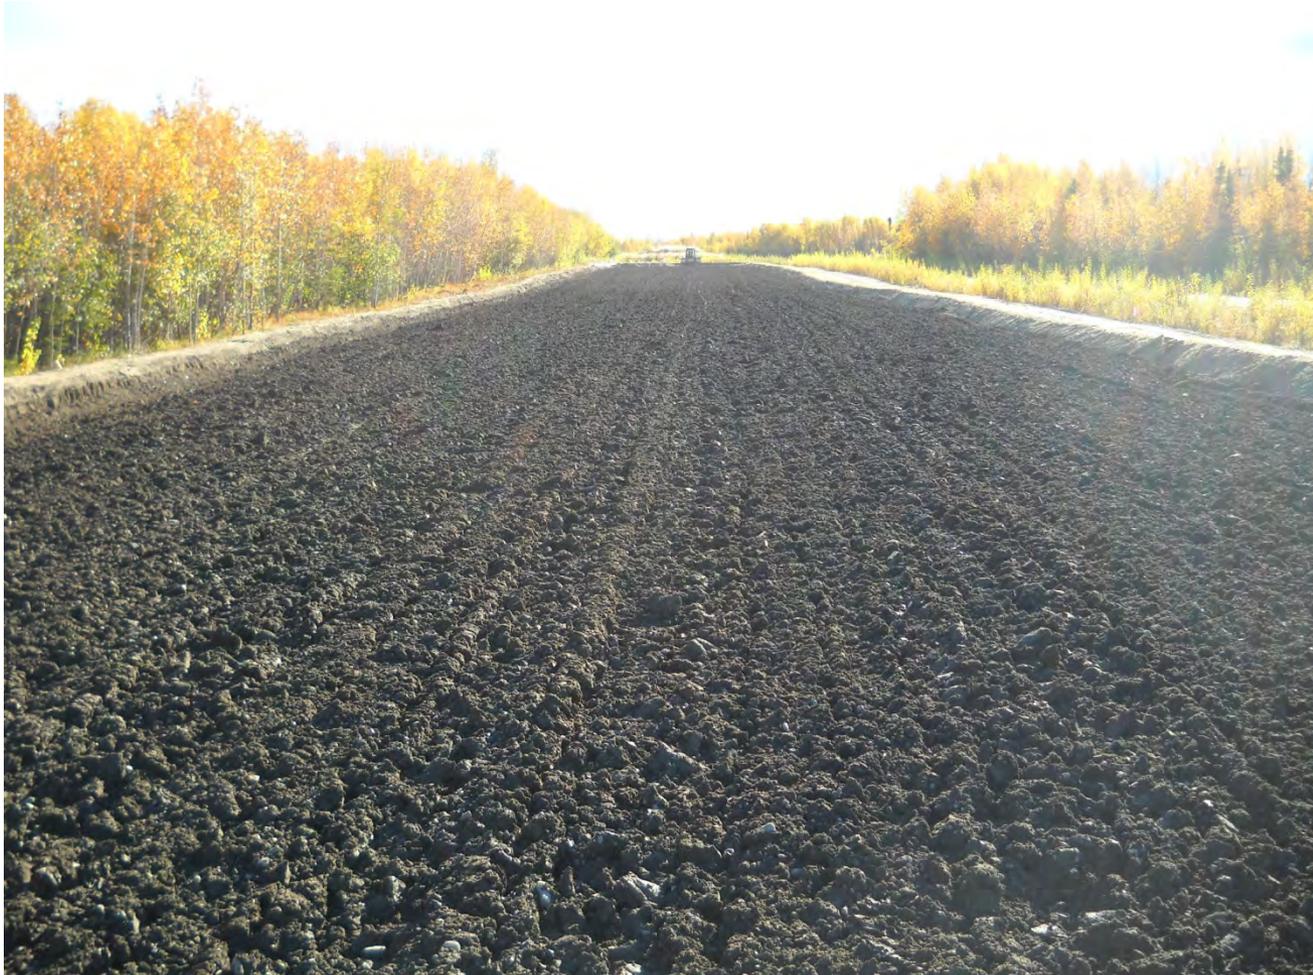
Tilled Landfarm (looking south)

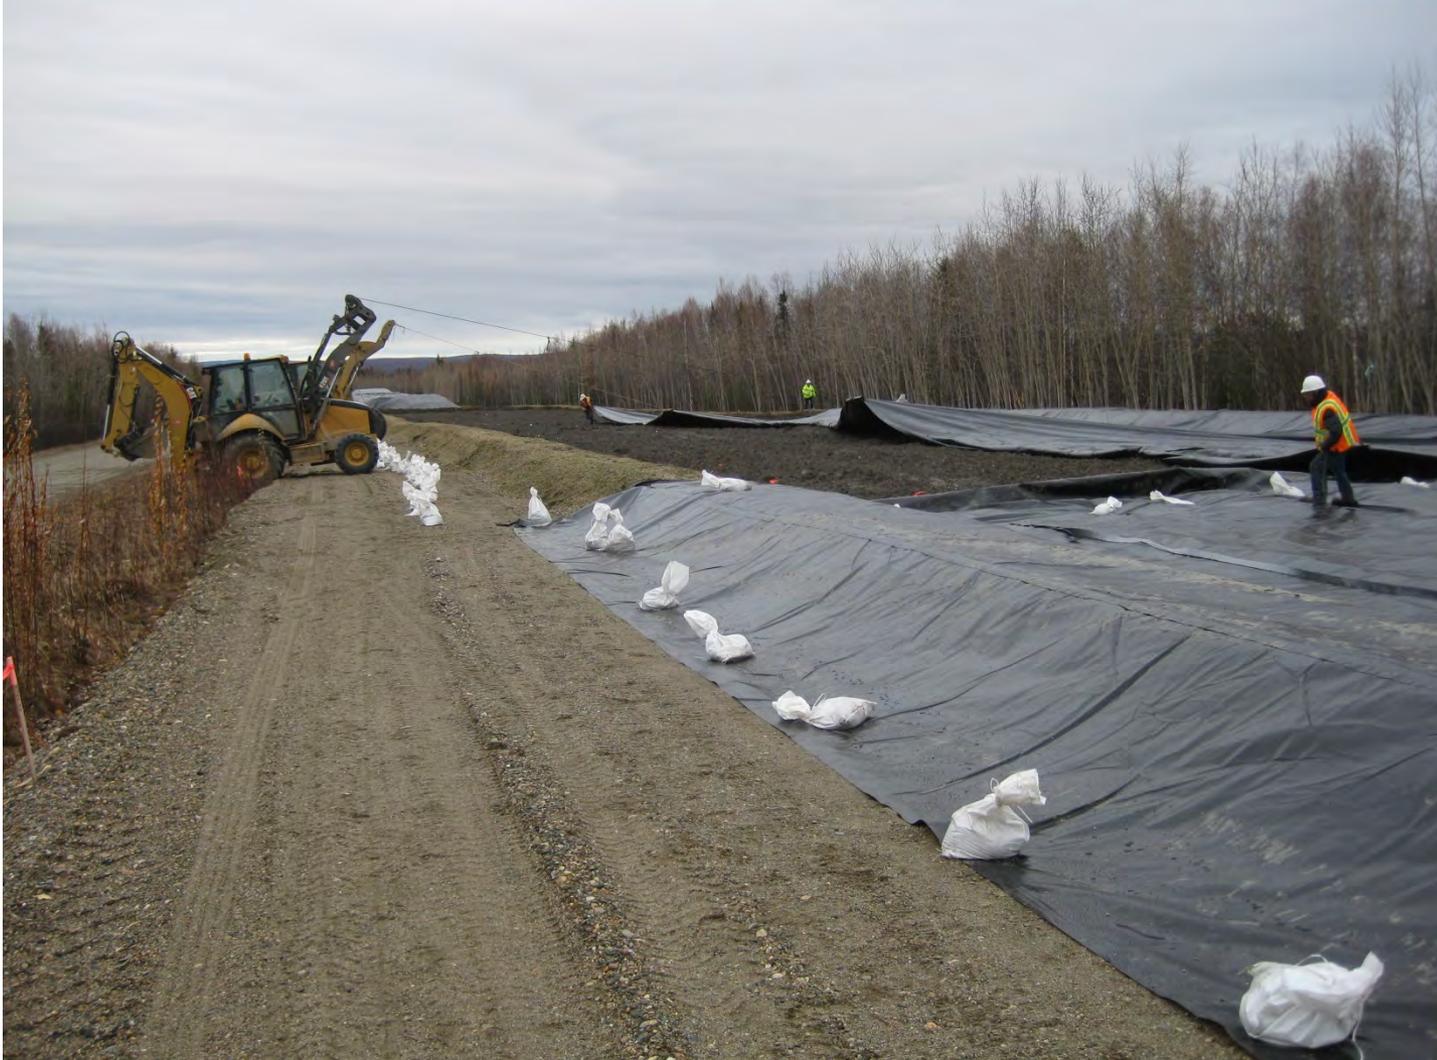
Placing Landfarm Cover

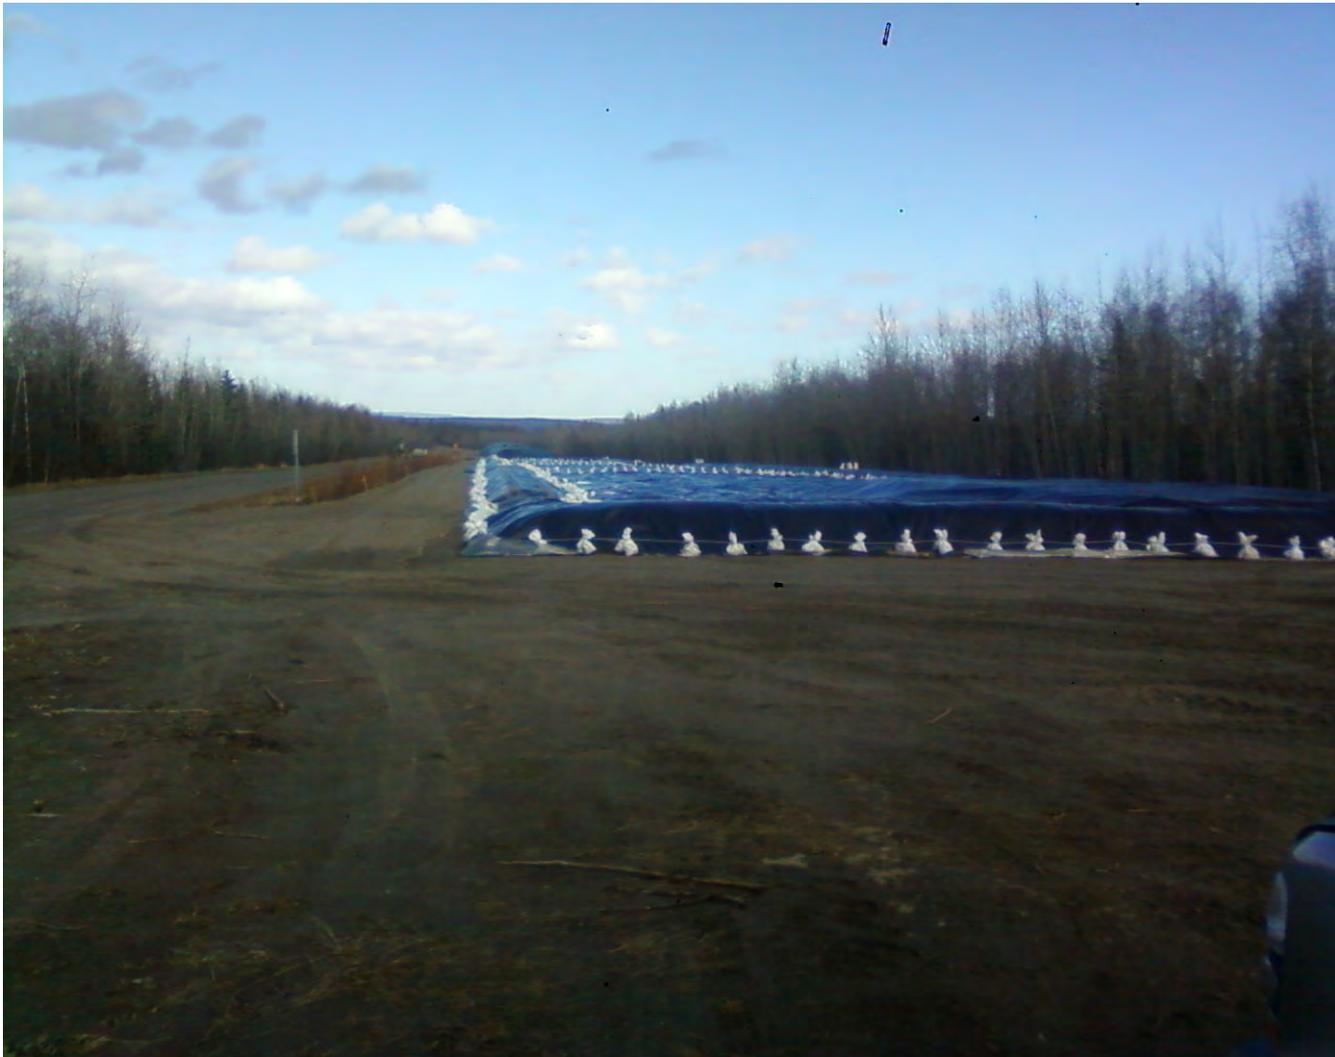
Winterized Landfarm

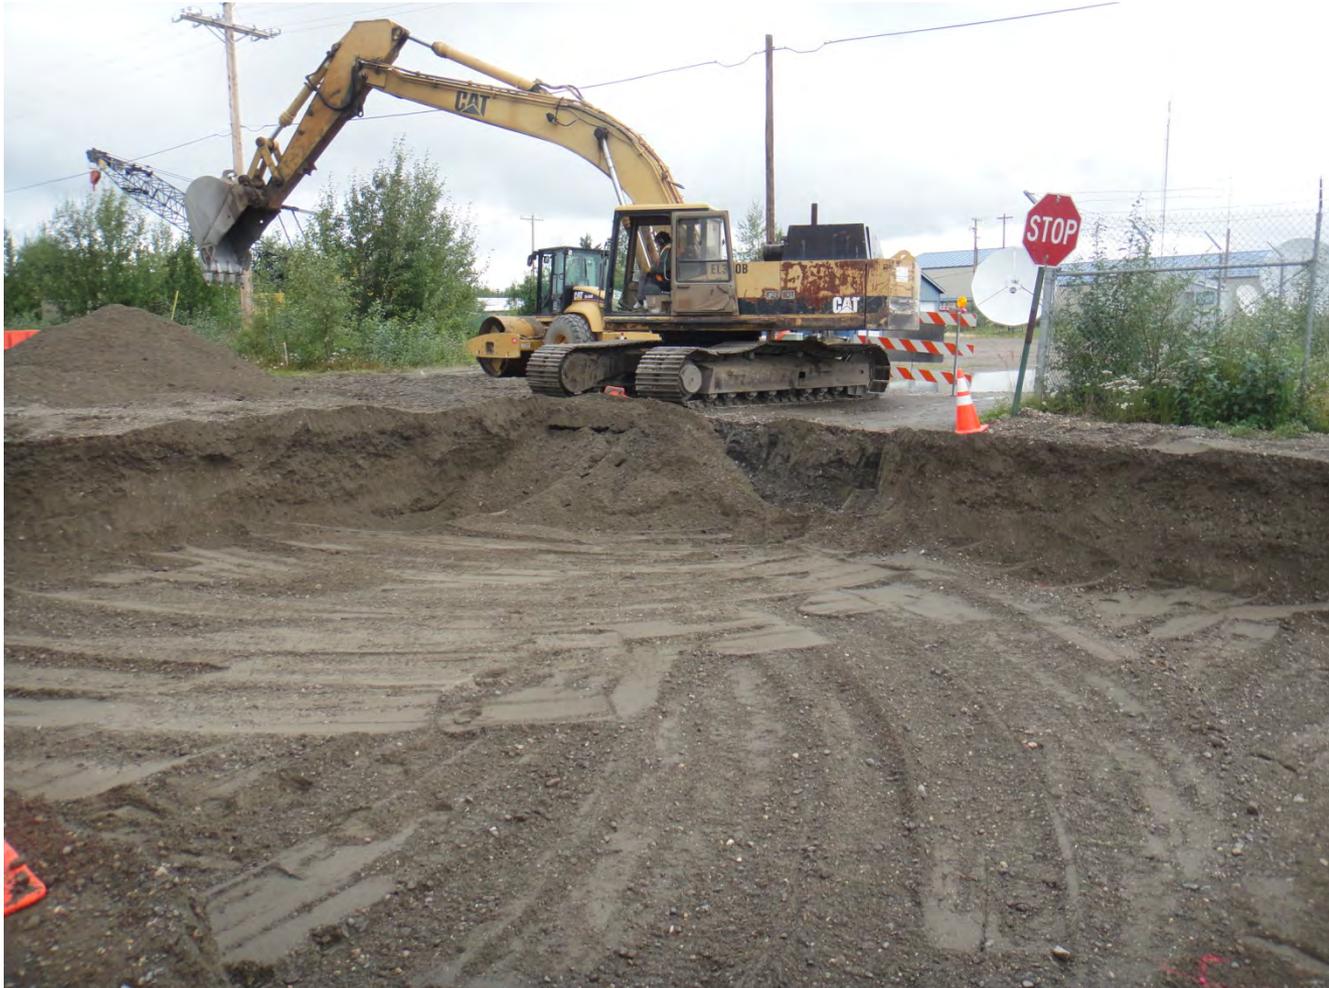
Subgrade Excavation on Birchwood Ave. (looking N/W)

- **Road reconstruction required at the intersection of Birchwood Avenue, Airport Road, and Levy Road**
 - **Delayed until 2012 to maximize excavation of contaminated soil in 2011**
 - **Performed according to ADOT requirements**
 - **Scope included:**
 - **Remove and recompact top 42” of subgrade to achieve 95% compaction**
 - **Screen local gravel and amend with silt to meet ADOT F-1 road surfacing gradation**
 - **Place 6” thickness of F-1 material to achieve 98% compaction**
 - **Blend in Calcium Chloride for dust suppression**
-

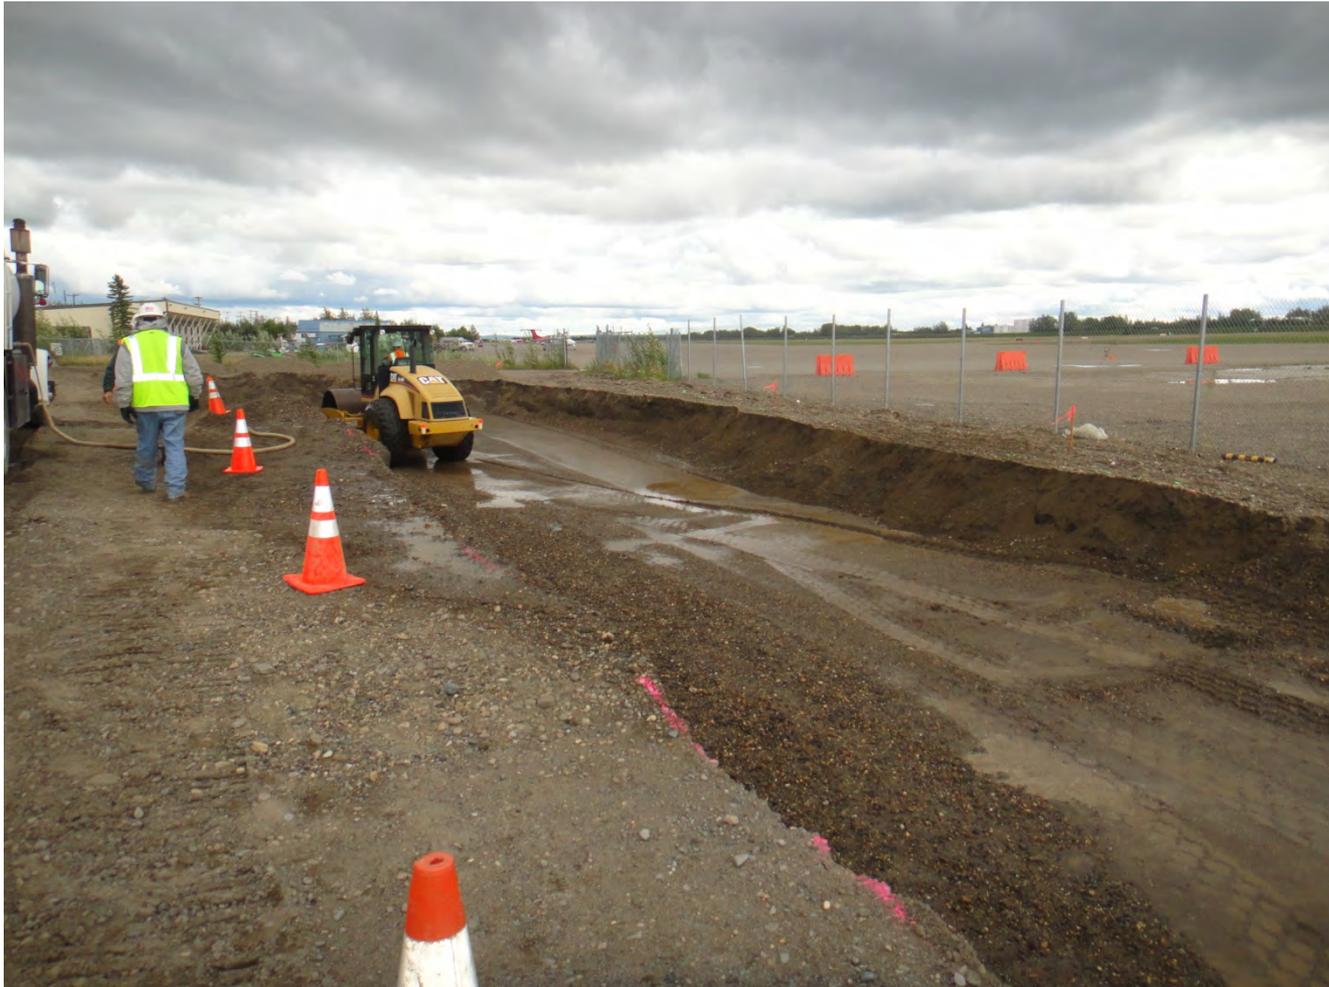
Subgrade Backfill and Compaction (looking east)

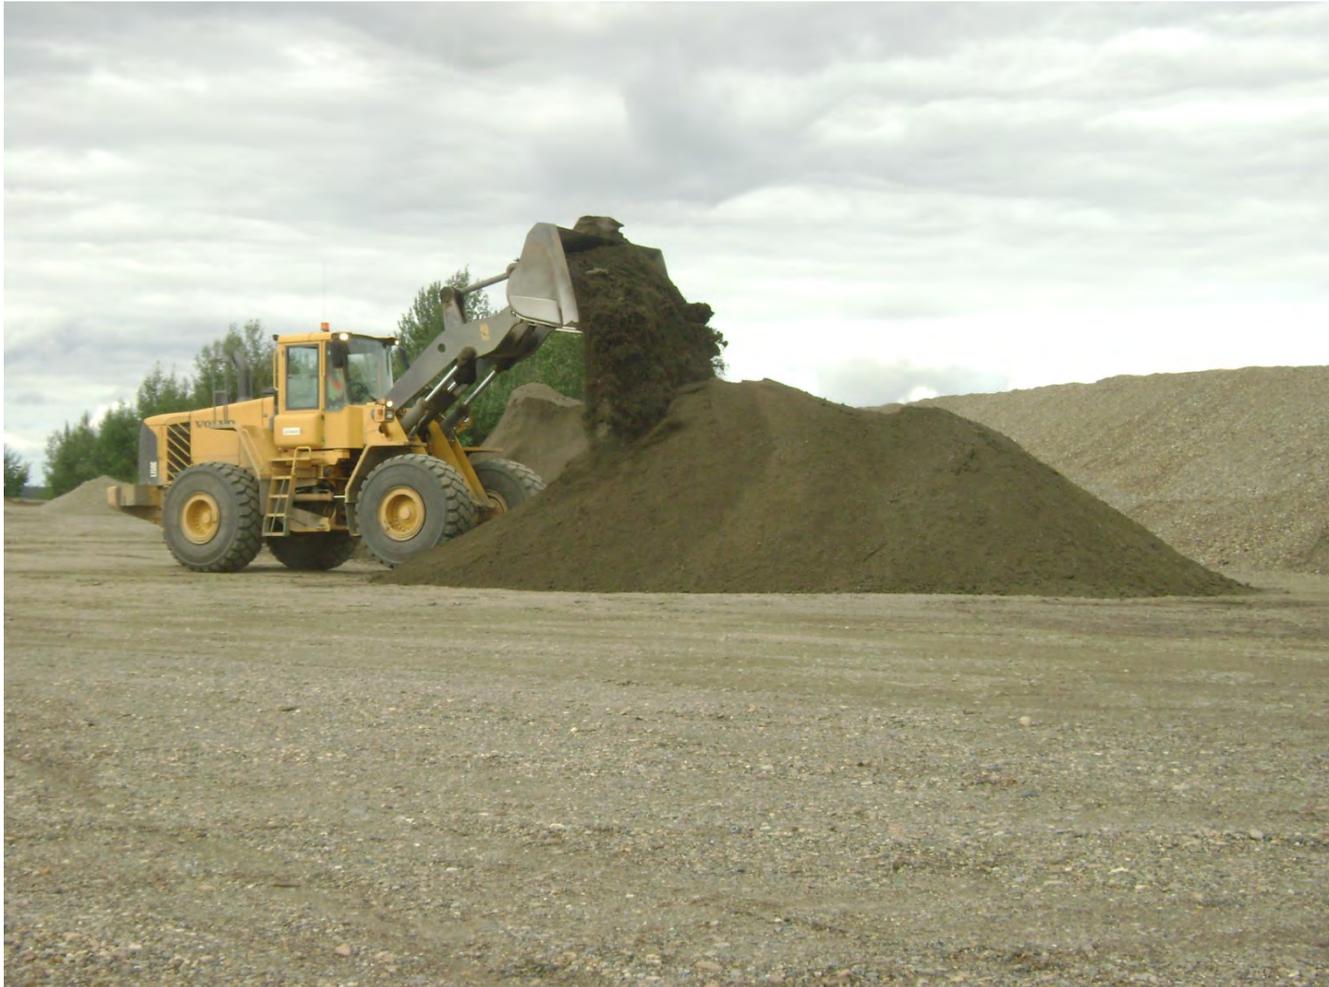
Blending Gravel and Silt to Meet ADOT F-1 Specification

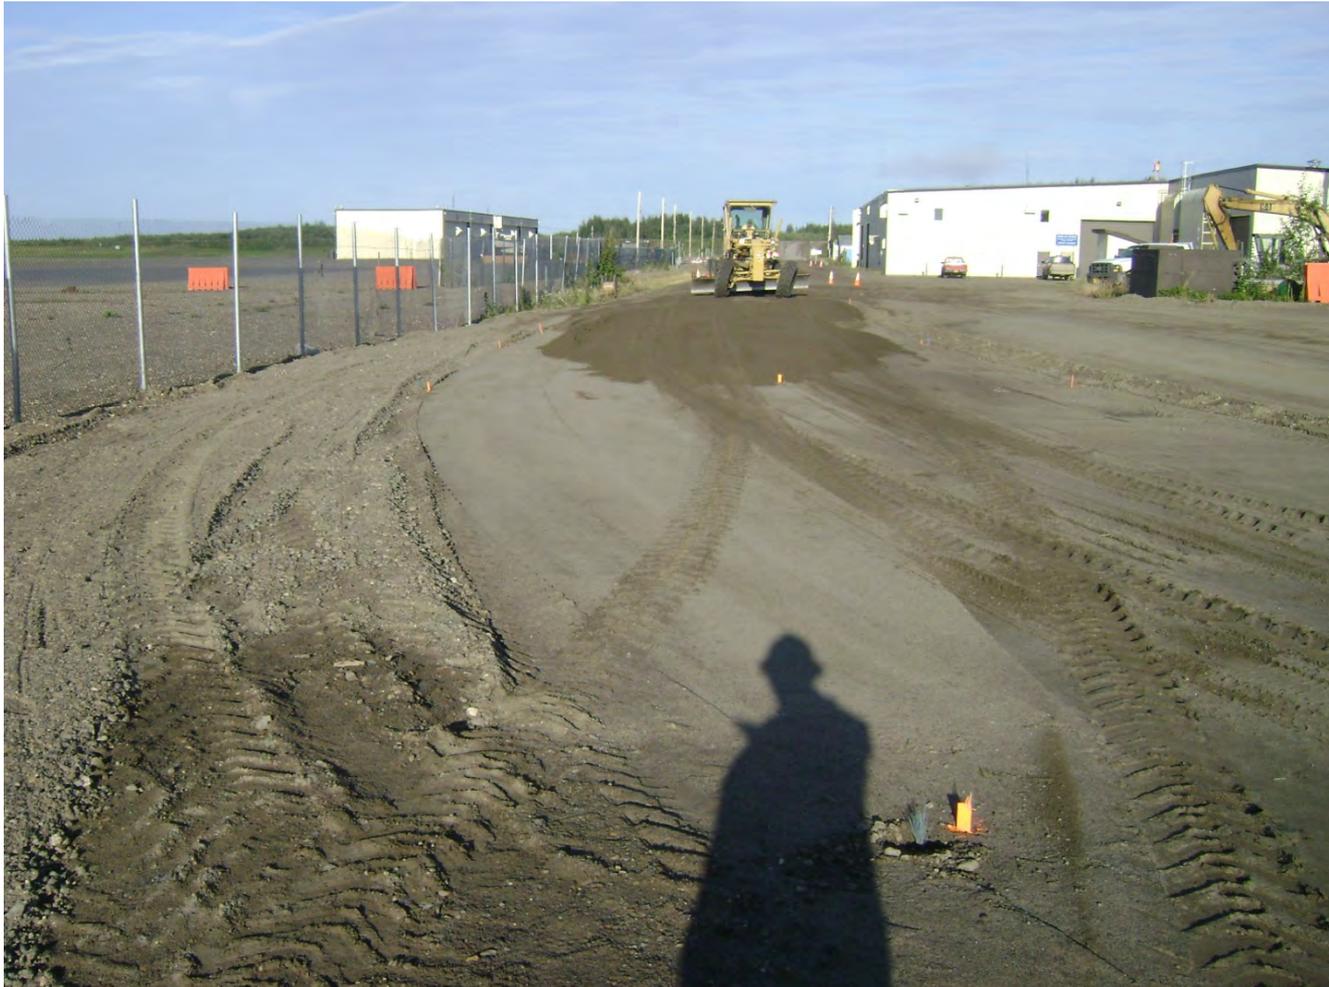
Placing F-1 Surfacing Material (looking west)
