Galena Restoration Advisory Board

Mr. AL Weilbacher
BRAC Environmental Coordinator
AFCEC/CZ
10 October 2012

Former Galena Forward Operating Location

***LANDFARM
CONSTRUCTION/OPERATION
& ROAD RECONSTRUCTION***

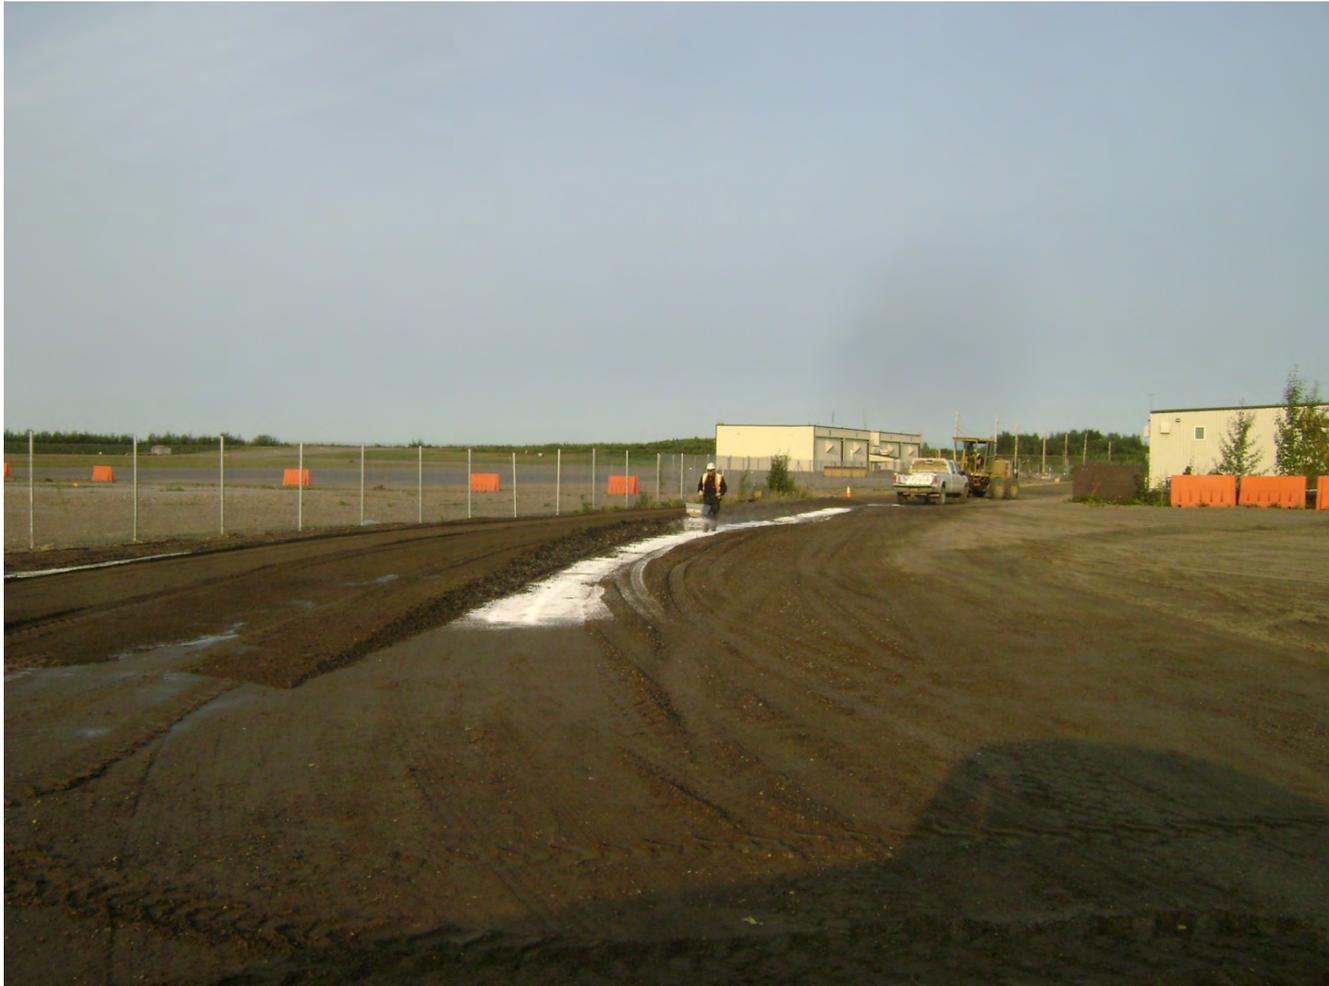
Adding Calcium Chloride (looking west)

- **Road reconstruction required at the intersection of Birchwood Avenue, Airport Road, and Levy Road**
 - **Delayed until 2012 to maximize excavation of contaminated soil in 2011**
 - **Performed according to ADOT requirements**
 - **Scope included:**
 - **Remove and recompact top 42” of subgrade to achieve 95% compaction**
 - **Screen local gravel and amend with silt to meet ADOT F-1 road surfacing gradation**
 - **Place 6” thickness of F-1 material to achieve 98% compaction**
 - **Blend in Calcium Chloride for dust suppression**
-

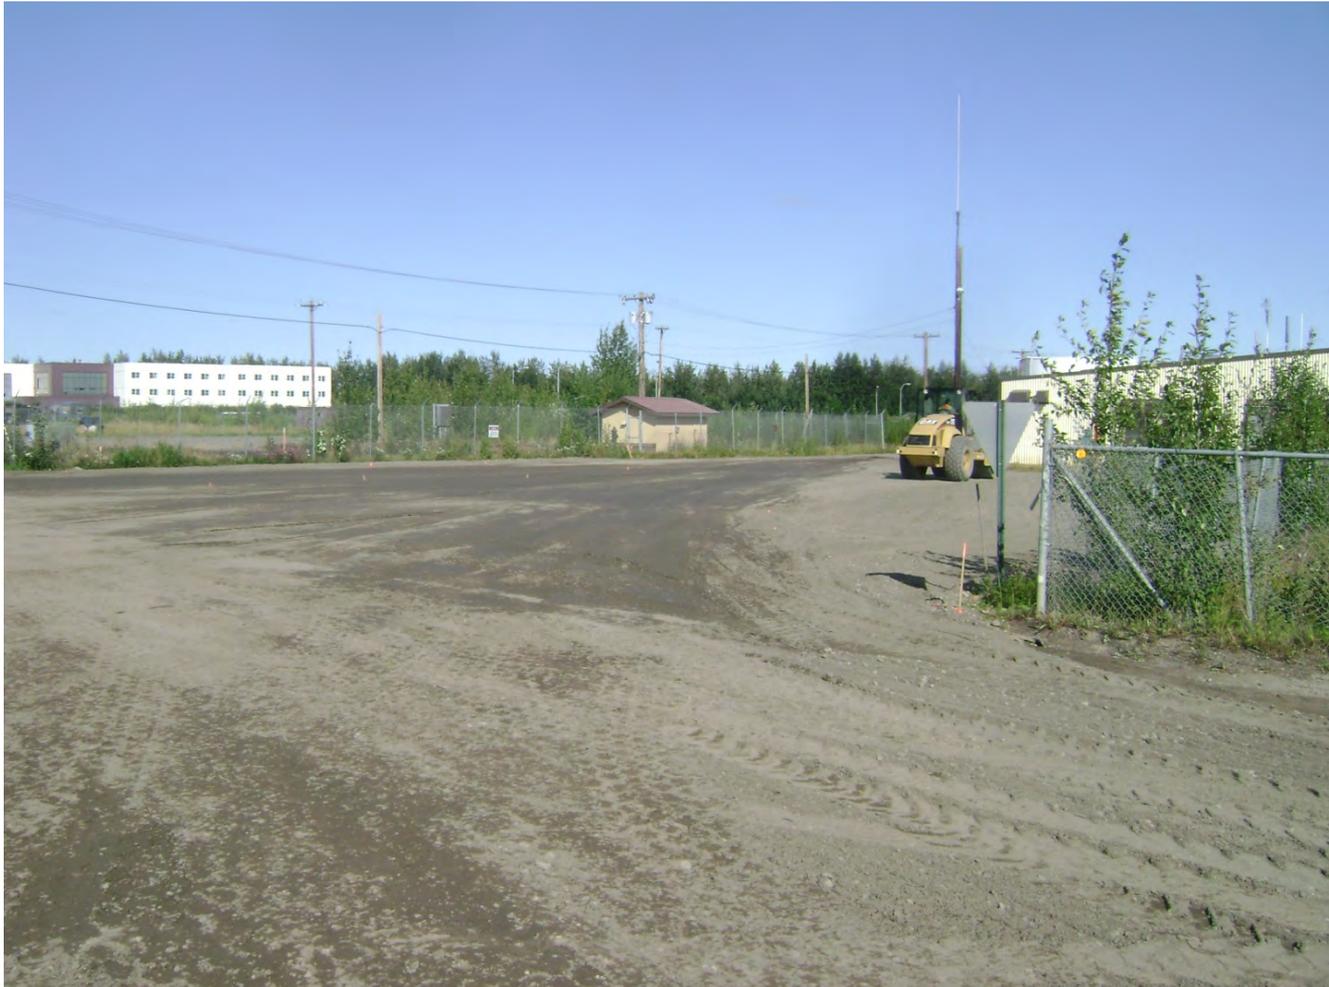
Completed Road Reconstruction (looking N/E)

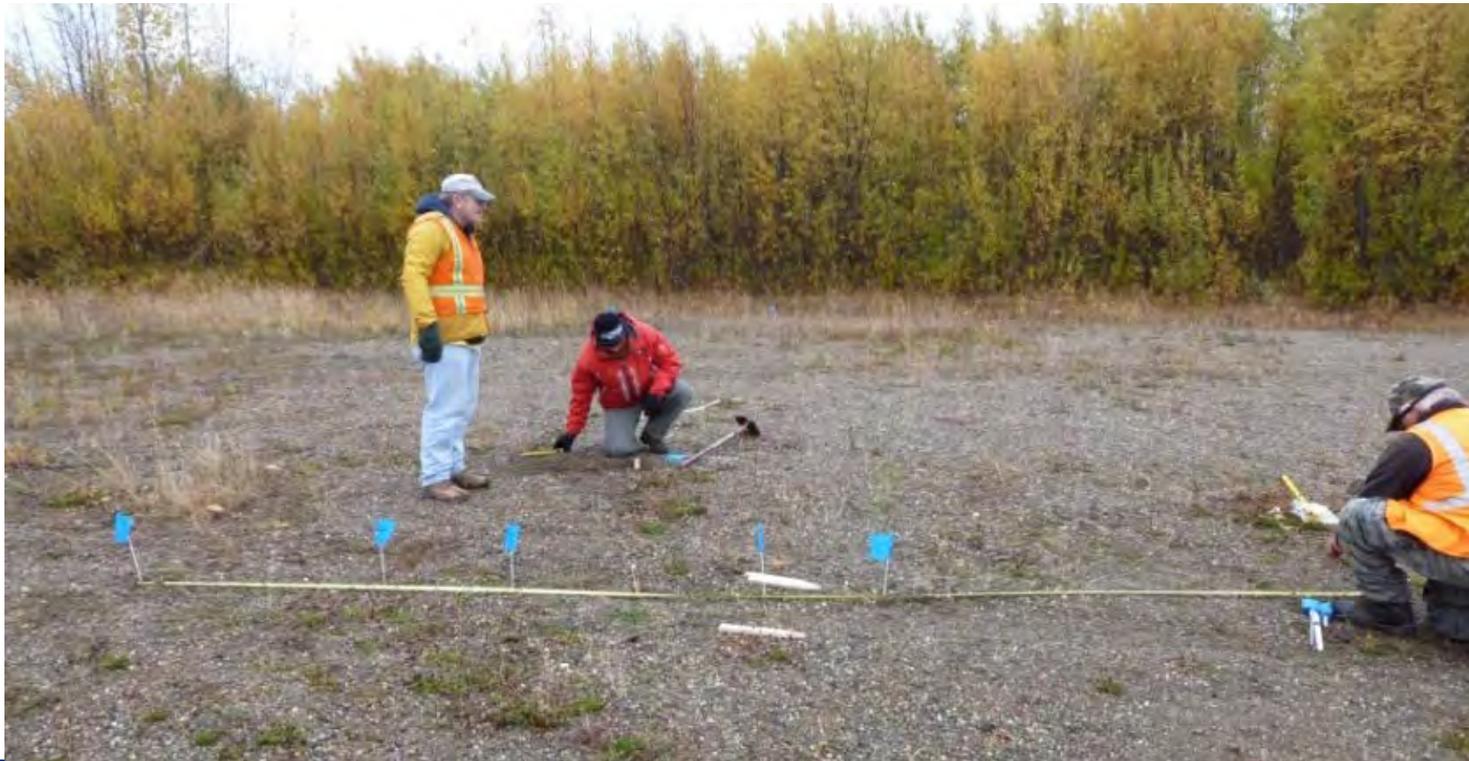
- Instrument Verification Strip (IVS)
 - Verifies equipment is operating properly through the detection of Industry Standard Objects (ISOs) buried in specific locations, depths, and orientations.

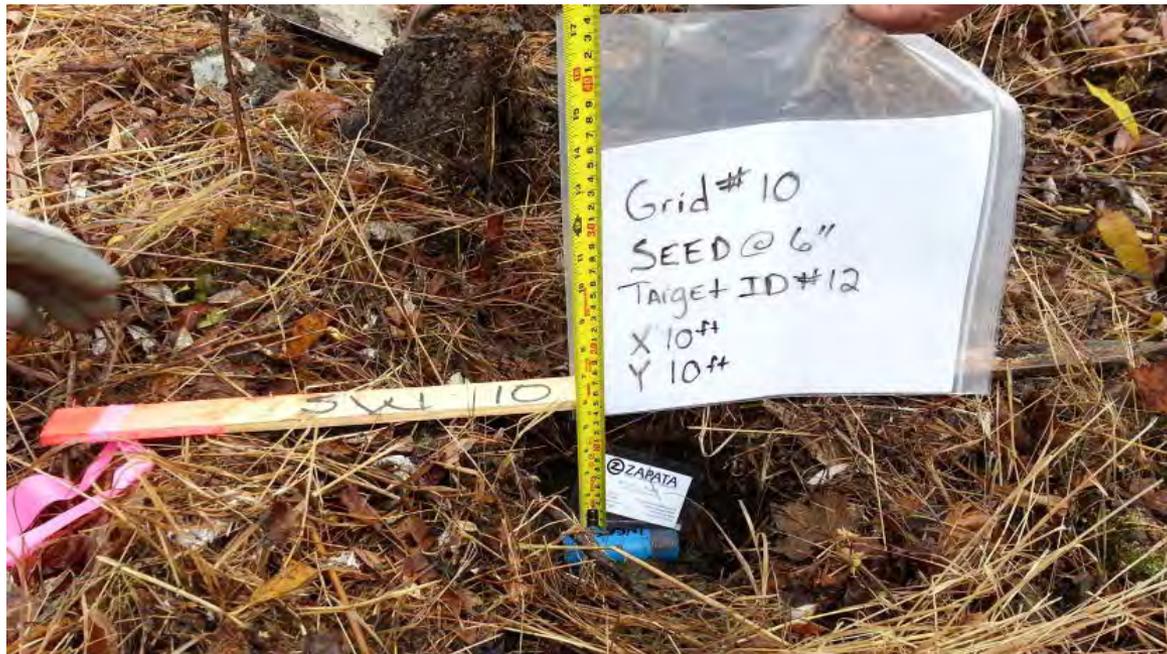
- Blind seeding the ISOs
 - Inert pieces of 1-inch piping, with a geophysical signature similar to munitions, are buried at locations unknown to the geophysical team
 - Ensures the team can locate munitions in the field

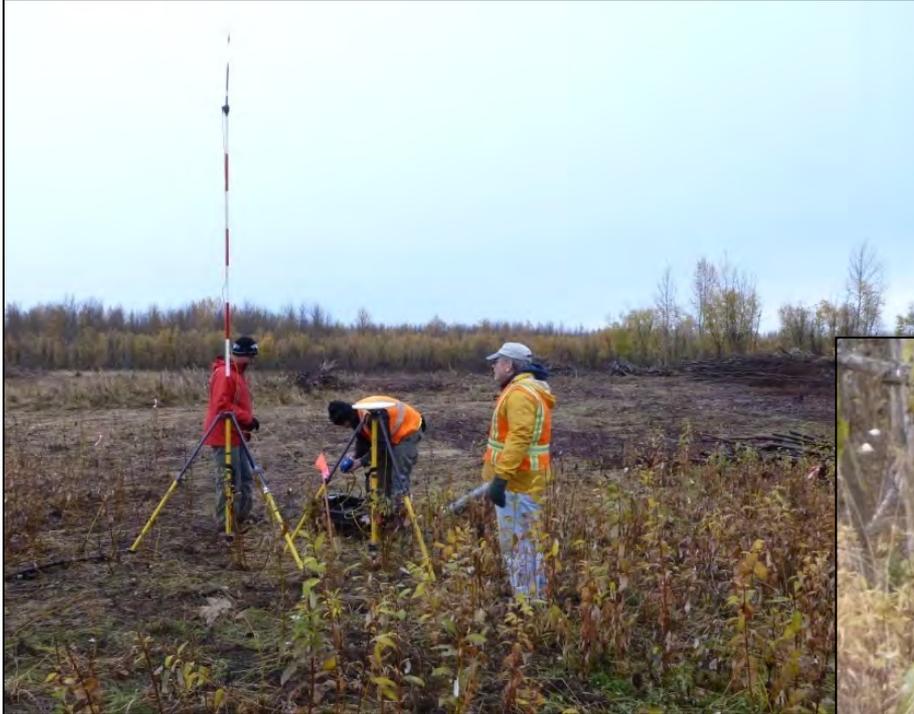
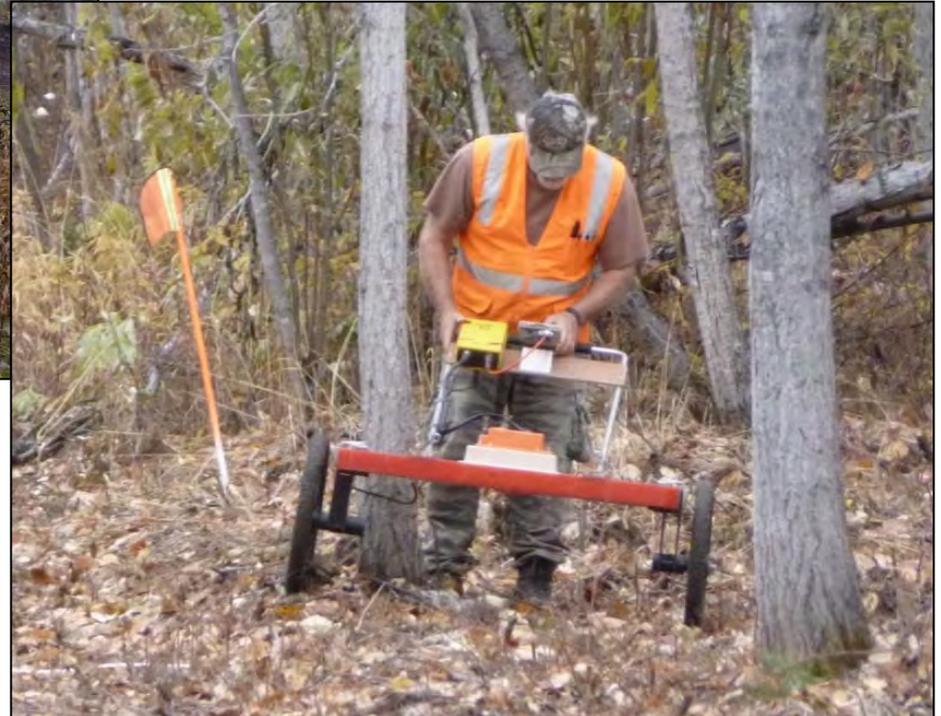
Geophysical Surveying

- **UXO surface sweeps prior to fieldwork at each site to ensure safety of onsite personnel**
- **Surveying of site boundaries**
- **Vegetation clearance at Parcel D grids and SOBS**
- **Digital geophysical surveying at Parcel D grids, SOBS, Hot Cargo Pad, Former Building 1400 and South Apron perimeter**
- **All workers were escorted by bear guards**

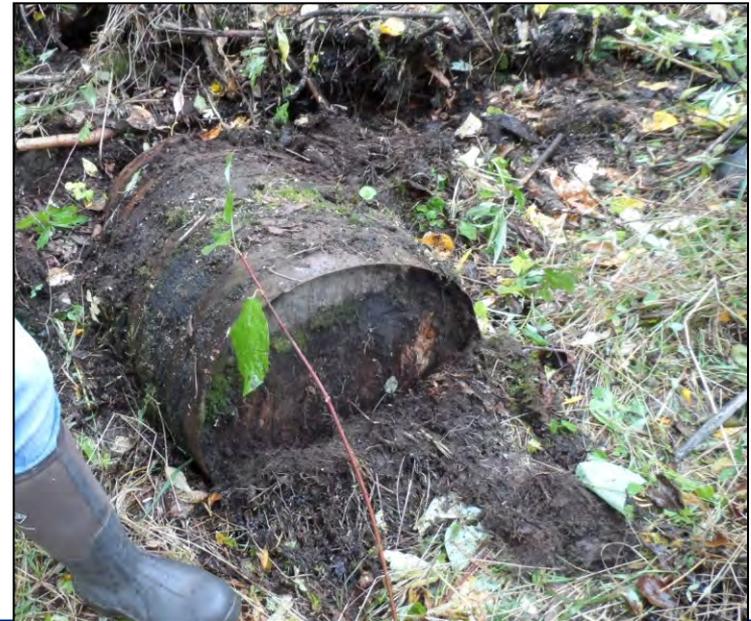
- **Sites are inspected for surface objects that will be detected by geophysical survey equipment**
- **Scrap metal, marsten matting, drums, and other cultural debris were found at Parcel D and SOBS**
- **To date, no ordnance or munitions debris have been found on the surface.**

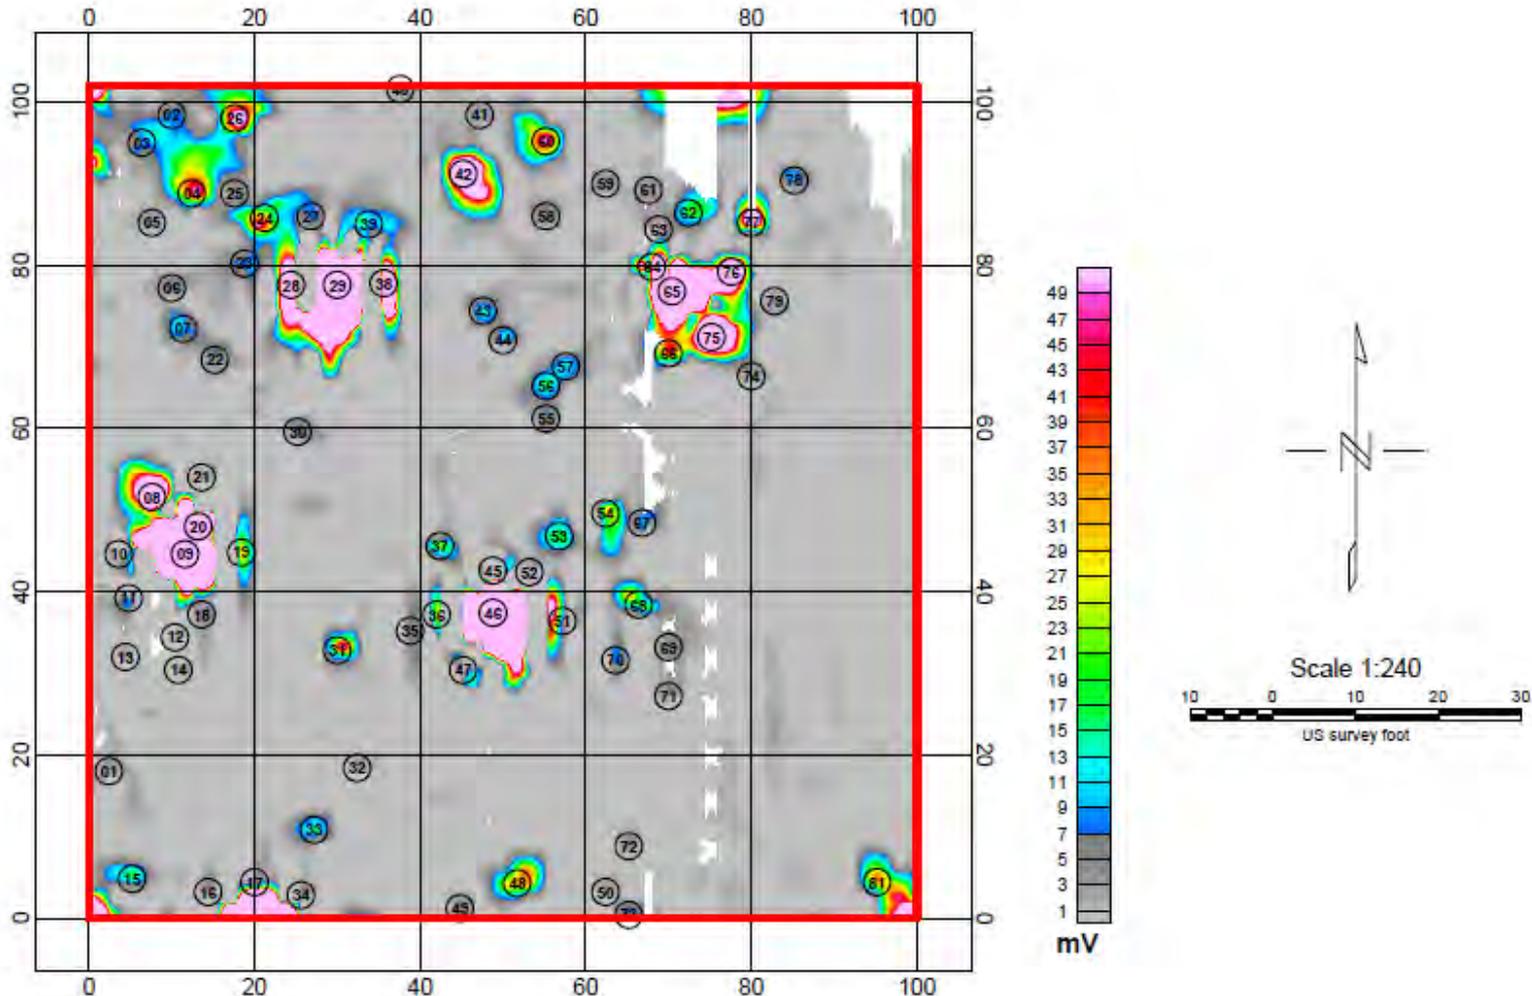
Example Geophysical Survey Results
