Air Force Real Property Agency

Kelly Restoration Advisory Board

May 10, 2011

Semiannual Compliance Plan Report

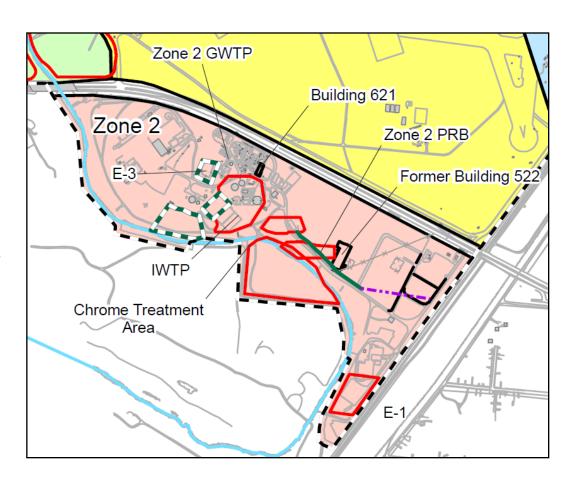
Active IRP or RCRA Sites - Zone 2

- RCRA Site E-3
- 600 Area Waste Management Area (WMA)
 - Building 621
 - Chrome Treatment Site
- 300 Area WMA
 - Zone 2 PRB
 - Building 522
- IRP Site E-1

- Groundwater recovery system currently consisting of three recovery wells
- Contaminants that exceeded the Compliance Plan Limits in July 2010 included benzene, chlorobenzene, cis 1,2-Dichoroethene (DCE), and vinyl chloride.

The groundwater recovery system for this site consists of two recovery wells within the boundaries of the former excavation area, and a third outside the footprint. Areas where groundwater exceeds the GWPSs are within the capture zone of the recovery system wells.

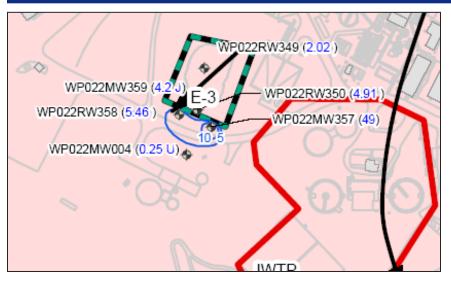
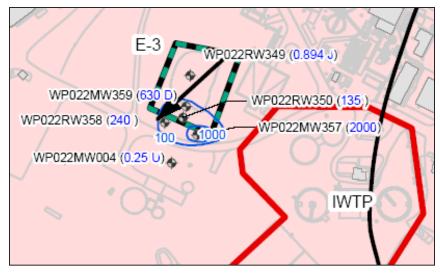
Benzene and Chlorobenzene Isoconcentration Maps, Site E-3

Benzene

Chlorobenzene

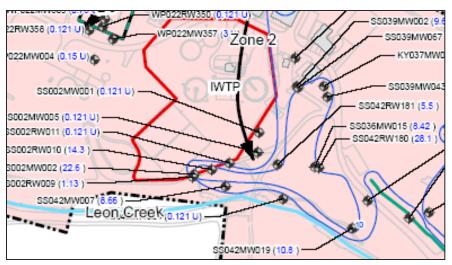
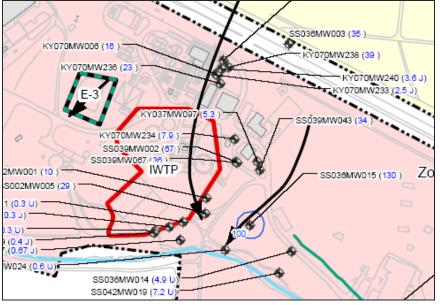
PCE and Chromium Isoconcentration Maps 600 Area Waste Management Area

- Includes Building 621 vegetable oil injection (VOI) site and hexavalent chromium treatment site.
- A PCE plume that initially originated in the vicinity of Building 621 is present in central portion of the WMA. Treatment includes:
 - Vegetable oil injection at Building 621 in February 2006
 - Five vertical groundwater recovery wells in the southern portion of the WMA; two of these wells were installed in 2009 to supplement the existing recovery network.
- Hexavalent chromium area represents a mixed hexavalent and trivalent chromium plume. Treatment to reduce hexavalent chromium to trivalent chromium includes bioremediation injections in 2004 & 2008
- Contaminants that exceeded the Compliance Plan Limits in July 2010 included PCE and total chromium.

PCE

Chromium (total)

Lower PCE concentrations remain throughout the center of the 600 Area WMA. Data indicate complete capture by the existing recovery system. TCE concentrations dropped below Compliance Plan limits in 2010.

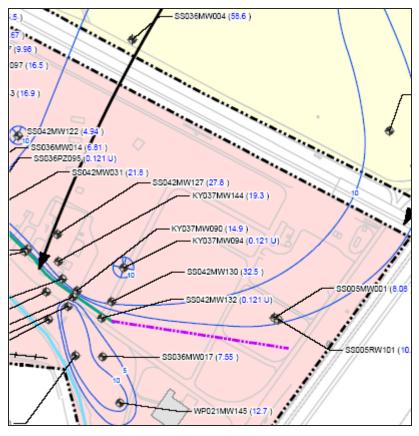
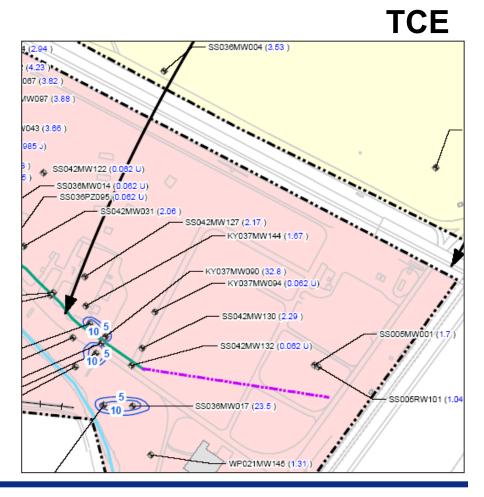
PCE and TCE Isoconcentration Maps, Zone 2 Portion of 300 Area WMA

- Represents the downgradient, southern end of a plume that originates in the northern portion of Zone 3.
- Current remedies include:
 - Vegetable oil injection at former Building 522
 - Zone 2 Permeable Reactive Barrier (PRB) and associated slurry wall
 - Groundwater pump and treat from one vertical recovery well
- Contaminants that exceeded the Compliance Plan Limits in July 2010 include Perchloroethene (PCE) and Trichloroethene (TCE).

PCE

The Iron Filing wall is working as intended to cut off PCE from further downgradient migration. PCE and vinyl chloride downgradient from the PRB continue to decrease in concentrations.

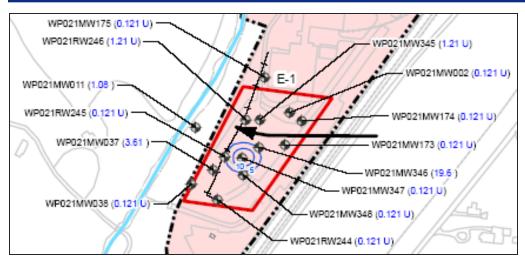
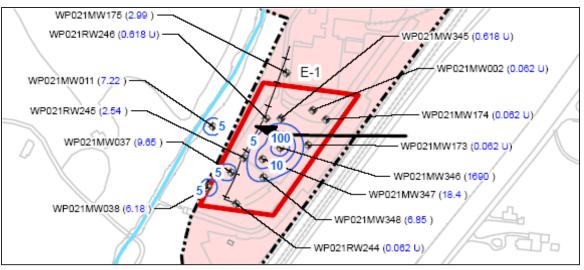
PCE and TCE Isoconcentration Maps, Site E-1

- Former evaporation pit
- Groundwater recovery system currently consisting of a groundwater recovery trench with four standpipes
- Contaminants that exceeded the Compliance Plan Limits in July 2010 included PCE, TCE, 1,2-DCA, cis 1,2-DCE, vinyl chloride, benzene, and chlorobenzene.

PCE

TCE

- The majority of the contamination at this site is located upgradient of the recovery trench, which is operating as intended.
- Three smaller, isolated plumes located downgradient of the recovery trench appear to be stable and not moving. The presence of cis 1,2-DCE concentrations suggest that the TCE plumes are naturally attenuating.
- Light non-aqueous phase liquid (LNAPL) was not identified in well WP021MW345 in 2010, while it had been observed for the previous five years.

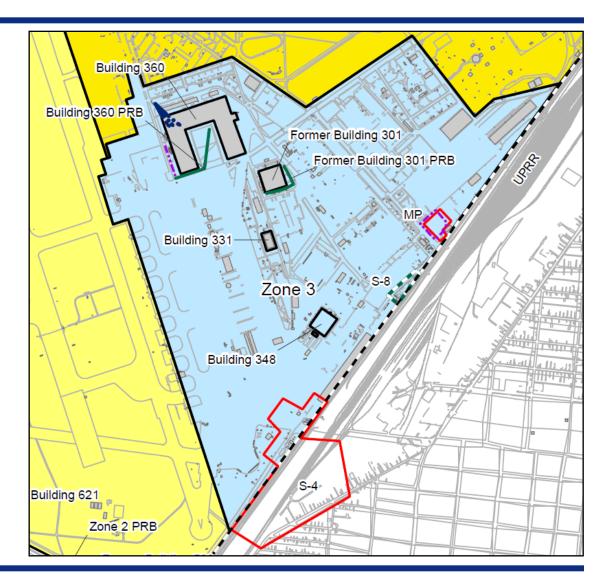
Active RCRA or IRP Sites - Zone 3

RCRA Site S-8

300 Area WMA

- Building 360
- Building 301
- Building 331
- Site MP
- Site S-4

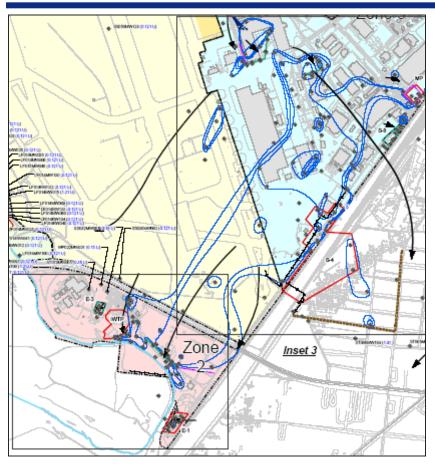
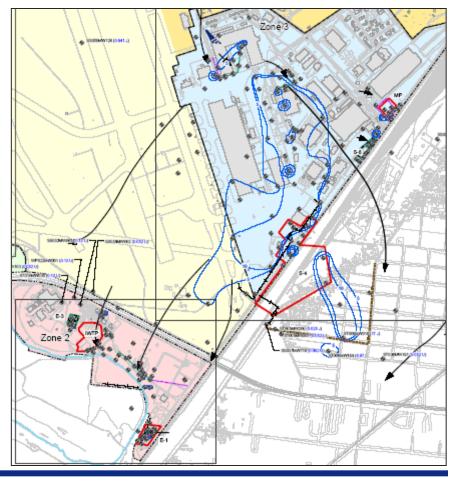
PCE and TCE Isoconcentration Maps Zone 3

PCE

TCE

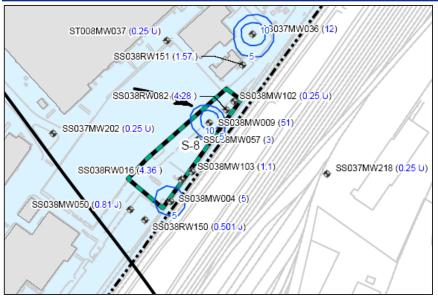
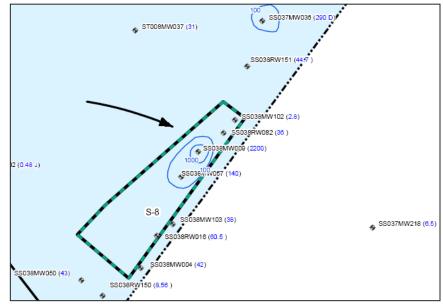
Benzene and Chlorobenzene Isoconcentration Maps, Site S-8

- Former UST facility and location of the "green worm" parts cleaning operation.
- Soil vapor extraction system operated from 2000 through 2001, when the system was converted to a biovent system. In 2010 the system was converted back to an SVE system.
- Groundwater recovery system currently consisting of four recovery wells.
- Contaminants that exceeded the Compliance Plan Limits in July 2010 included benzene, chorobenzene, PCE, TCE, cis 1,2-DCE, vinyl chloride, and arsenic.

Benzene

Chlorobenzene

- Isolated PCE, TCE, and cis 1,2-DCE plumes are present in the northern portion of the site. These plumes are not associated with the zone-wide PCE and TCE plumes.
- An isolated chlorobenzene plume exists north of Site S-8.
- Two new recovery wells were installed at Site S-8 to provide complete plume capture.

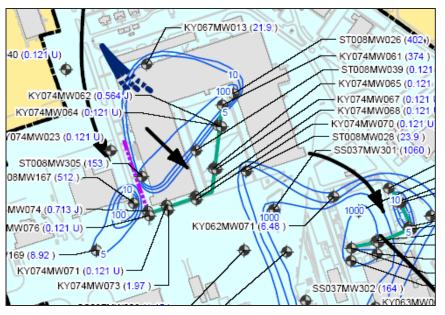
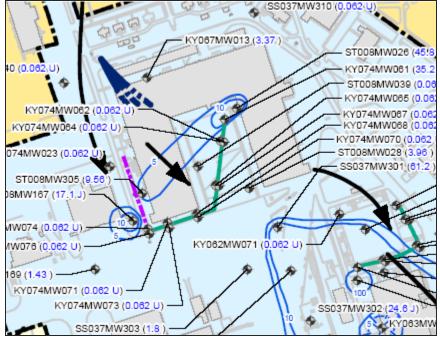
PCE and TCE Isoconcentration Maps Building 360

- Contaminant sources from historic chemical storage and usage include the northwest corner of the building and the basement area in the western wing of the building.
- Current remedies include:
 - PRB and associated slurry wall installed in 2003
 - Vegetable oil injections performed in 2006 and 2008
 - Soil Vapor Extraction system with 3 horizontal wells installed in 2008
- Contaminants that exceeded the Compliance Plan Limits in 2010 included PCE, TCE, cis 1,2-DCE, and vinyl chloride.

PCE

TCE

- The vegetable oil injection performed in 2008 appears to have been effective in enhancing reductive dechlorination of the plume located upgradient of the PRB.
- The PRB is operating as intended.

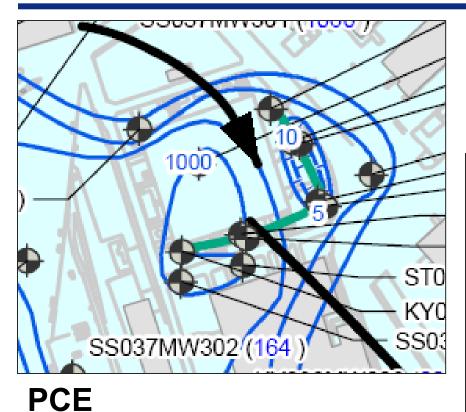
PCE and TCE Isoconcentration Maps, Building 301

- Current remedies include:
 - Permeable Reactive Barrier installed in 2003
 - Electrical Resistance Heating system operated in 2008-2009 to treat soil
- Contaminants that exceeded the Compliance Plan Limits in 2010 included PCE, TCE, cis 1,2-DCE, and vinyl chloride.

TCE

- Higher PCE concentrations in the immediate vicinity of the ERH system are believed to be a temporary, localized effect resulting from operation of the ERH system.
- Groundwater appears to be moving parallel to the eastern wing wall of the PRB, instead of perpendicular and through the wall.

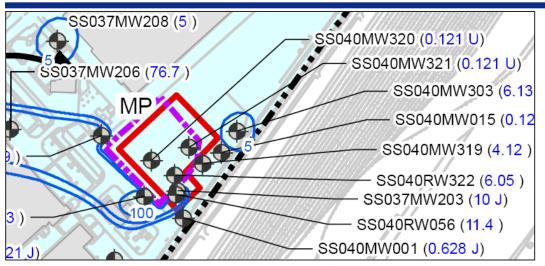
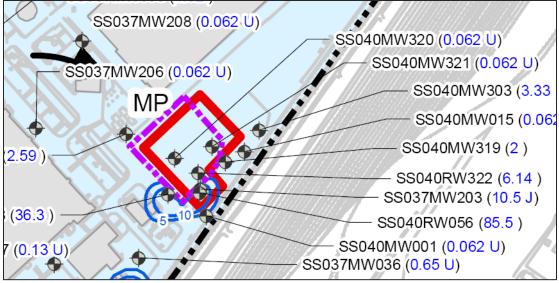
PCE and TCE Isoconcentration Maps, Site MP

- Location of two former shop buildings, Buildings 258 and 259, that served as a maintenance depot for aircraft. In the late 1950's, Building 259 was modified into a plating shop.
- Soil excavation (source removal) occurred in 2009
- Current remedies include:
 - Enhanced bioremediation
 - Groundwater pump and treat from downgradient vertical recovery wells
- Contaminants that exceeded the Compliance Plan Limits in 2010 included PCE, TCE, cis 1,2-DCE, and vinyl chloride.

TCE

PCE

- VOC concentrations inside the slurry wall are an order of magnitude lower than 2008 data.
- VOC concentrations were not detected in samples from POC wells again in 2010 suggesting that the current combined remedy is effective.

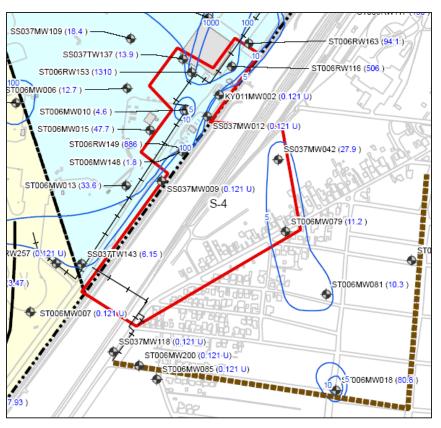
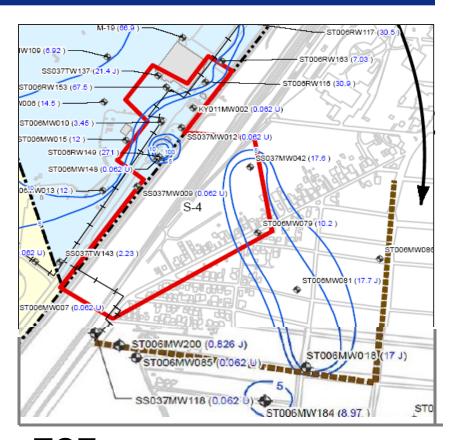
PCE and TCE Isoconcentration Maps, Site S-4

- Site S-4 contamination is from abandoned fuel distribution lines and UST facilities
- Current remedies include:
 - Groundwater recovery from on-base and off-base recovery trenches and vertical recovery wells
 - Off-base low permeability barrier with monitored natural attenuation
- Contaminants that exceeded the Compliance Plan Limits in 2010 included PCE, TCE, cis 1,2-DCE, vinyl chloride, benzene, and arsenic.

PCE TCE

Groundwater recovery system and off-base monitored natural attenuation appear to be effective remedies.

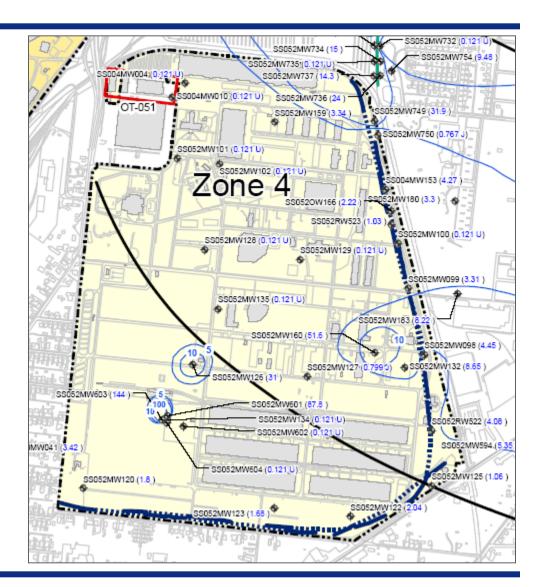
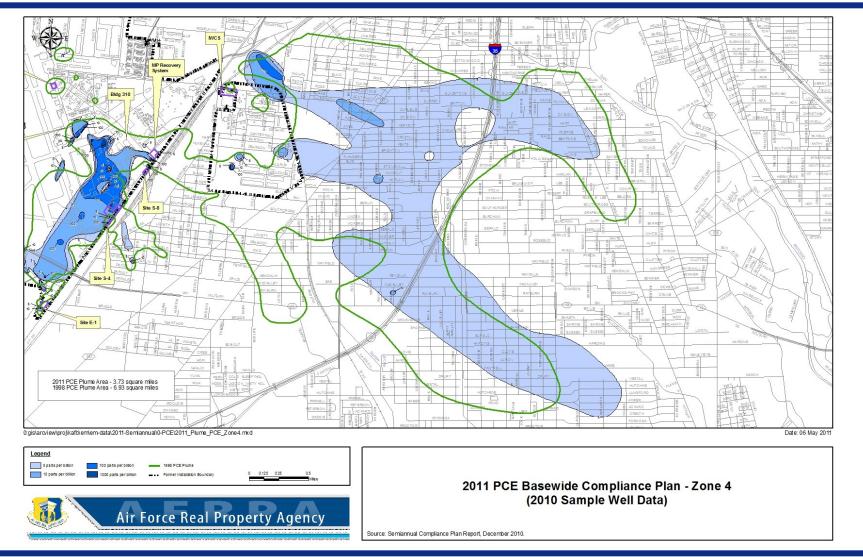
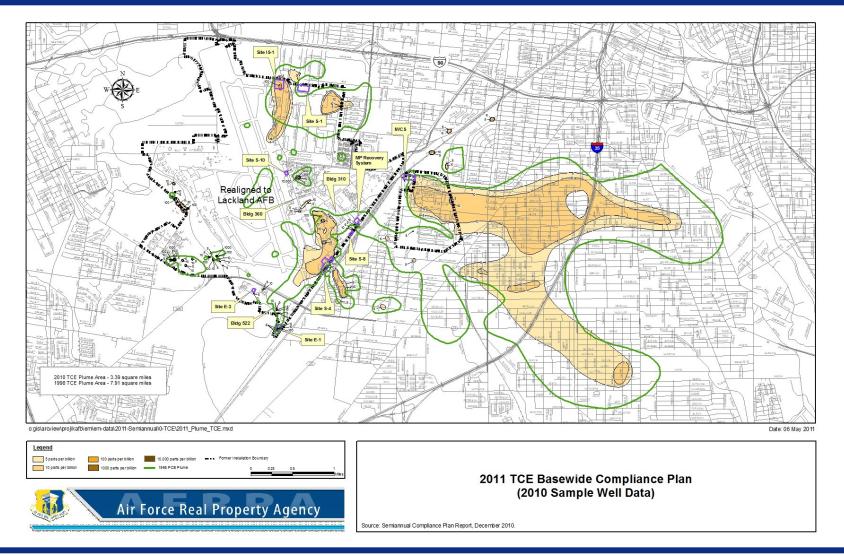
Active IRP Sites – Zone 4

- East Kelly WMA
 - Site OT-051
 - East Bank Area
 - South Bank Area
- Zone 4 Groundwater (SS052)

PCE and TCE in shallow groundwater above GWPS. Plumes on base and off base show long-term decreasing concentration trends, suggesting that natural attenuation is occurring.

TCE and VC continue to decrease through natural degradation/reductive dechlorination

- Overlapping horizontal well remediation systems for TCE and PCE in groundwater
- South Bank system operation discontinued due to no plumes moving in that direction; East Bank system operating and capturing majority of upgradient plume.

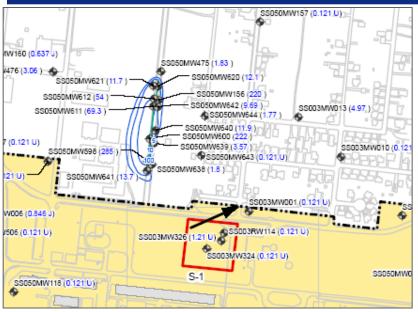
PCE and TCE Isoconcentration Maps, Zone 5

PCE

TCE

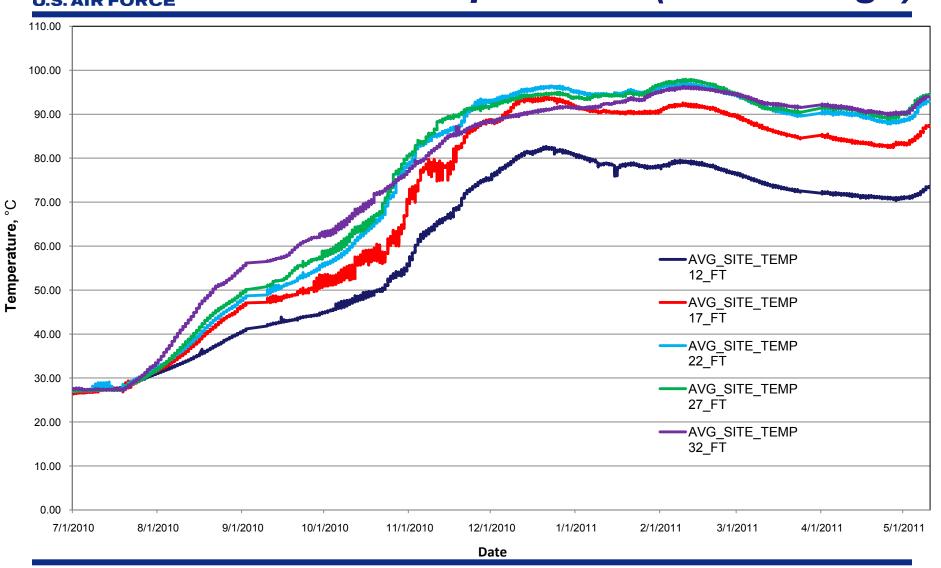
Site S-1 (SS003) Temperature (TC Average)

•	JUL 2010	Construction of ERH System completed; Start up activities commenced
•	JUL 2010	Baseline Sampling conducted
•	OCT/ NOV 2010	Injected steam into gravelly areas to supplement heating
•	DEC 2010	Reached maximum site temperatures; replaced electrodes that had failed
•	MAR 2011	60% Groundwater Sampling conducted
•	APR 2011	Repaired damaged drip system
•	MAY 2011	 Mass removed to date: 120 pounds Chlorobenzene 89 pounds 1,2-Dichlorobenzene 17 pounds 1,4-Dichlorobenzene 3 pounds Benzene

- Gravel areas (northernmost area / portion of southern area) present challenges to ERH operation
- Areas with gravel / clay mixture in subsurface require constant tweaks to find optimal moisture content and a balance between the three phases of power
- Removal rate is lower than projected in design resulting in longer run time to achieve total mass removal goals
- Contaminant mass in the subsurface is being recalculated due to possible variability in the design calculation and actual mass
- System is being evaluated to determine if continued operation is beneficial

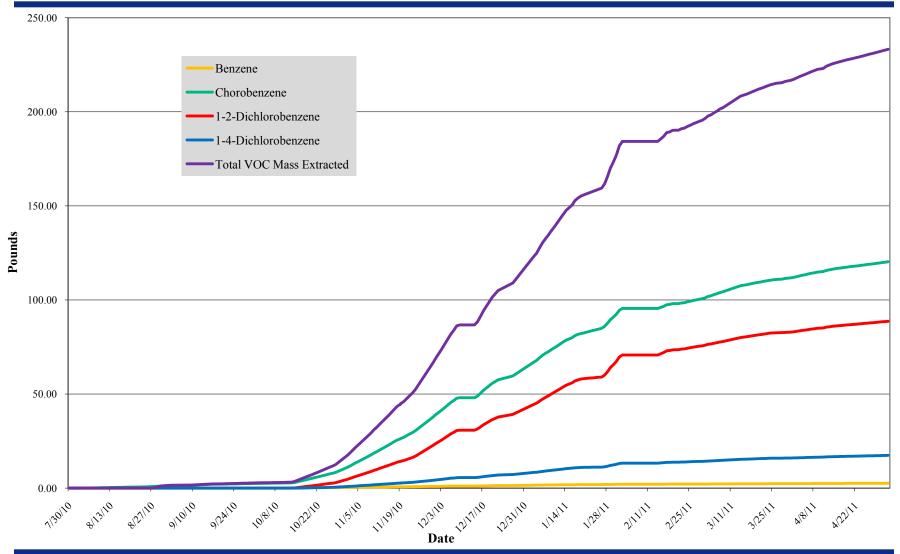
Site S-1 (SS003), VOC Mass Removal by Contaminant

>765 pounds of TPH

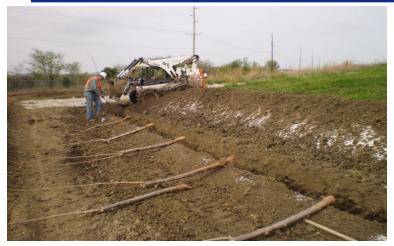
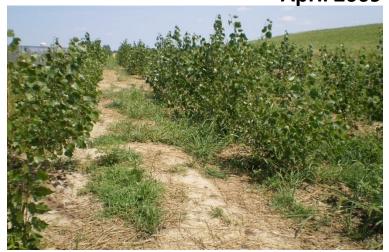
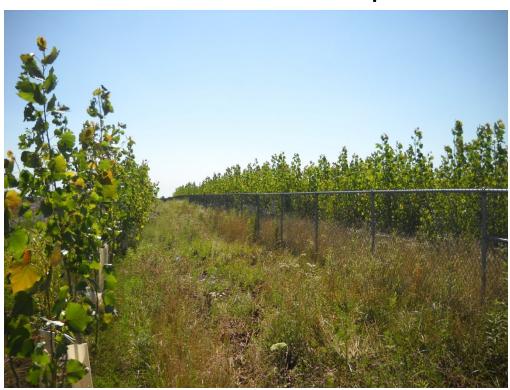
- Largest Plume, originally over 3 miles long, has significantly decreased in size and contaminant mass has been reduced over 80% since optimization activities began.
- At the current rate of contaminant mass removal, AFRPA anticipates reaching the regulatory limit (<5 μg/l) for TCE) by 2014, more than 20 years earlier than originally planned.

April 2009

August 2009

August 2010

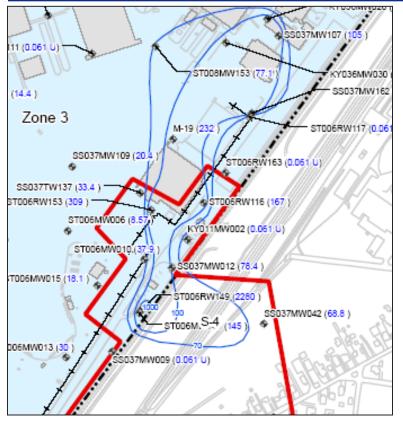
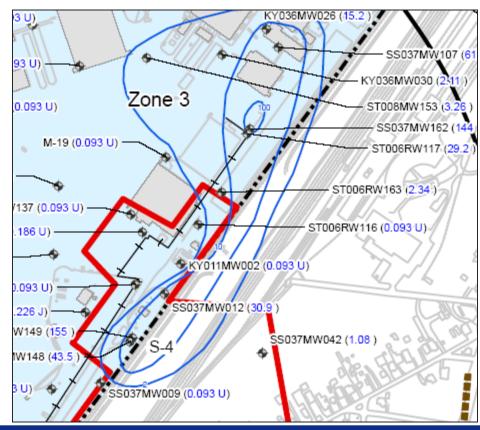
cis 1,2-DCE and VC Isoconcentration Maps, Site S-4

cis 1-2, DCE

VC

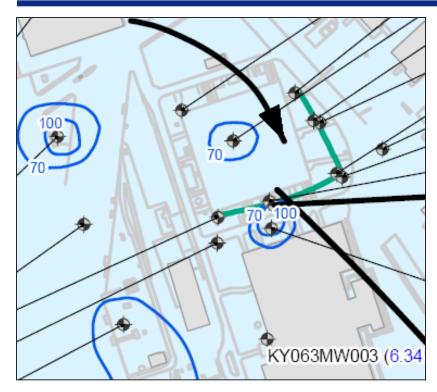
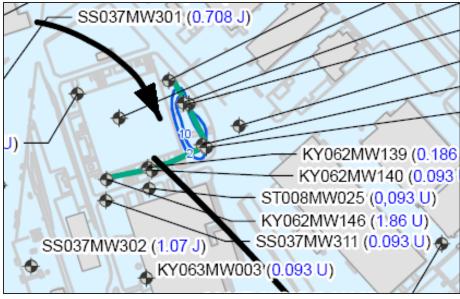
cis 1,2-DCE and VC U.S. AIR FORCE LSOCONCENTRATION Maps, Building 301

cis 1,2-DCE

VC

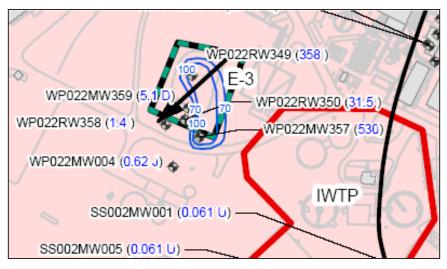
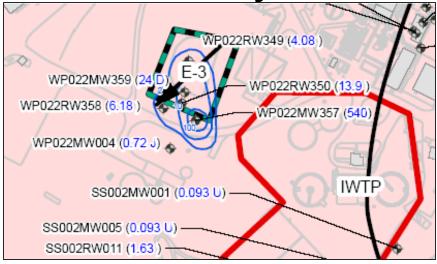
cis 1,2-DCE and Vinyl Chloride Isoconcentration Maps, Site E-3

cis 1,2-DCE

Vinyl Chloride

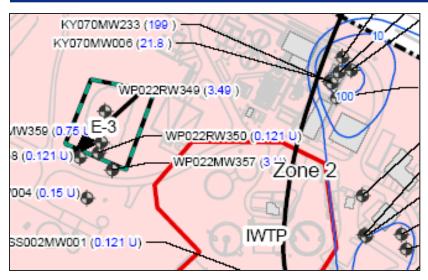
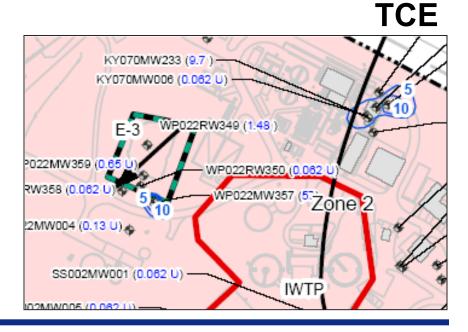
PCE and TCE Isoconcentration Maps, Site E-3

PCE

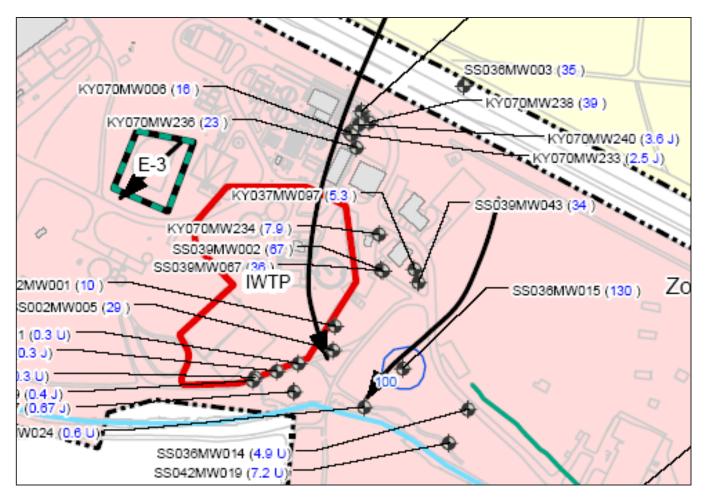
Chromium Isoconcentration Map 600 Area Waste Management Area

Chromium (total)

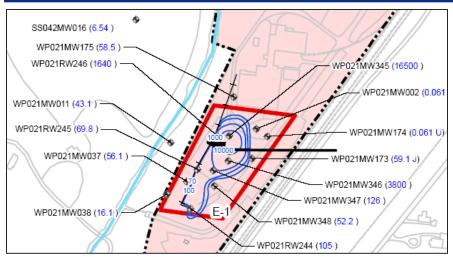
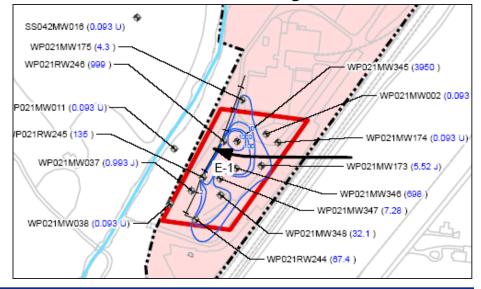
cis 1,2-DCE and VC Isoconcentration Maps, Site E-1

cis 1,2-DCE

Vinyl Chloride

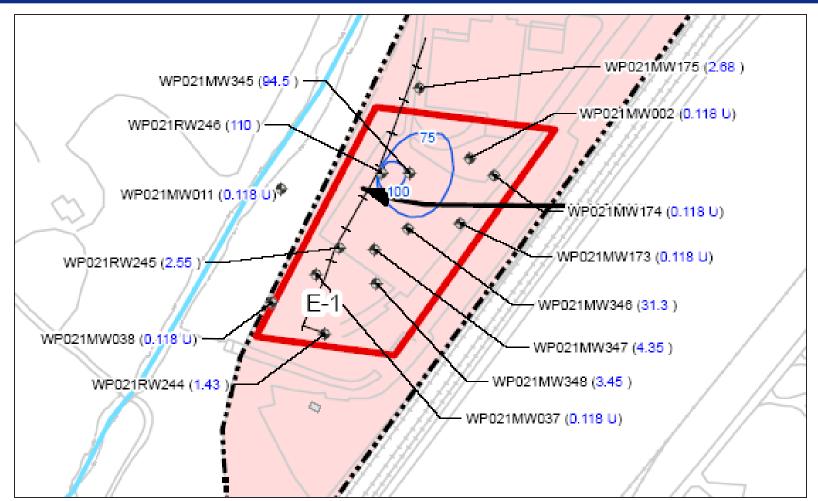
1,4-Dichlorobenzene Isoconcentration Map, Site E-1

1,4-Dichlorobenzene

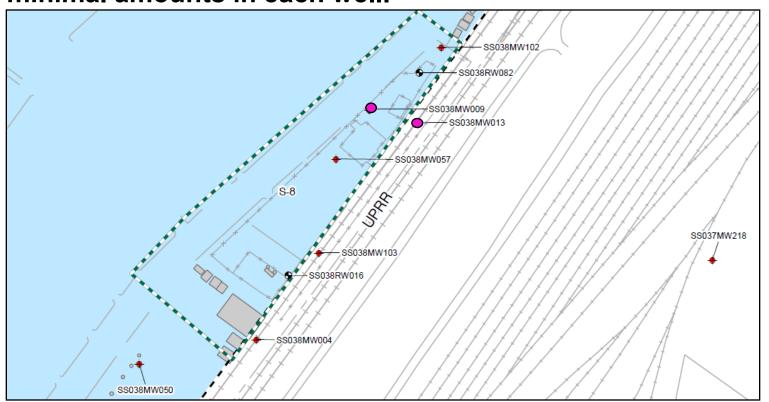
Site S-8 LNAPL

- Light Non-Aqueous Phase Liquid (LNAPL) in two on-site wells in Jul/Aug 2010
- Manual removal of LNAPL has reduced the volume of LNAPL to minimal amounts in each well.

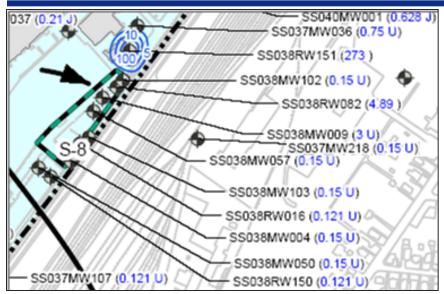
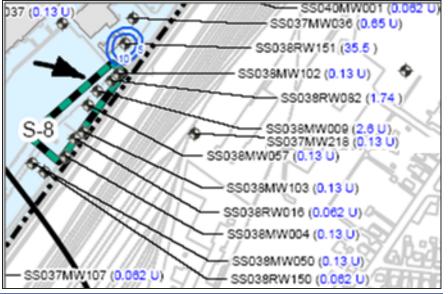
PCE and TCE Isoconcentration Maps Site S-8

PCE

TCE

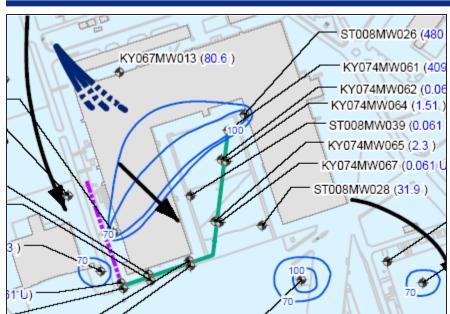
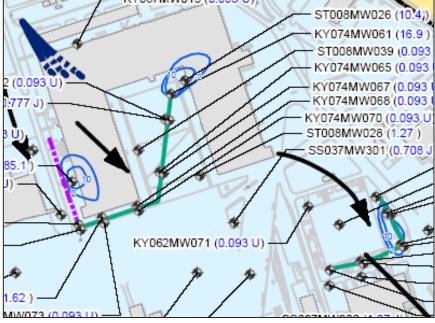
cis 1,2-DCE and Vinyl Chloride Isoconcentration Maps, Building 360

cis 1,2-DCE

Vinyl Chloride

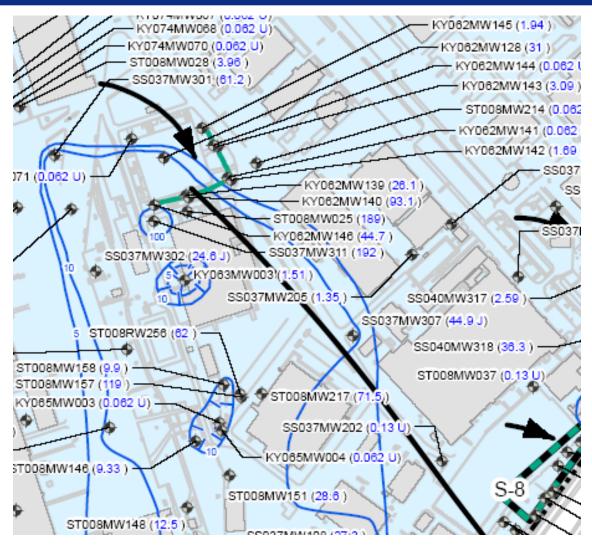
Isoconcentration Map, Building 301

TCE
