## Former Williams AFB Restoration Advisory Board (RAB)

**August 24, 2010**

## ST012 Thermal Enhanced Extraction Evaluation Report Summary

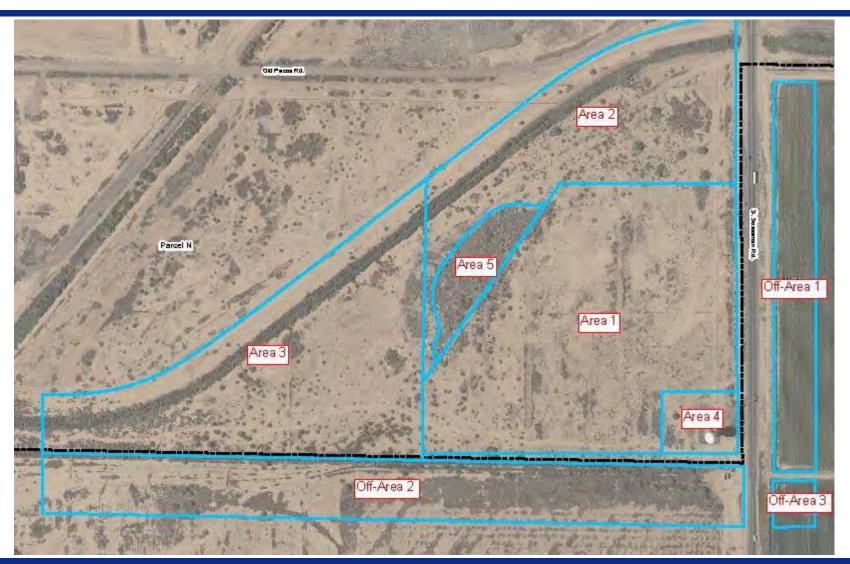
### PNDA – SI/MEC Investigation Site Map

- Oct 2003 Initial site discovery by Technical Working Group (ADEQ and AF). The TWG discovered ruptured .50 cal cartridges on the surface.
- **Dec 2005** AFRPA performed a Remedial Process Optimization (RPO) review where this site was addressed.
- Jan 2009 The AF conducted a Preliminary Assessment and recommended additional follow-on activities.
- Summer 2010 The AF conducted a MEC Site Investigation.

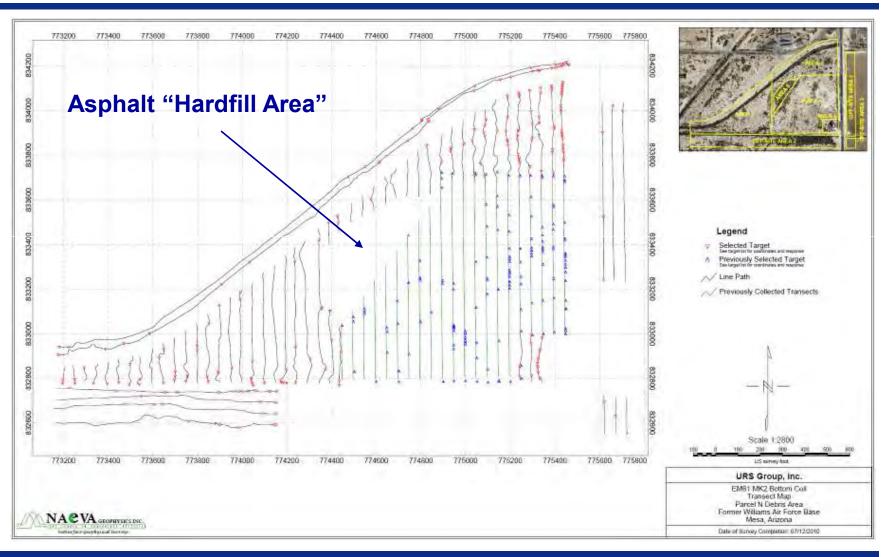
# PNDA – SI/MEC Investigation Results for Geophysical Survey

- SI/MEC Investigation (Phase 2)
  - Digital Geophysical Mapping (DGM) data were collected over designated transects in Areas 2, 3, and 4 and Off-Site Areas 1, 2, and 3 [40.5 acres total]).
  - The investigation did not include 8.1 acres where rights-of-entry (ROE) from property owners were not obtained.
  - Based on DGM results, selected target anomalies were reacquired and excavated in Areas 1, 2, 3, and 4 to determine if target anomalies.
  - Recovered items were inspected for the presence of MEC or munitions-related activities.
