# ***FINAL*** **FIVE-YEAR REVIEW** **Fourth Five-Year Review Report**

Former Castle Air Force Base,  
California

Contract No. FA8903-08-D-8777  
Task Order 0144

March 2014

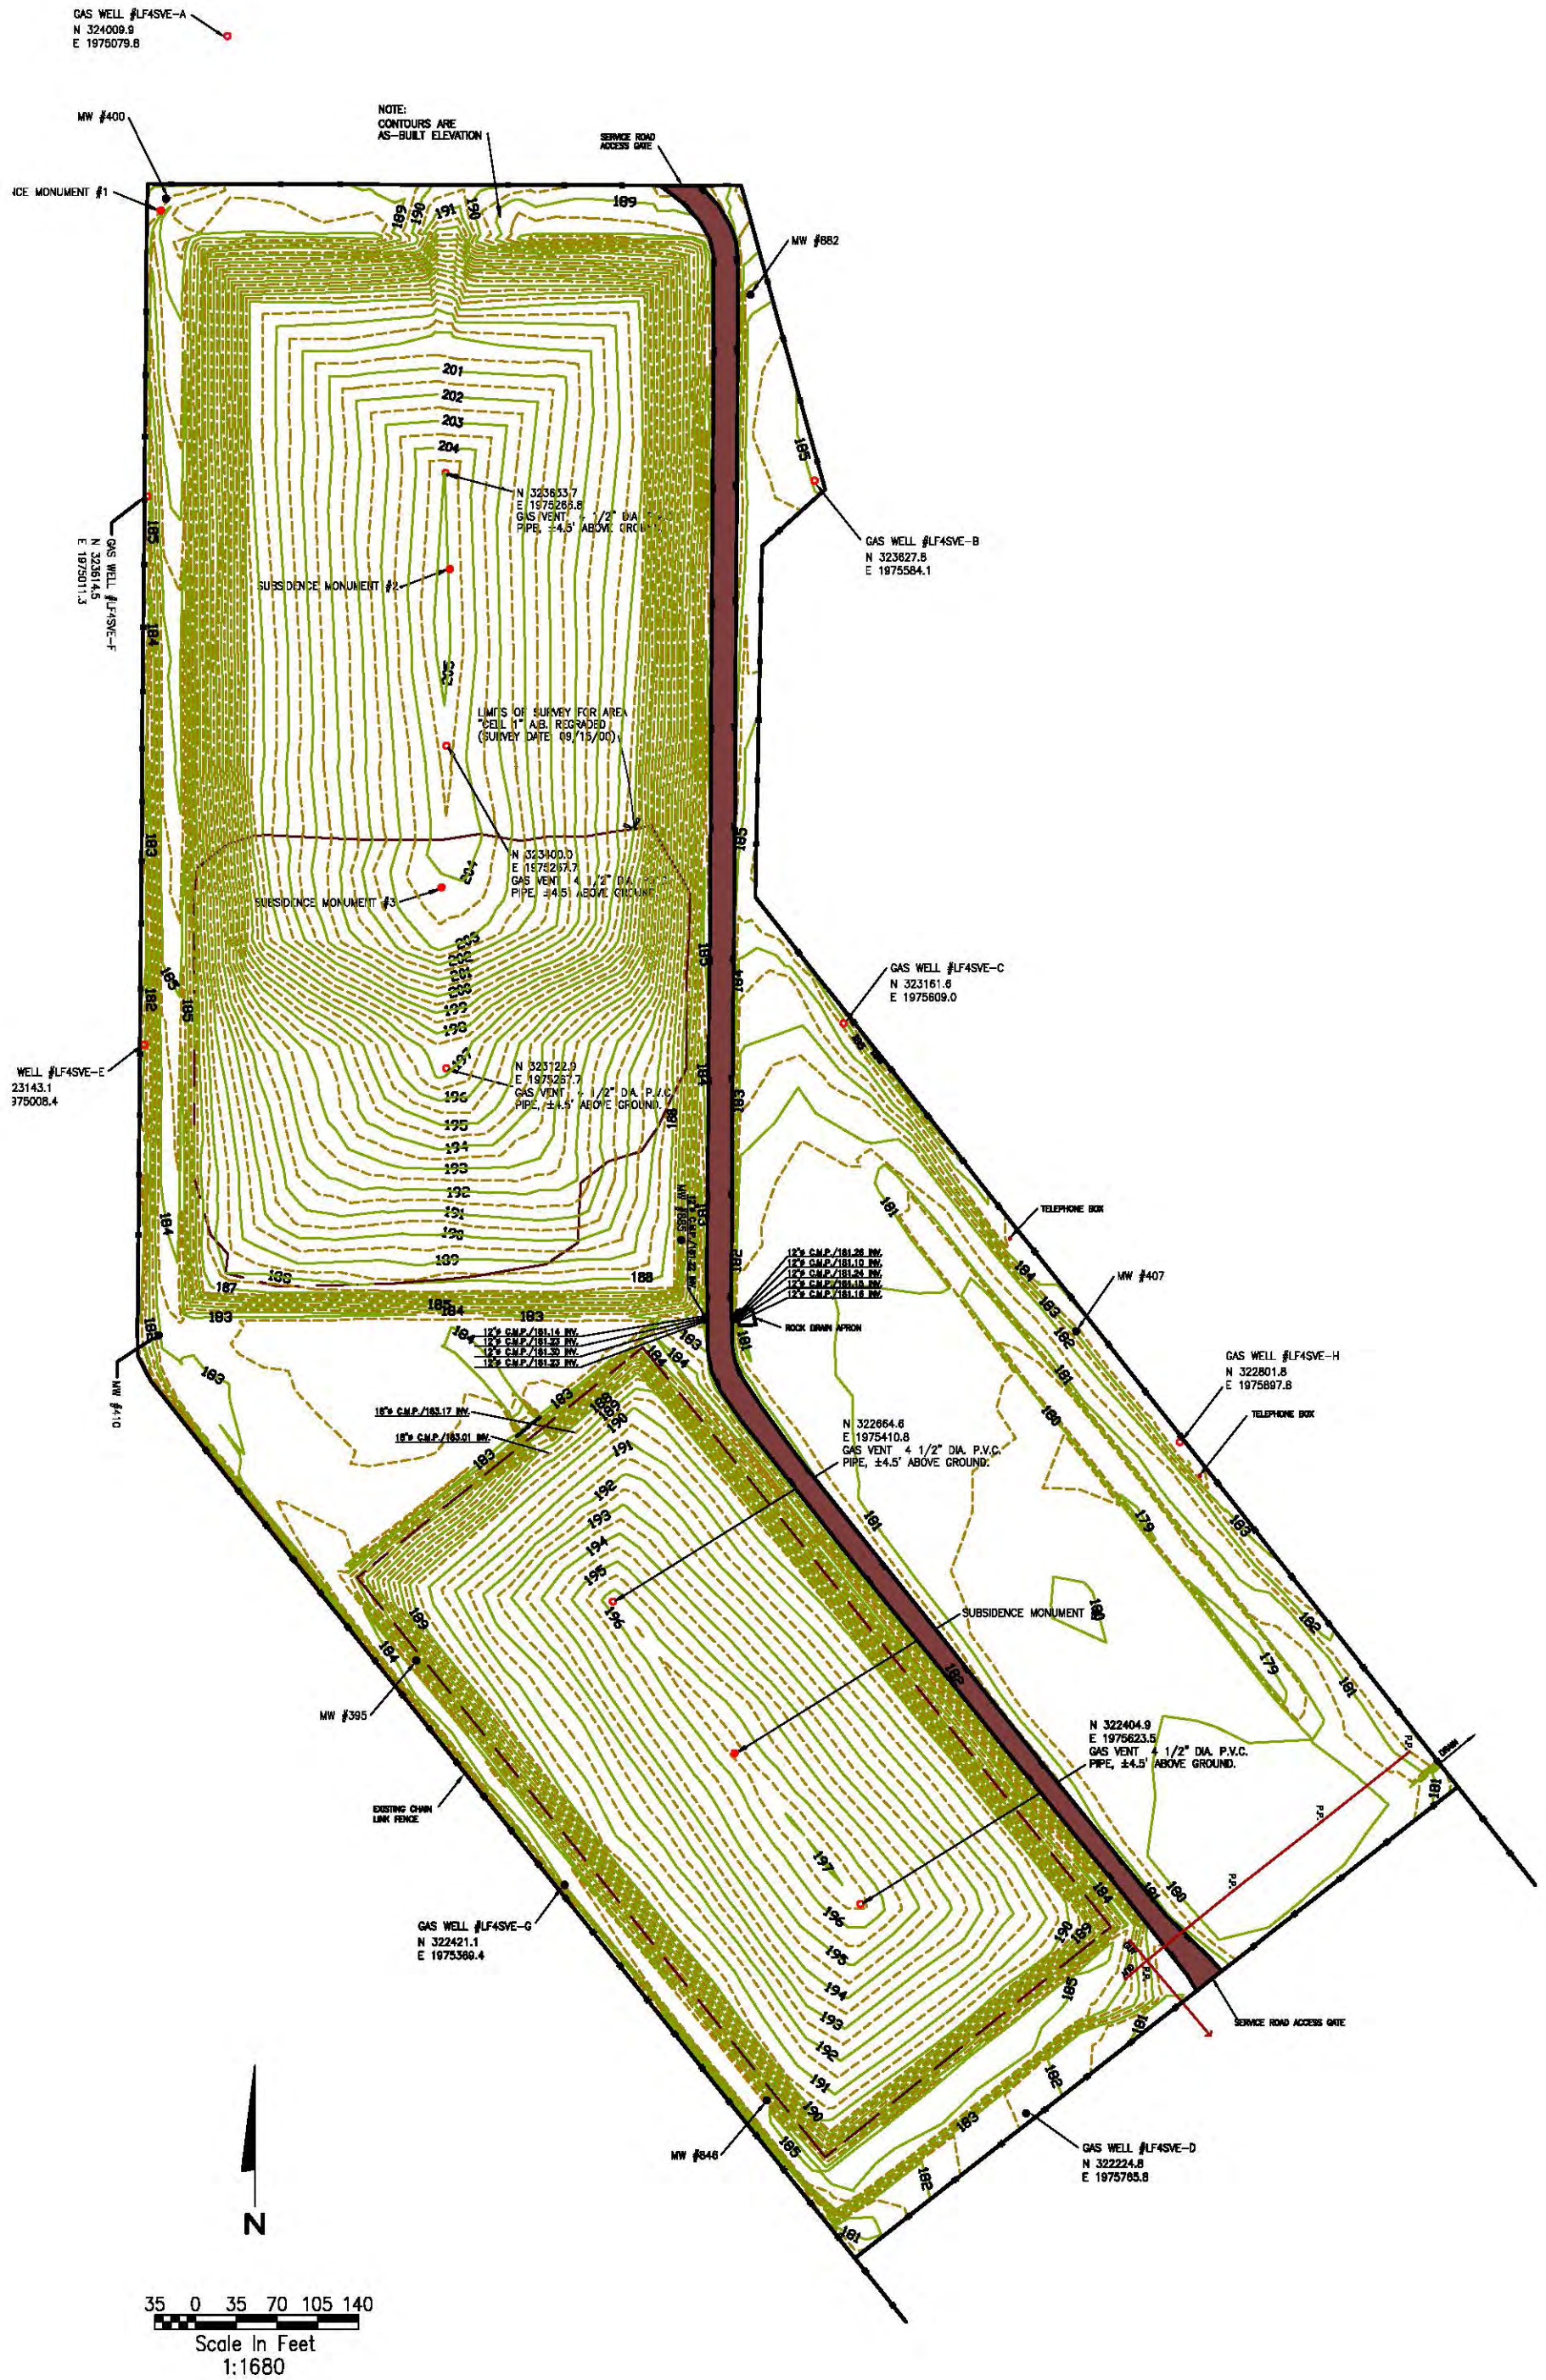
FIGURE 4-3

LTM for LF-4 was initiated in 1999 and consisted of a post-closure monitoring and maintenance program for the caps, and a post-closure monitoring program for landfill gas and groundwater beneath the landfill. Landfill cap and groundwater monitoring features at LF-4 are shown on Figures 4-3 and 4-4, respectively. Cap monitoring and maintenance activities and landfill gas and groundwater monitoring are conducted in compliance with the approved *Closure and Post-Closure Maintenance Plan for Castle Airport Landfills* (Jacobs, 1997c) and the *Landfill 4 and Landfill 5 Closure and Post-Closure Maintenance Plan Update* (Jacobs, 2000b). Cap monitoring and maintenance activities for LF-4 consist of quarterly to semiannual inspections of the cap, landfill gas collection system, monitoring wells, drainage ditch elevations and condition (additional inspection after major rain events), settlement monuments, site security, roads, and completion of any necessary repairs. Reports documenting inspection results are prepared annually.

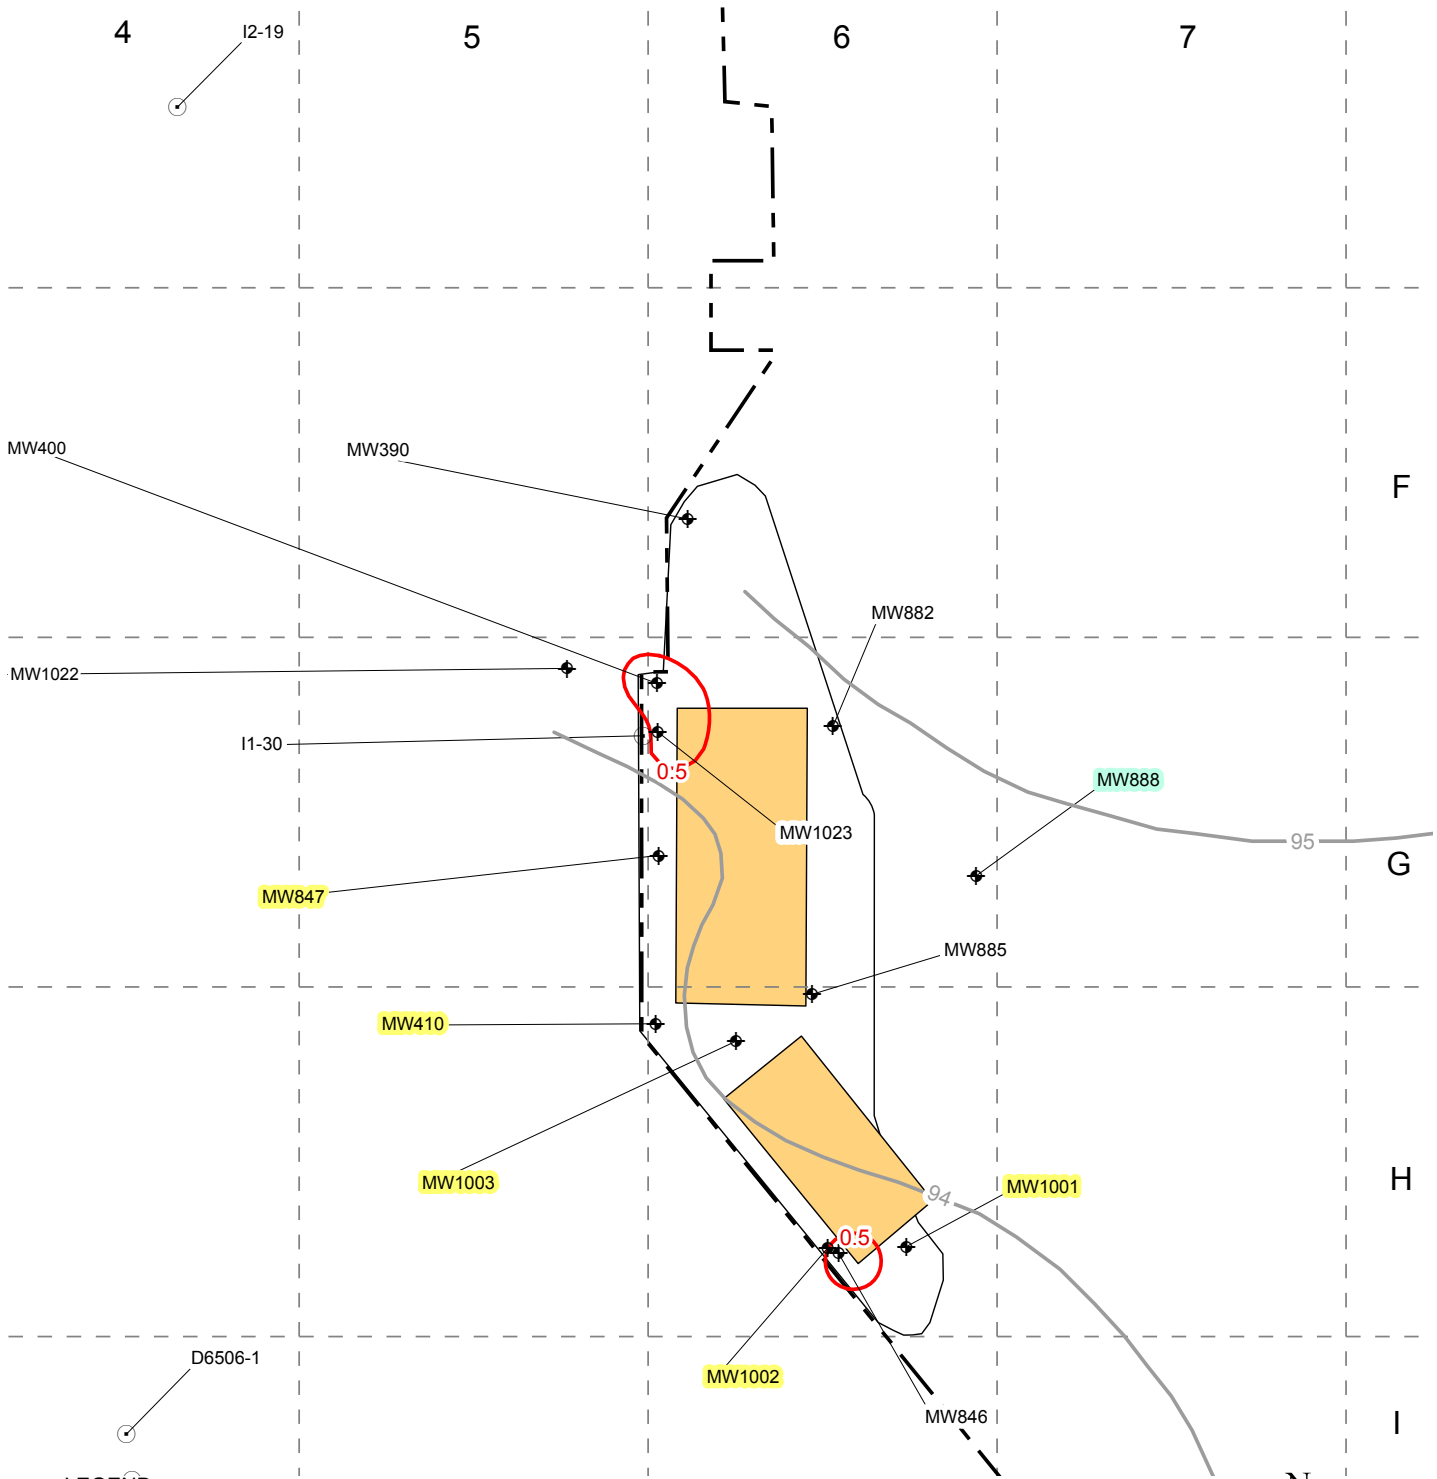
Figure 4-4

Because decreases in regional groundwater levels at Castle resulted in the wells in the LF-4 area going dry, one new well was installed during August 2013. This well was installed under a regulatory approved work plan. Sampling of the newly installed wells will be completed with scheduled LTGSP sampling and reported in the 2013 Annual LTGSP report. Once data from the new background well at LF-4 are collected and the groundwater flow direction in this area is confirmed, the number and location of replacement downgradient wells at LF-4 will be determined.

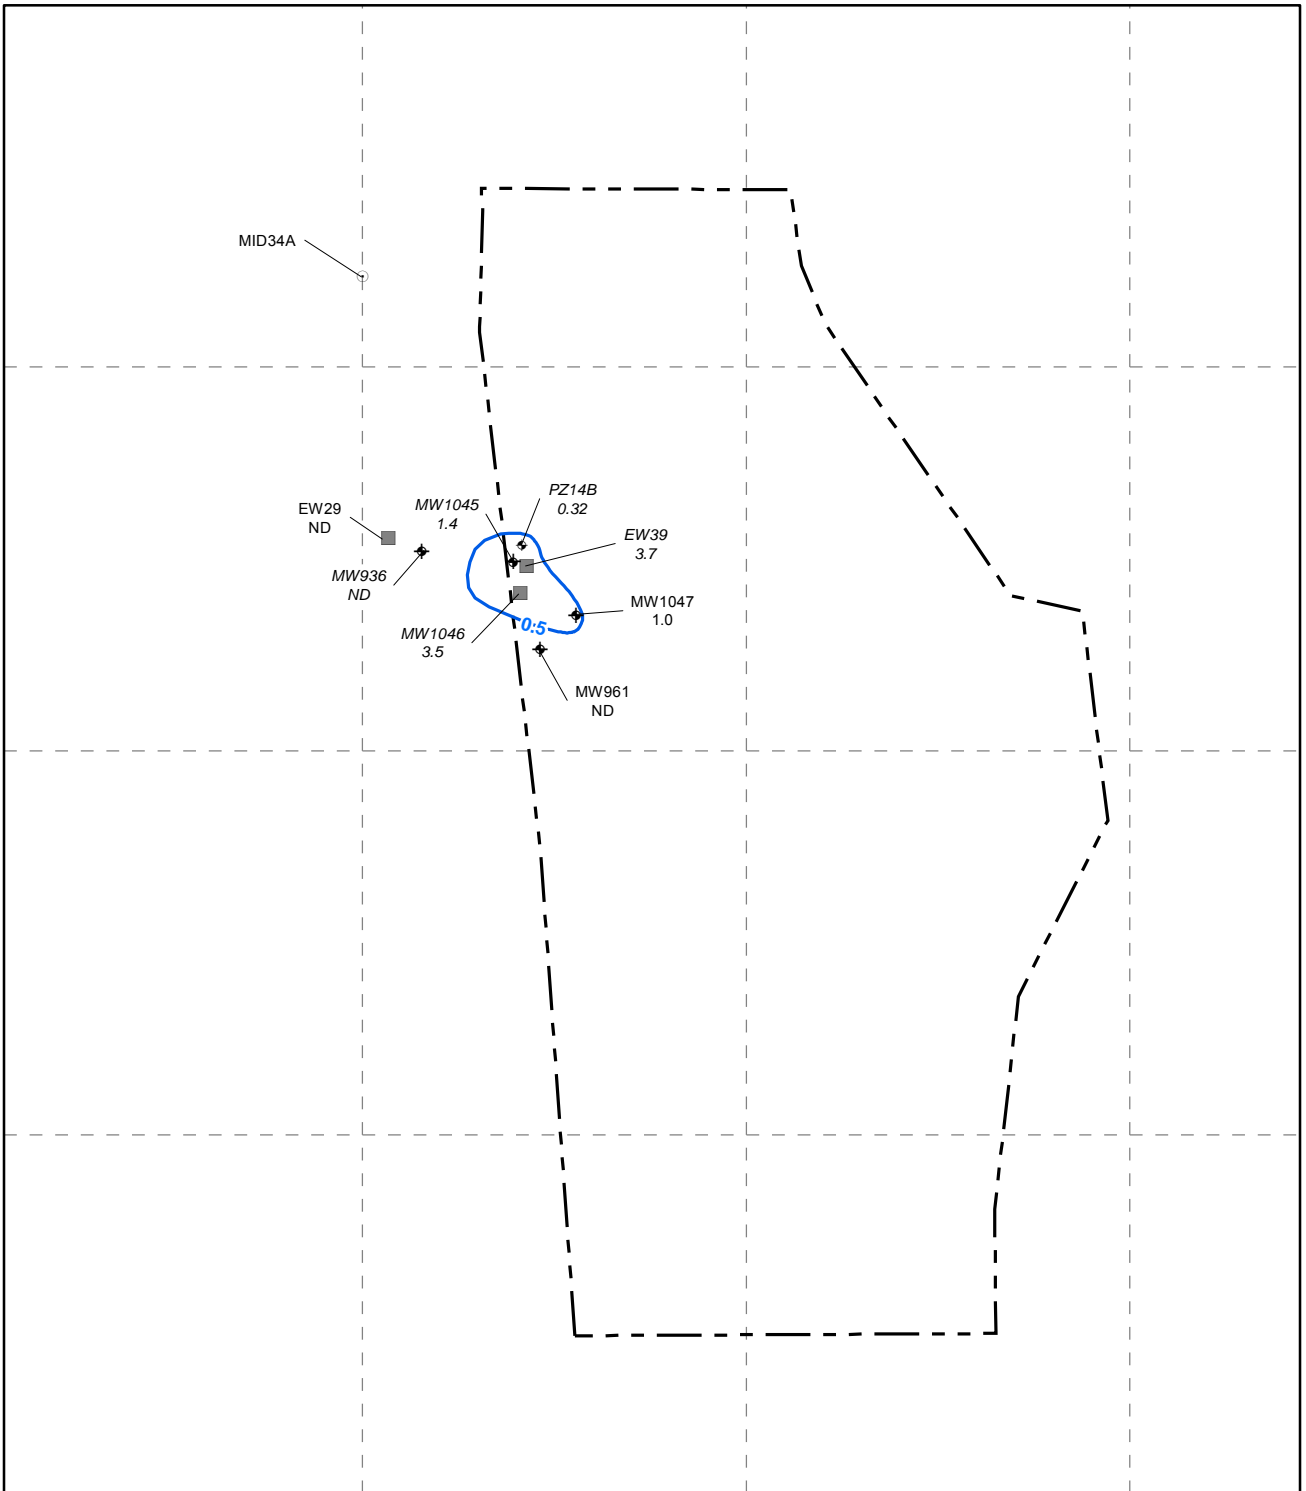
**FIGURE 7-5**  
**Castle Vista cis-1,2-DCE Plume Delineation Map, Fourth Quarter 2012**  
**Shallow Hydrostratigraphic Zone**  
LTGSP 2012 Annual Report  
Former Castle AFB, Atwater, California

The Castle Vista Plume wellhead system was shut down with agency concurrence for a long-term rebound study in 2010. Cis-1,2-DCE periodically recurs at levels exceeding the MCL in a very small area and the Air Force and regulatory agencies coordinate on implementation of rebound monitoring and system operation to address this issue. The system was restarted on 15 April 2013 due to cis-1,2-DCE exceeding restart criteria and operated through 20 June 2013, when it was shut down due to pump failure. The system was restarted again following repair of the pump in August 2013.

Current (Q4/12) *cis*-1,2-DCE plume configuration for the Shallow HSZ is shown on Figure 7-5. A figure is not presented for current *cis*-1,2-DCE plume configuration in the USS HSZ because the plume in the USS HSZ was eliminated by Castle Vista groundwater treatment plant operation. Comparison of the current (Q4/12) Shallow HSZ *cis*-1,2-DCE plume configuration (Figure 7-5) with that from Q1/97 (Figure 3-8) shows that the Shallow HSZ plume has nearly been eliminated over the 15-year period as a result of the remedial action. All that remains at present (Q4/12) is a small plume in the immediate vicinity of wells EW39, MW1046, MW1045, and MW1047. The

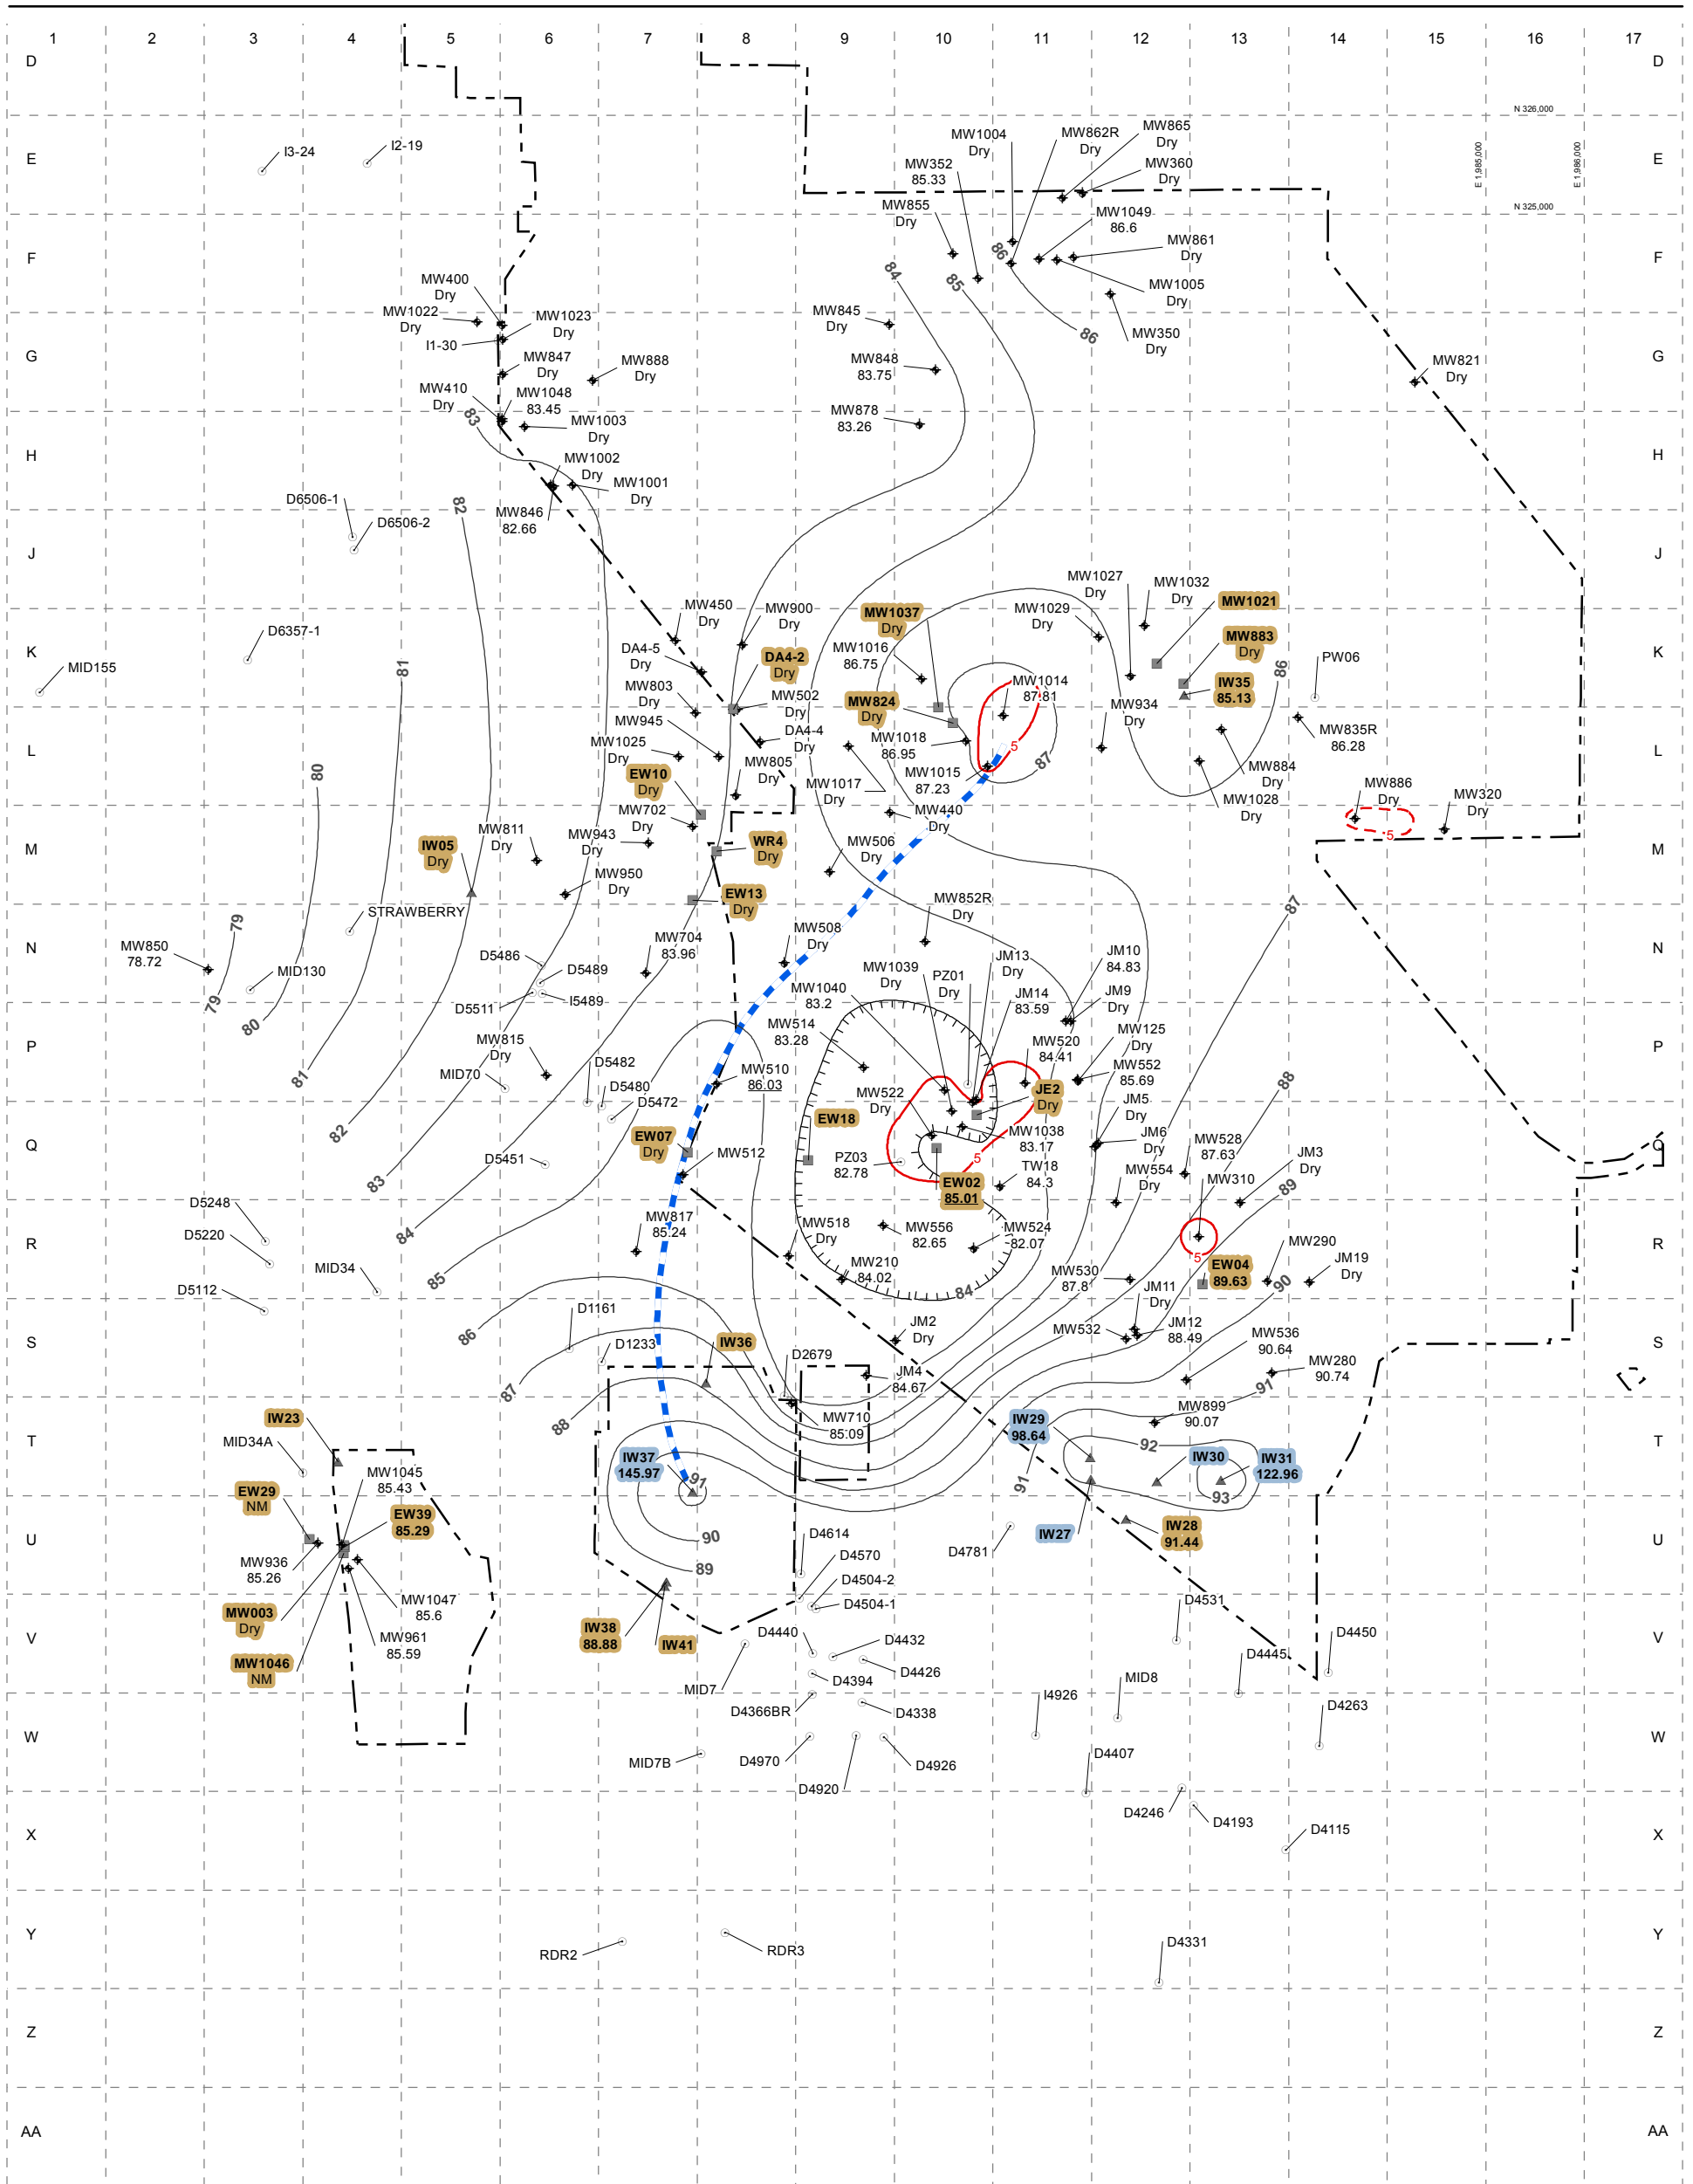
**FIGURE 7-6**  
**Estimated Plume Capture, Fourth Quarter 2012**  
**Shallow Hydrostratigraphic Zone**  
 LTGSP 2012 Annual Report  
 Former Castle AFB, Atwater, California

<b>OU(s): Groundwater</b>	<b>Issue Category: Remedy Performance</b>			
	<p><b>Issue - Main Base Plume:</b> Capture of the northeast base plume area in the Shallow HSZ by the MW824/MW1037 wellhead treatment system. Capture of this portion of the plume is unlikely unless water levels rise such that pumping from the Shallow HSZ can resume.</p> <p><b>Recommendation:</b> The treatment system was shutdown in 2006 when water levels decreased such that pumping could not be sustained. Since 2006, the system has remained off line with regulatory agency concurrence and associated monitoring wells have been monitored in accordance with recommendations established in the annual LTGSP Reports (2007-2012). While the NEBP is not captured, monitoring results establish that the remaining NEBP area is very small, the contaminant concentrations have not indicated an increasing trend, and the limited area and levels of groundwater contamination have not migrated. Monitoring of the limited wells that are just above the MCL is appropriate and recommended until MCLs are achieved provided the contaminant concentrations do not show an increasing trend or the plume area does not migrate. Should monitoring under the LTGSP indicate an increasing contaminant trend or plume migration, the AF in consultation with the regulatory agencies, should evaluate if other action is warranted.</p>

Estimated hydraulic capture zones and the Q4/12 MCL plume contours (5 µg/L plume contour for TCE) for the Main Base Plume are also shown on Figures 7-6 through 7-9. The hydraulic capture zones portrayed on these figures are the

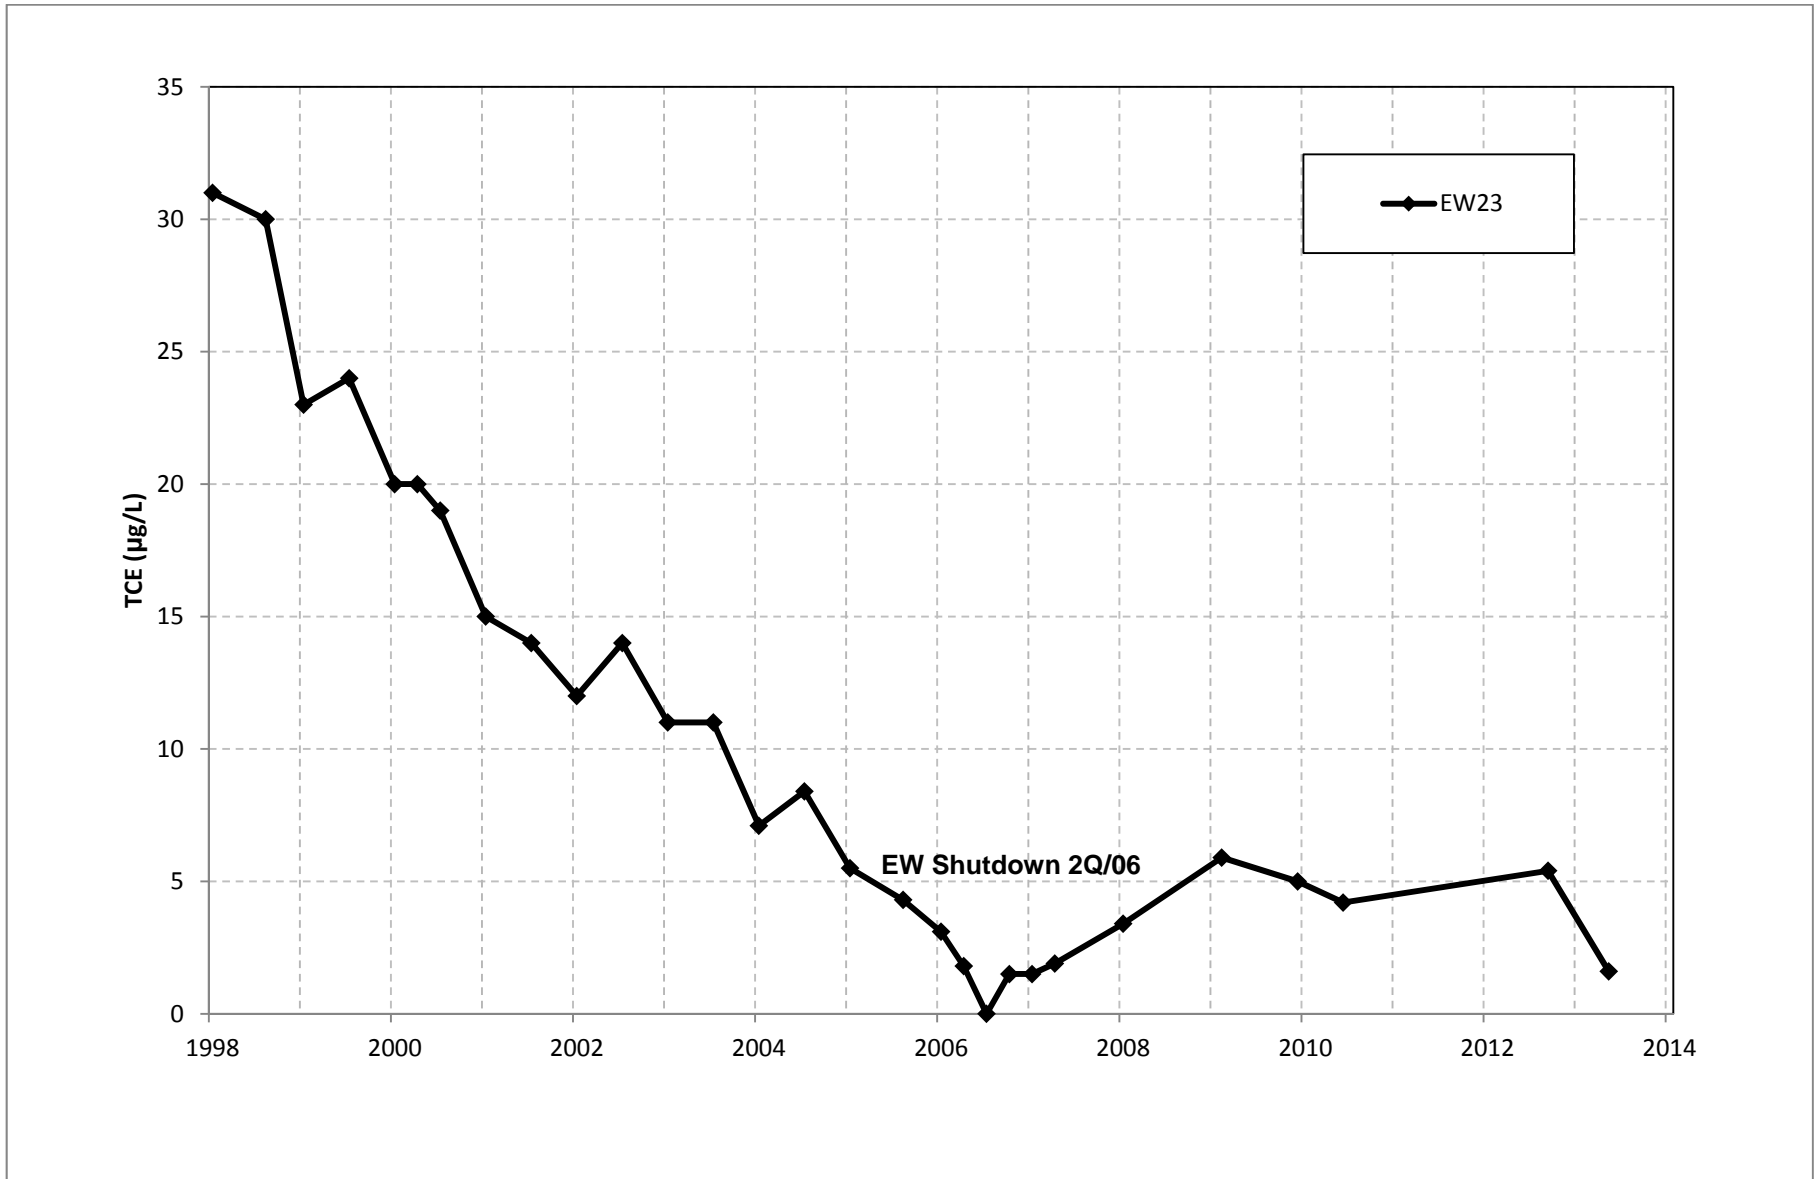
## EW23 TCE DATA TABLE

Comment Number	Section	Comment	Response
<b>COMBINED US EPA AND STATE OF CALIFORNIA COMMENTS (DATED 24 FEBRUARY 2014)</b>			
<b>General Comments</b>			
1	Section 7 Technical Assessment, Section 7.1 Main Base Plume, Section 7.1.1 Question A, Section 7.1.1.1.4 CB ROD-Part 2 Remedies, Appendix A Response to Comments Responses to Agency Comments on the Draft, Appendix A General Comment 3 and Specific Comment Numbers 7 and 8	The AF responses and revisions to the FYR partially address EPA's concern regarding the Main Base Plume Capture evaluation in Section 7, Technical Assessment. The agency's concern regarding the delineation of the TCE plume and capture at depth are not addressed. Section 7.1.1.1 Plume Capture describes the status of capture for the various Hydrostratigraphic Zones, both on and off-base, and is supplemented by Figures 7-6 through 7-9. The report does not state that capture is complete for the Confined Hydrostratigraphic Zone (HSZ), and Figure 7-9 does not display an estimated zone of capture at the 5 µg/L TCE isoconcentration contour, near MW 606.	The 5 µg/L isoconcentration contour for the on-base Confined Hydrostratigraphic Zone (HSZ) shown on Figure 7-9 is based on data for EW23 which is collocated with MW606. Based on data through 4Q2012, EW23 (5.4 µg/L) was the only on-base well that exceeded the MCL for TCE in the Confined HSZ. MW606 had no monitoring objective so it was removed from the LTGSP in 3Q1999 (see LTGSP reports). EW23 was shut off in 2Q2006 with agency approval after three consecutive sampling events with TCE concentrations below the MCL and has since been monitored and evaluated for restart in the LTGSP reports. The 2Q2013 analytical result for TCE was 1.6 µg/L. As stated in 2012 Annual LTGSP report, results have not warranted EW23 restart (see response to EPA General Comment 6 on the 2012 Annual Report, shutdown and restart criteria are discussed in the comment response). Since shutdown, TCE has not been sustained above the MCL and the maximum result since EW23 was turned off was 5.9 µg/L in 1Q09. Time series data for EW23 is attached. The following text has been added to the last paragraph of Section 7.1.1.1.1: "As of Q4/12, EW23 is the only location that exceeded the MCL in the on-base Confined HSZ. EW23 was shut off in Q2/06 with agency approval after three consecutive sampling events with TCE concentrations below the MCL and has since been monitored and evaluated for restart in the LTGSP reports. Since shutdown, TCE has not been sustained above the MCL and the maximum result since EW23 was turned off was 5.9 µg/L in Q1/09. The Q2/13 analytical result for TCE was 1.6 µg/L such that there currently is no on-base Confined HSZ plume that exceeds the TCE MCL. As stated in the 2012 Annual LTGSP report (CH2M HILL, 2013a), monitoring results since shutdown have not warranted EW23 restart. Monitoring and evaluation of EW23 and the on-base Confined HSZ continues under the LTGSP."

Comment Number	Section	Comment	Response
1 (cont'd)		<p>Regarding the off-base plume that requires well head treatment to address groundwater contamination exceeding MCLs within the Confined HSZ, the report indicates that MW951 is capturing a portion of the off-Base plume segment, however does not clearly state whether all of the wells above MCLs are being satisfactorily addressed by wellhead treatment. Based on Figure 7-9, it appears that MW1008 is above MCLs, but not influenced by capture. The text on Page 7-10 does not mention the TCE levels for this well. While capture is not required, the report should confirm that the wellhead treatment objectives reduce the concentrations below MCLs are being achieved for all wells above MCLs, to ensure additional monitoring or wellhead treatment is not necessary.</p>	<p>TCE sample results for MW951, MW1008, and AM-18 have been added to the local well treatment portion of Section 7.1.1.1.4 and further explanation has been provided on how implementation of the CB ROD Part 2 remedy continues to achieve the CB ROD Part 2 RAO. The CB Part 2 remedy for the off base confined HSZ does not specify that all wells above the MCL be addressed by wellhead treatment. The off base confined remedy requires that local wellhead treatment remove contaminant mass and/or reduce potential impact on municipal water supply wells in the area (e.g., AM18) (CB ROD Part 2 Section 2.12.3). The CB ROD Part 2 RAO is to prevent exposure to groundwater from a Castle AFB plume containing chemicals of concern above the MCL (CB ROD Part 2 Section 2.8). Results of current implementation as reported in the LTGSP reports and FYR indicate the remedy has been effective in reducing the concentration at AM18 and within the off-base confined plume area such that achieving the RAO has been maintained. The monitoring results and achieving the RAO establish that additional monitoring or wellhead treatment is not necessary for achieving the RAO. As established by the CB RI/FS Part 2 and the CB ROD Part 2, capture of the off-base confined HSZ plume area is impractical due to the influence of municipal well pumping. Based on the CB Part 2 ROD remedies, wellhead treatment or an alternative water supply would be evaluated in consultation with the agencies if a water supply well (such as AM18) begins to exceed one-half the MCL.</p>
