Galena Restoration Advisory Board

Mr. Greg Gangnuss
Strategic Communications Chief,
AFRPA/CIOC
26 Apr 2012

Overview of Environmental Restoration Strategy

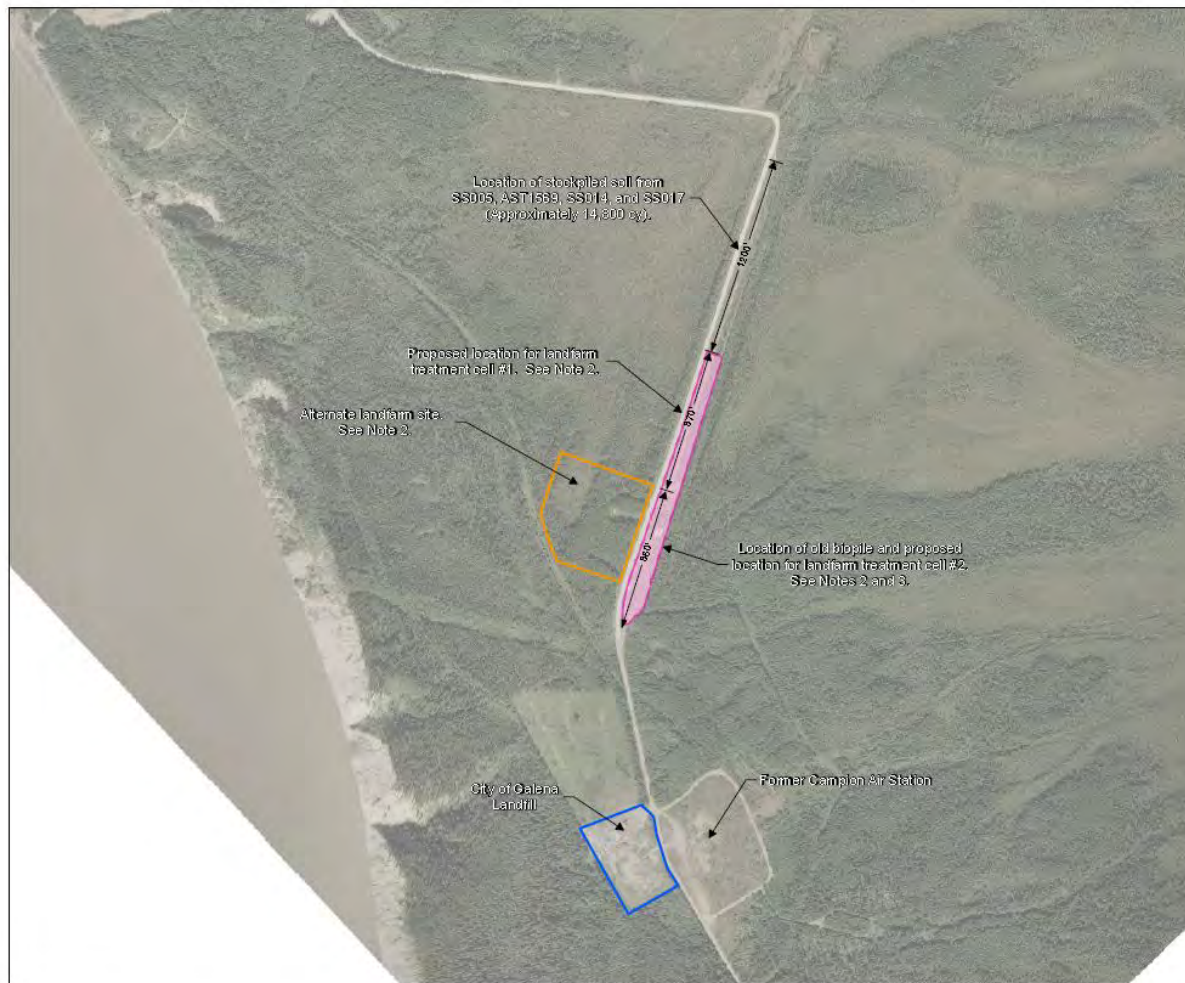
FIGURE 2-2
Landfarm Location
 Landfarm Work Plan

- LEGEND**
- City of Galena Landfill
 - Alternate Landfarm Location
 - Proposed Landfarm Location

- Notes:**
1. 12" = cubic yards
 2. There have been cut in this area, but stumps, roots, and surface vegetation remain.
 3. The existing biopile contains approximately 7,200 cubic yds used to construct the landfarm cell beams.
 4. Aerial photography courtesy Alaska Department of Commerce, Community and Economic Development, Division of Community and Regional Affairs, July 7, 2010. Pixel size 2-foot.

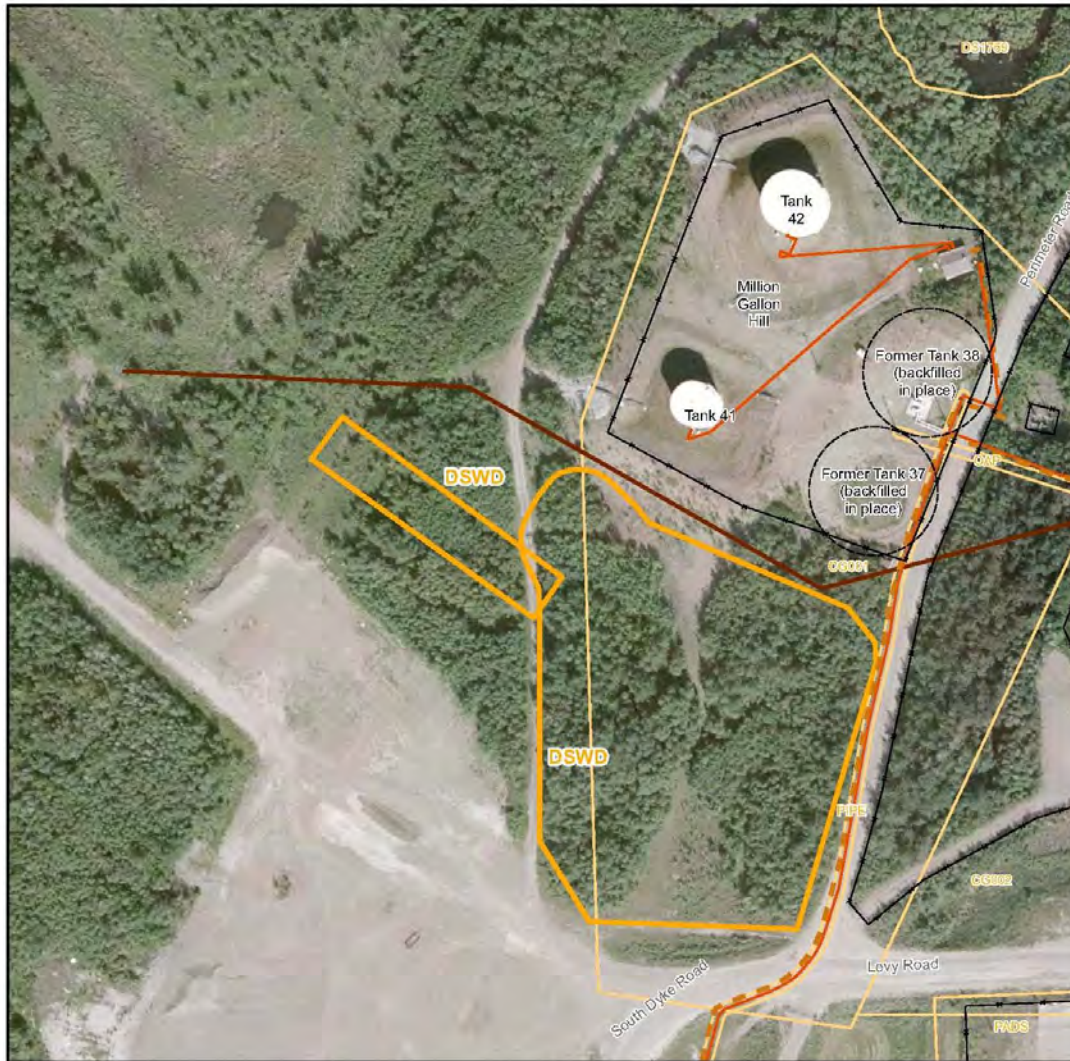
DSWD – Site Layout

- DSWD
- Adjacent Site
- Fence
- Abandoned Fuel Line
- Main Fuel Line
- Main Wastewater Line

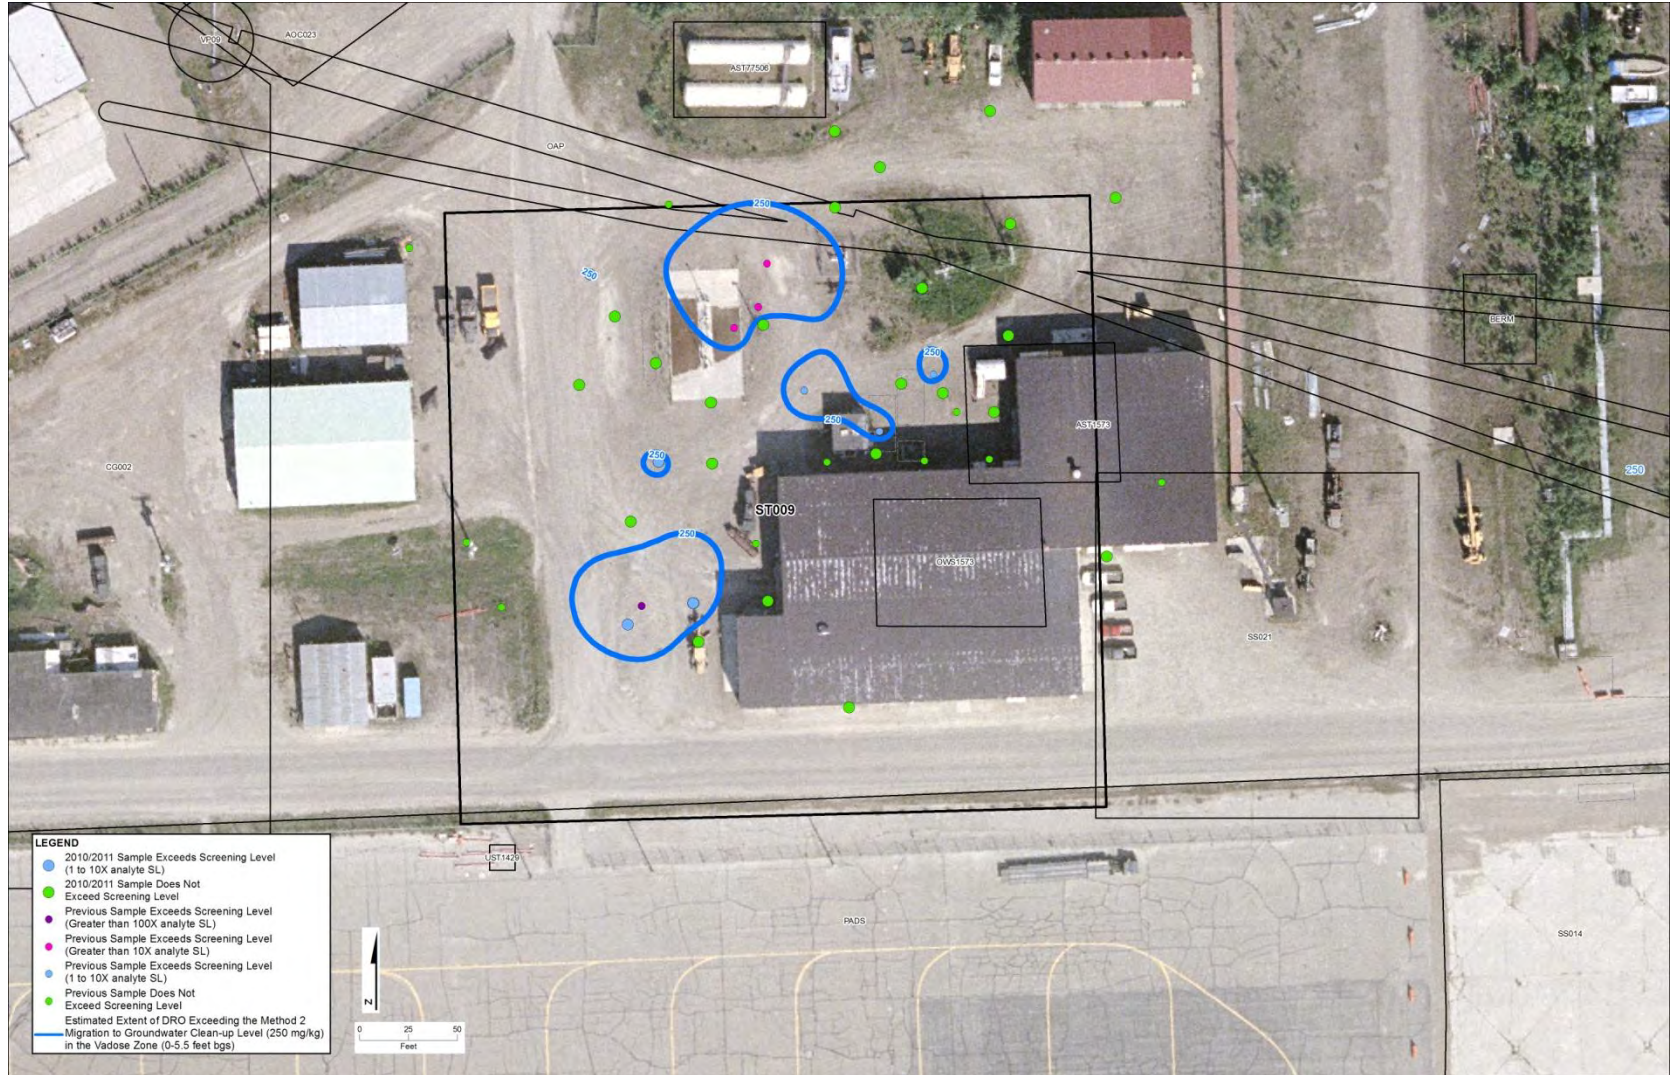
Site ST009 – Distribution of DRO in the Vadose Zone (surface to 6 feet below ground surface)

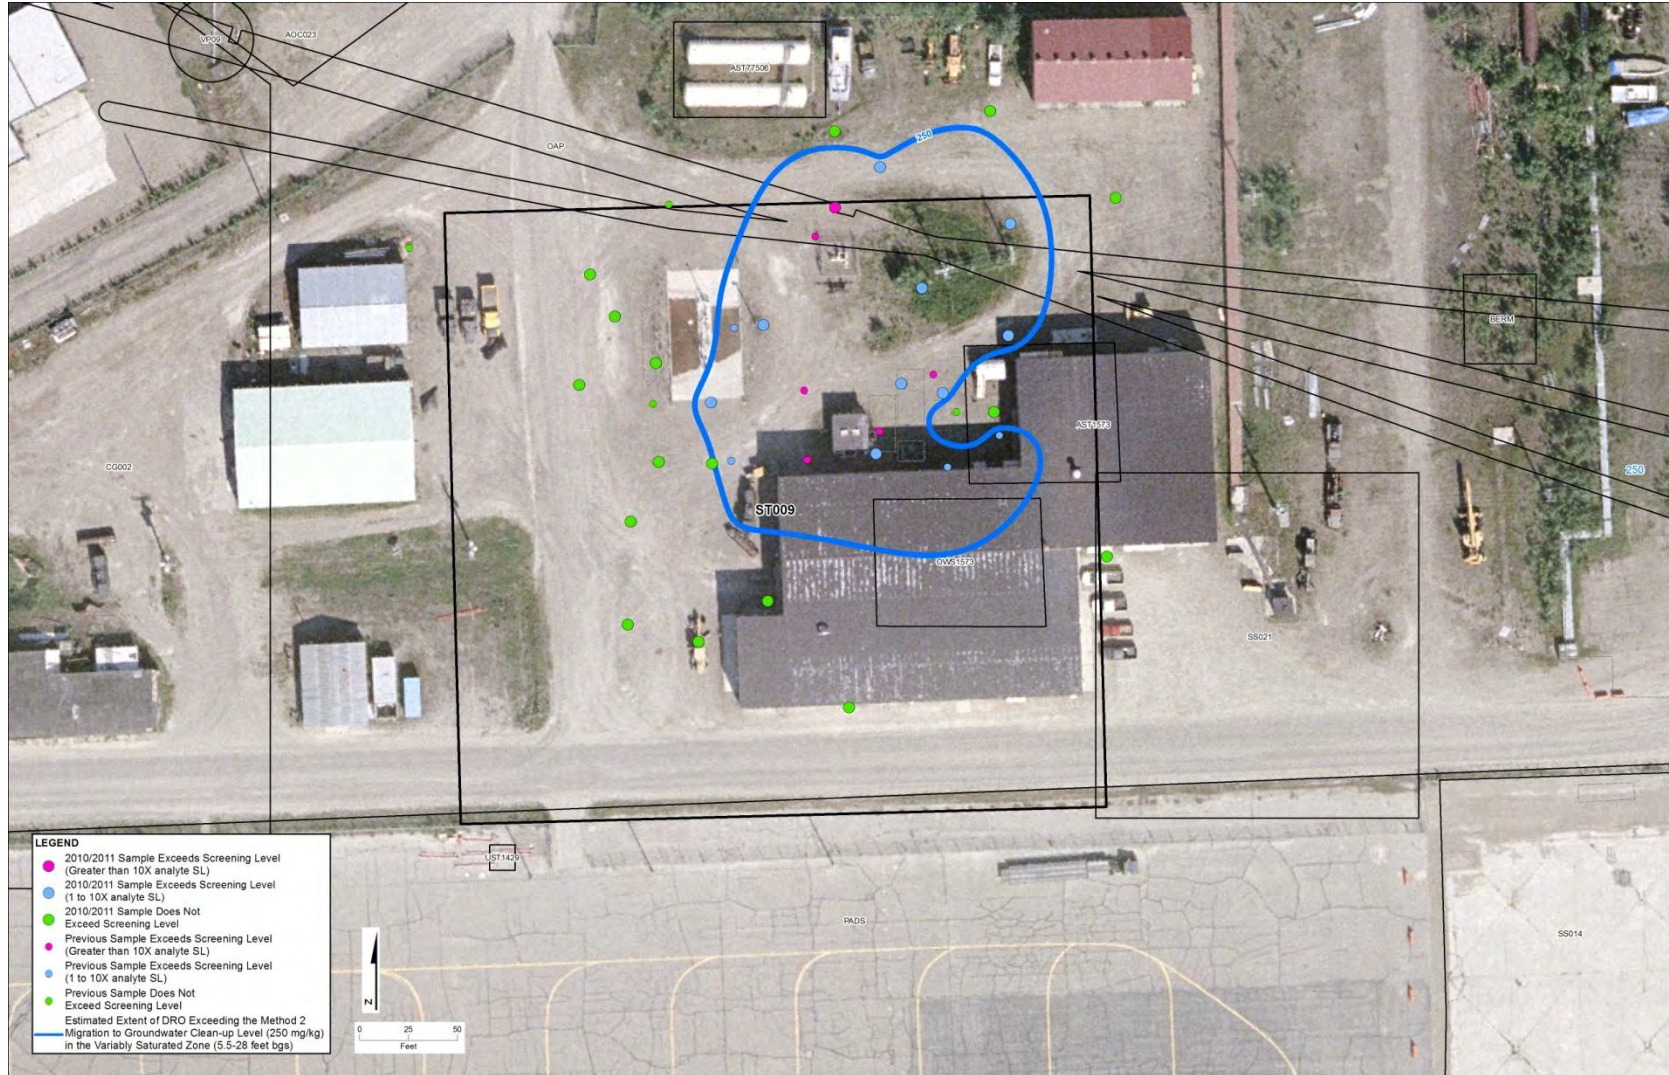
Site ST009 – Distribution of DRO in the Variably Saturated Zone (6 to 27 feet below ground surface)

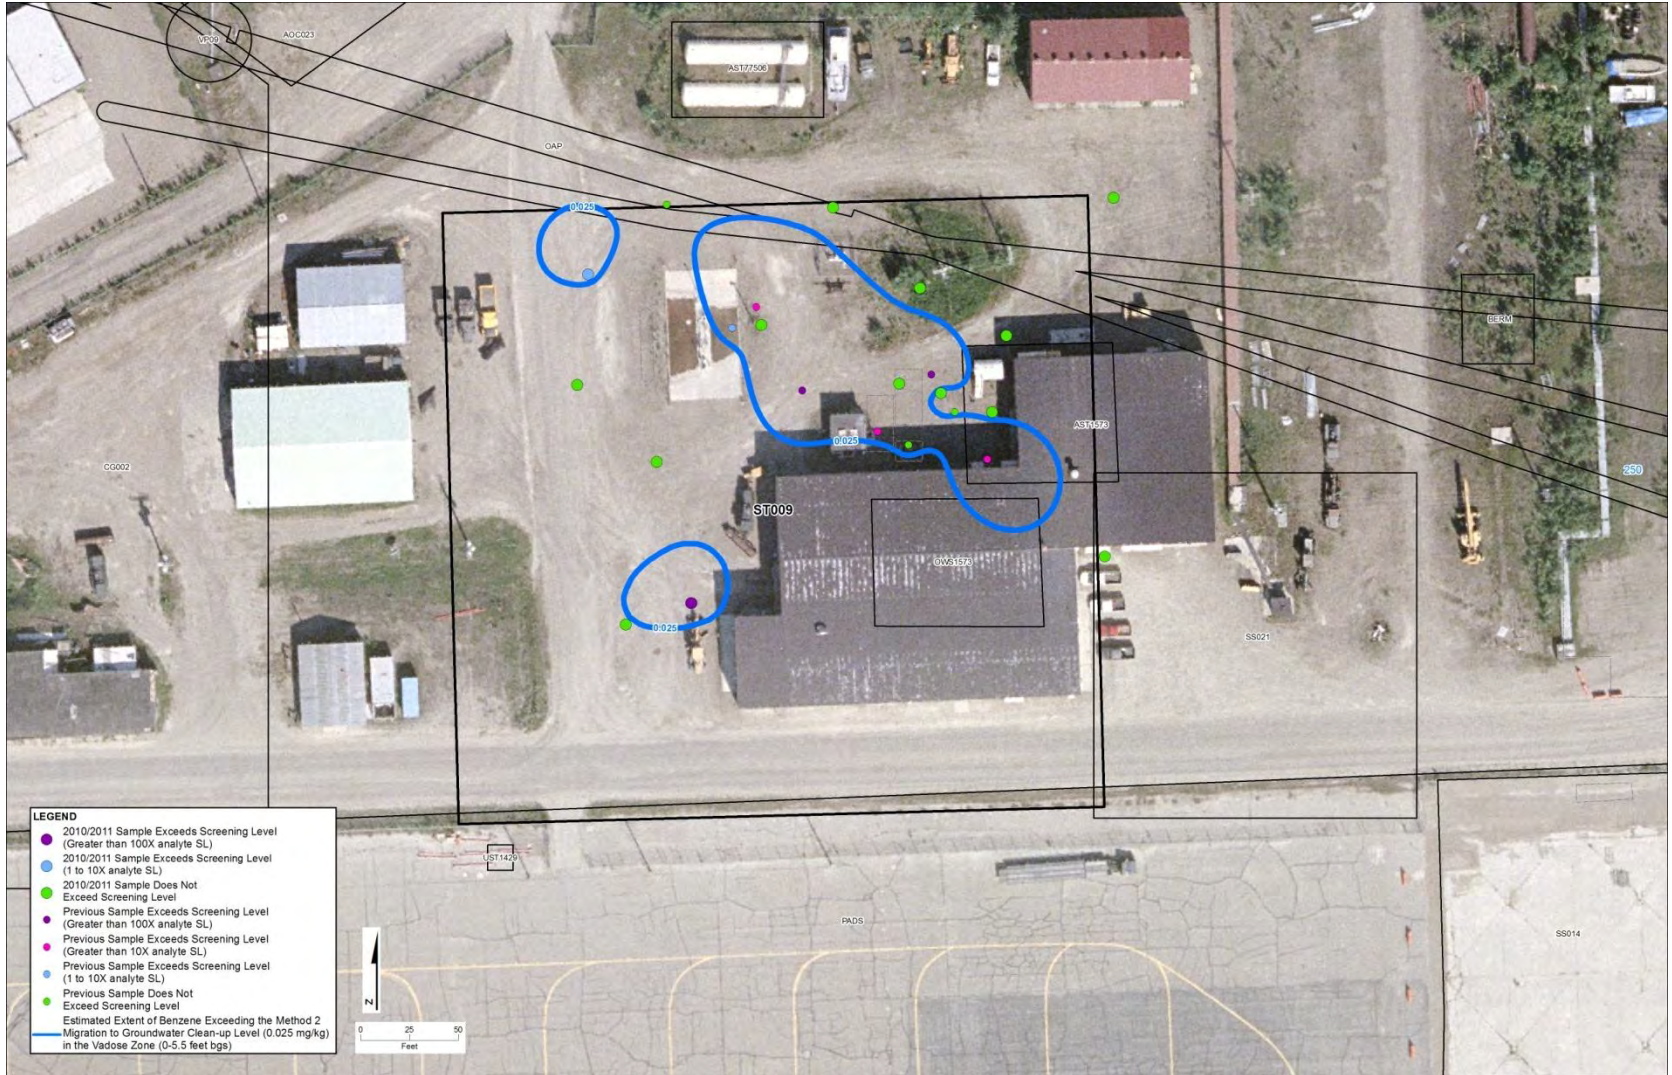
Site ST009 – Distribution of Benzene in the Vadose Zone (surface to 6 feet below ground surface)

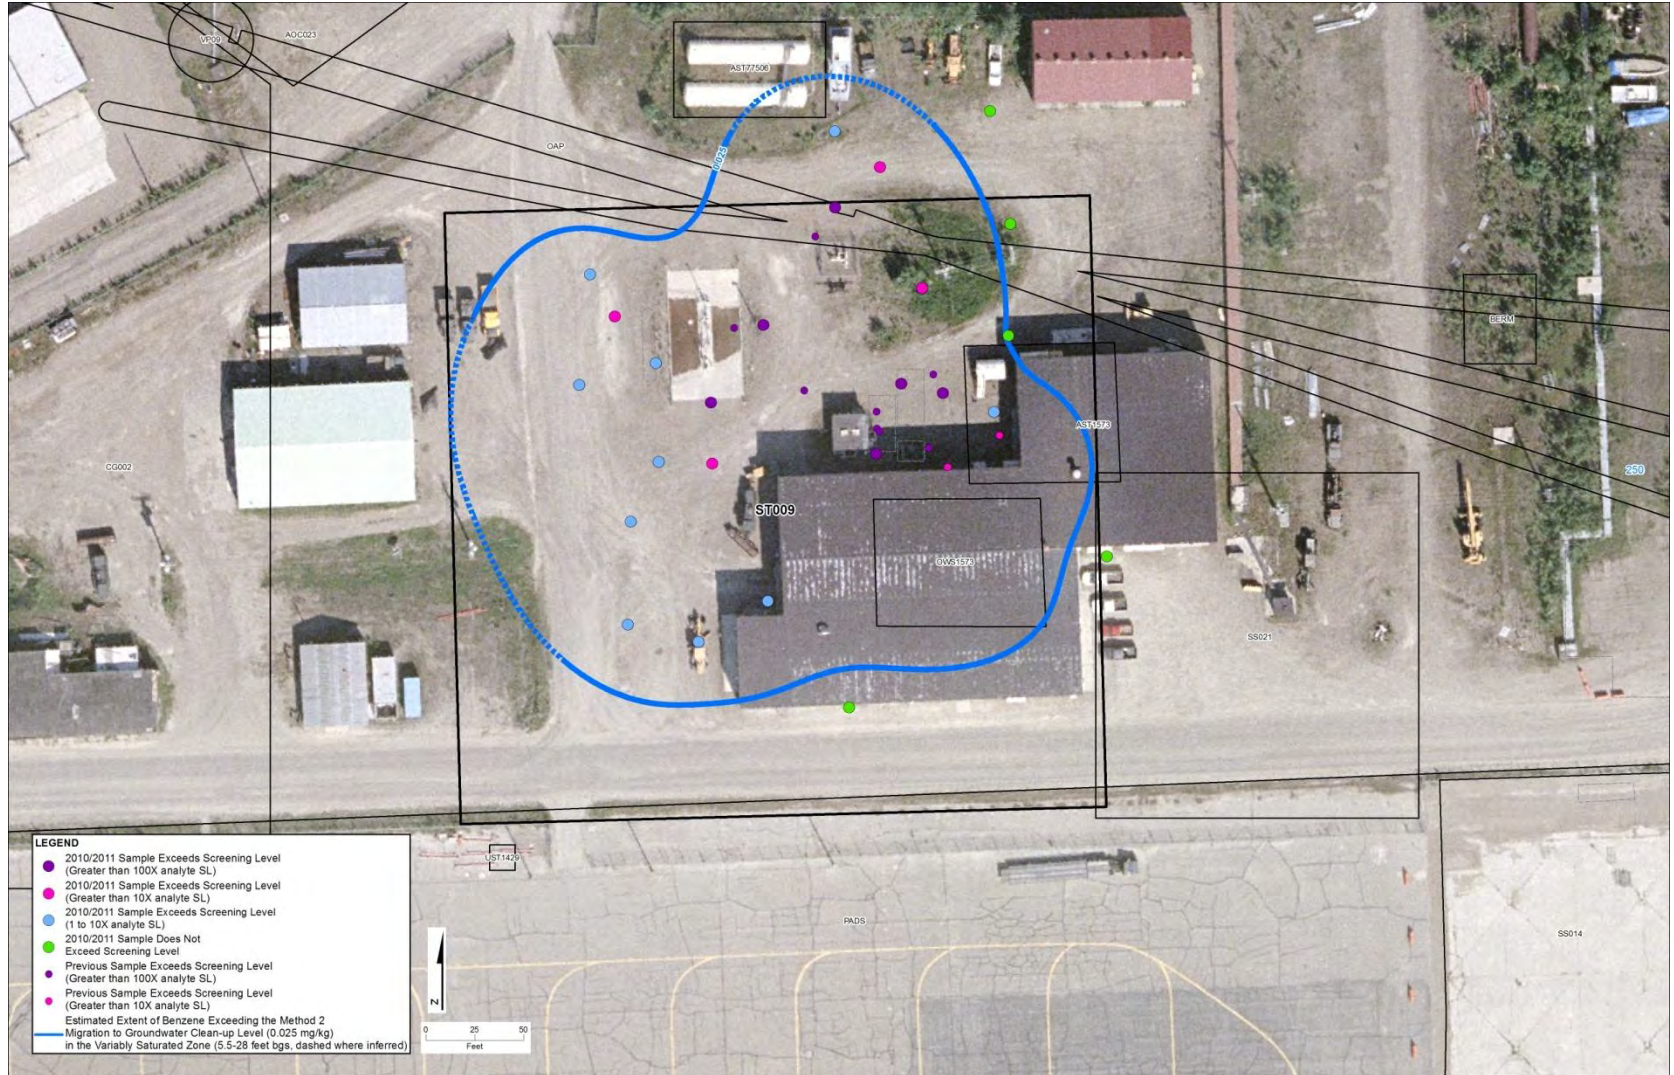
Site ST009 – Distribution of Benzene in the Variably Saturated Zone (6 to 27 feet below ground surface)

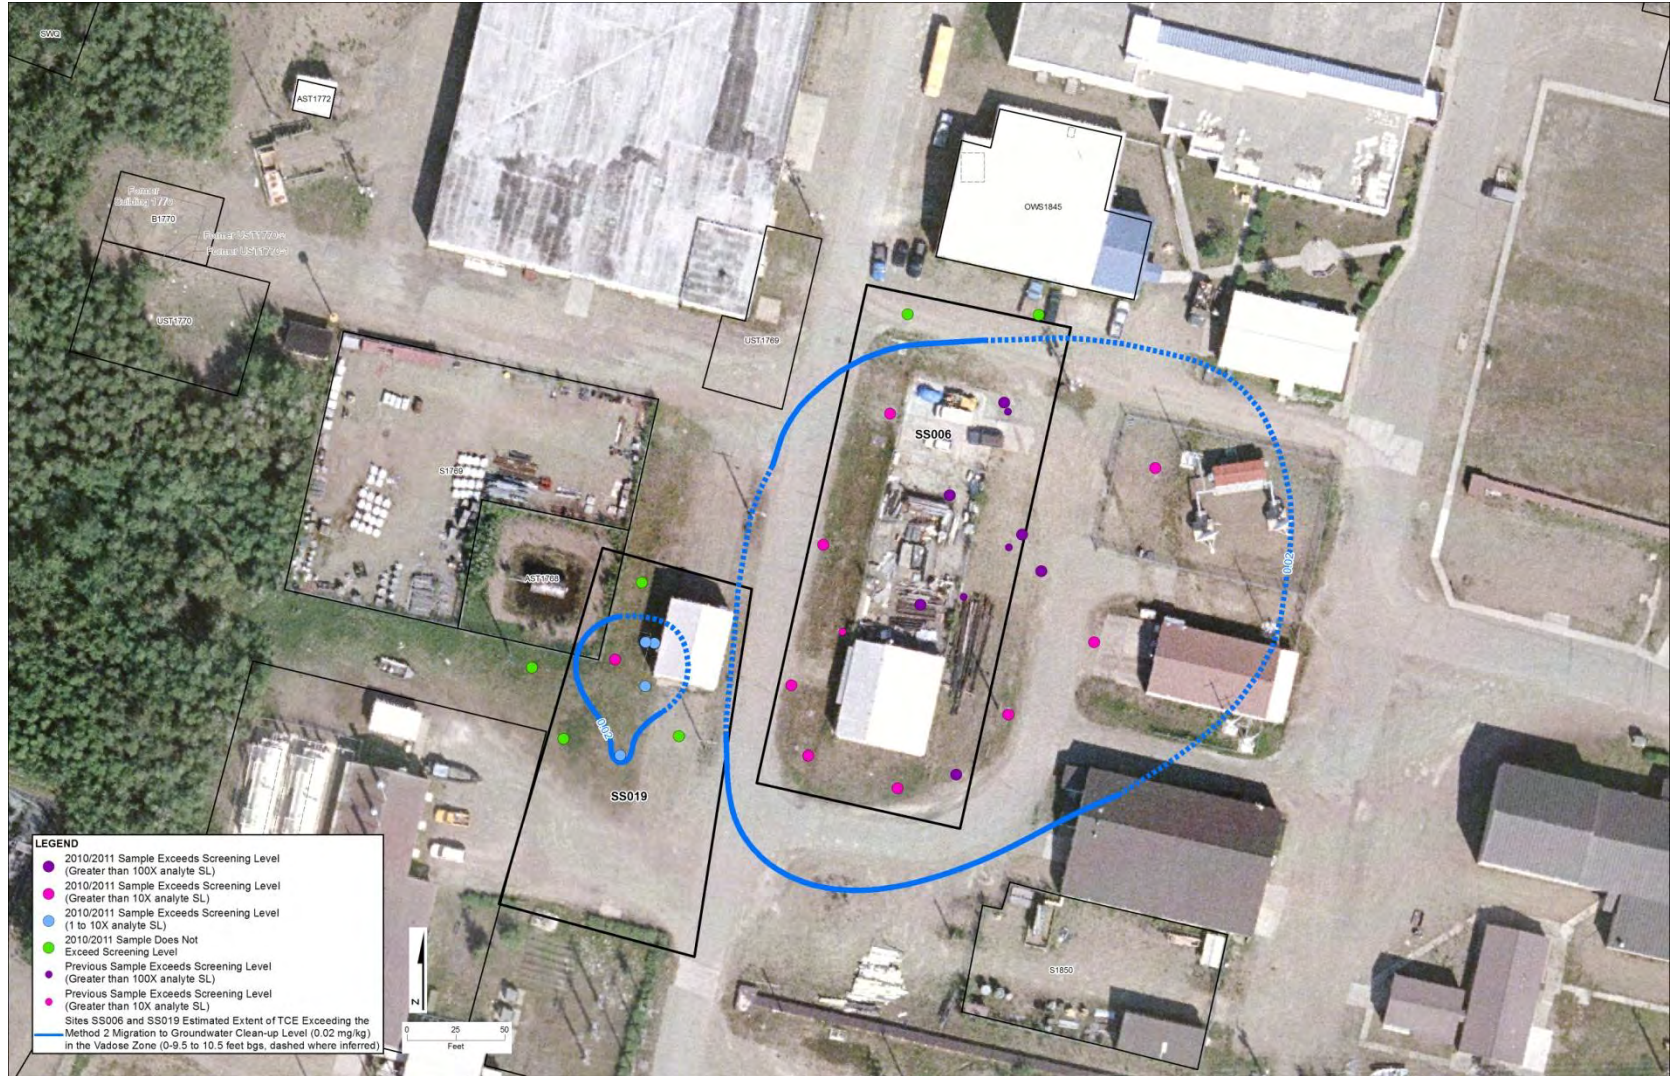
Sites SS006 and SS019 – Distribution of TCE in the Vadose Zone (surface to 9 feet below ground surface)

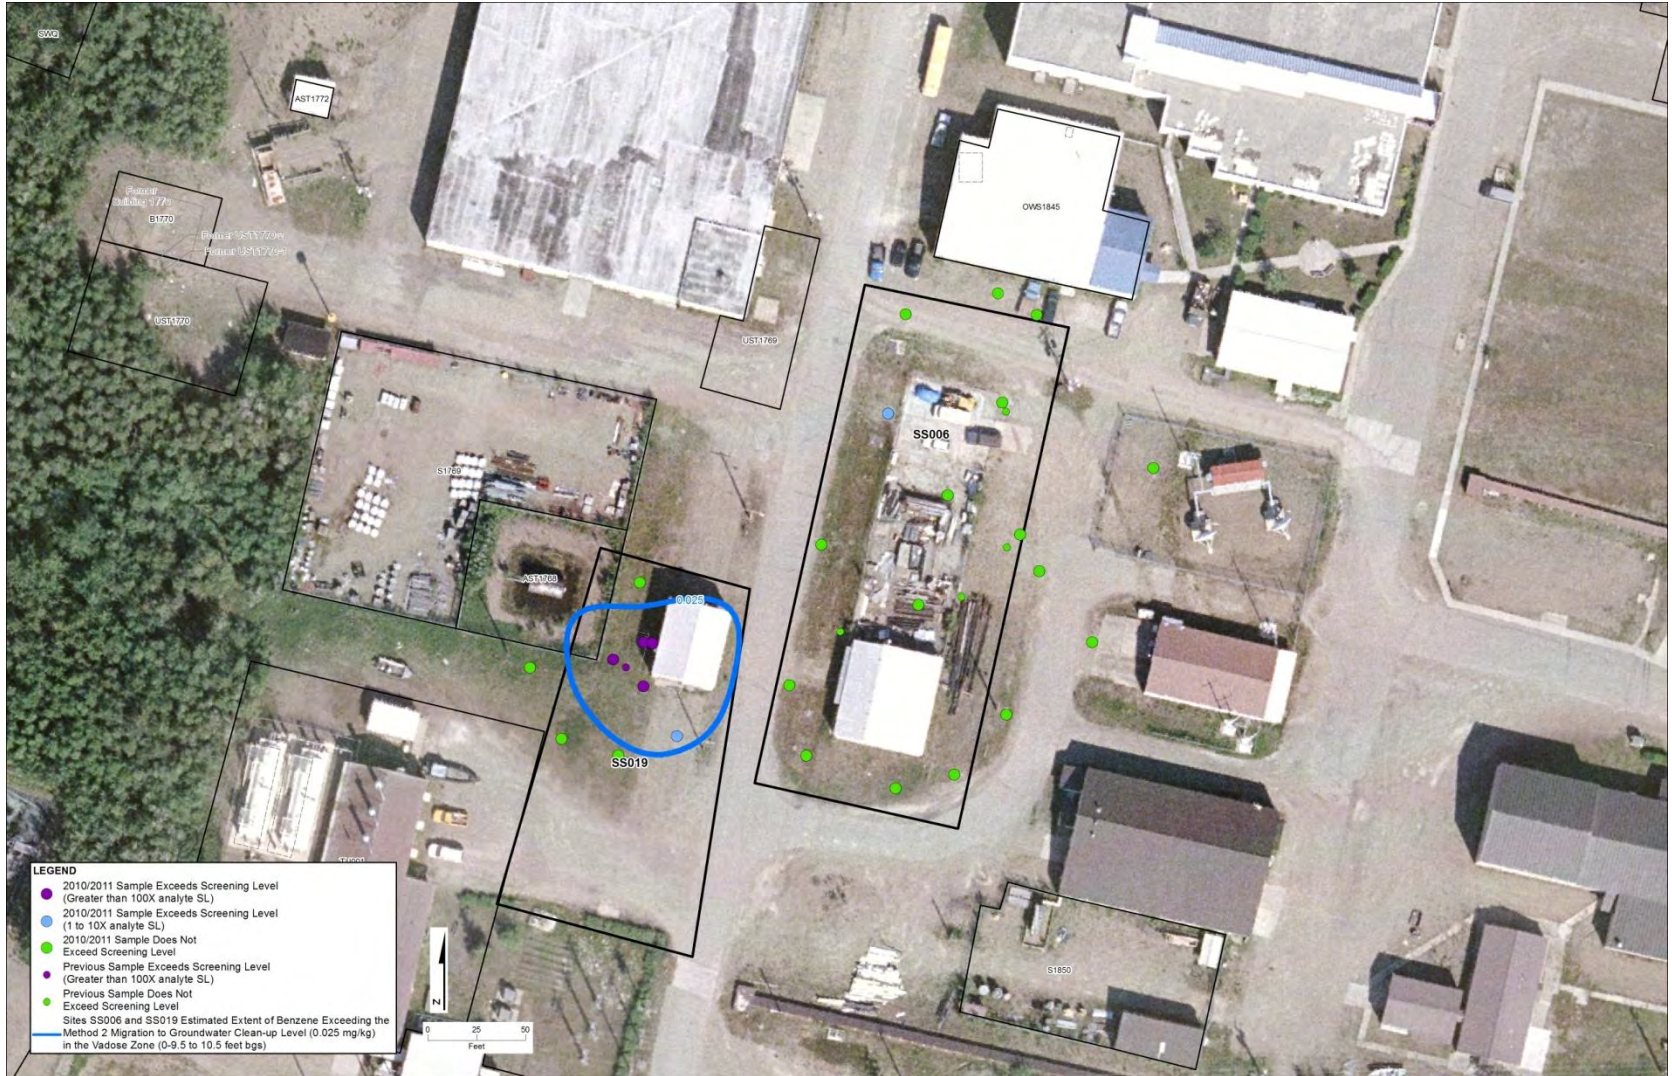
Sites SS006 and SS019 – Distribution of Benzene in the Vadose Zone (surface to 9 feet below ground surface)

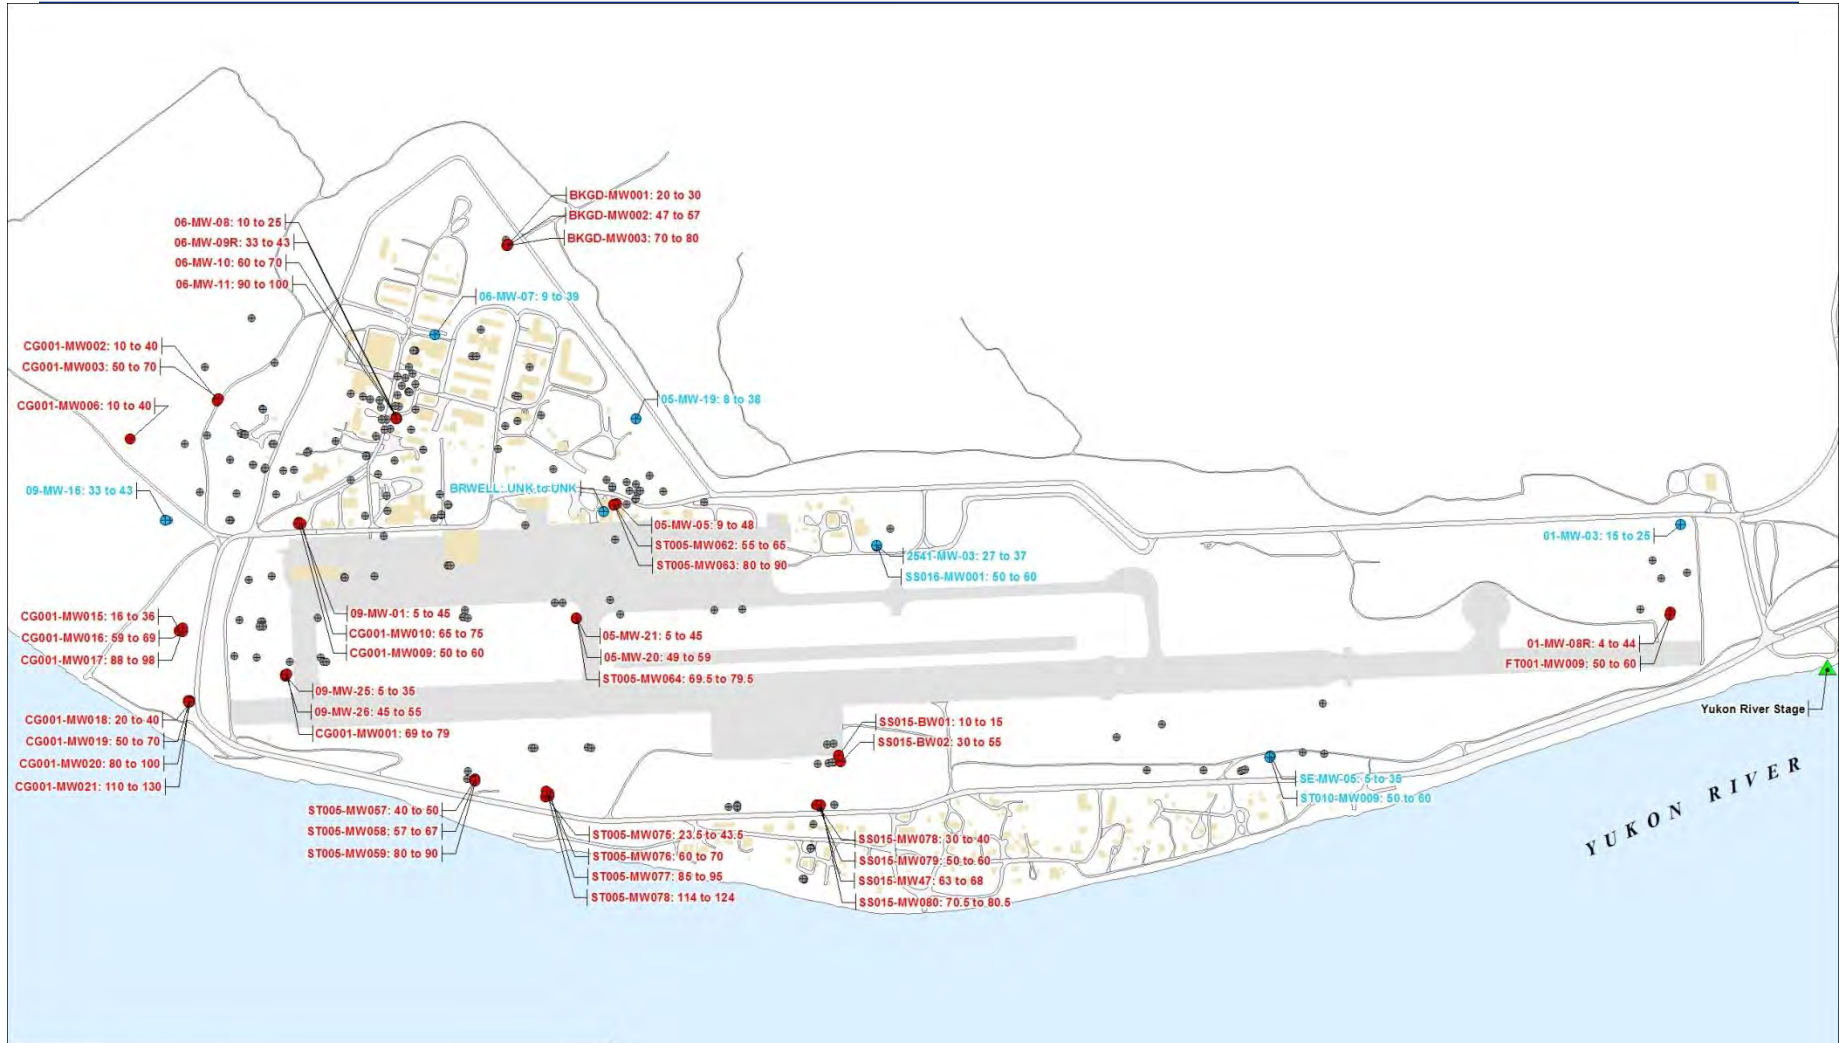
Transducer Deployment

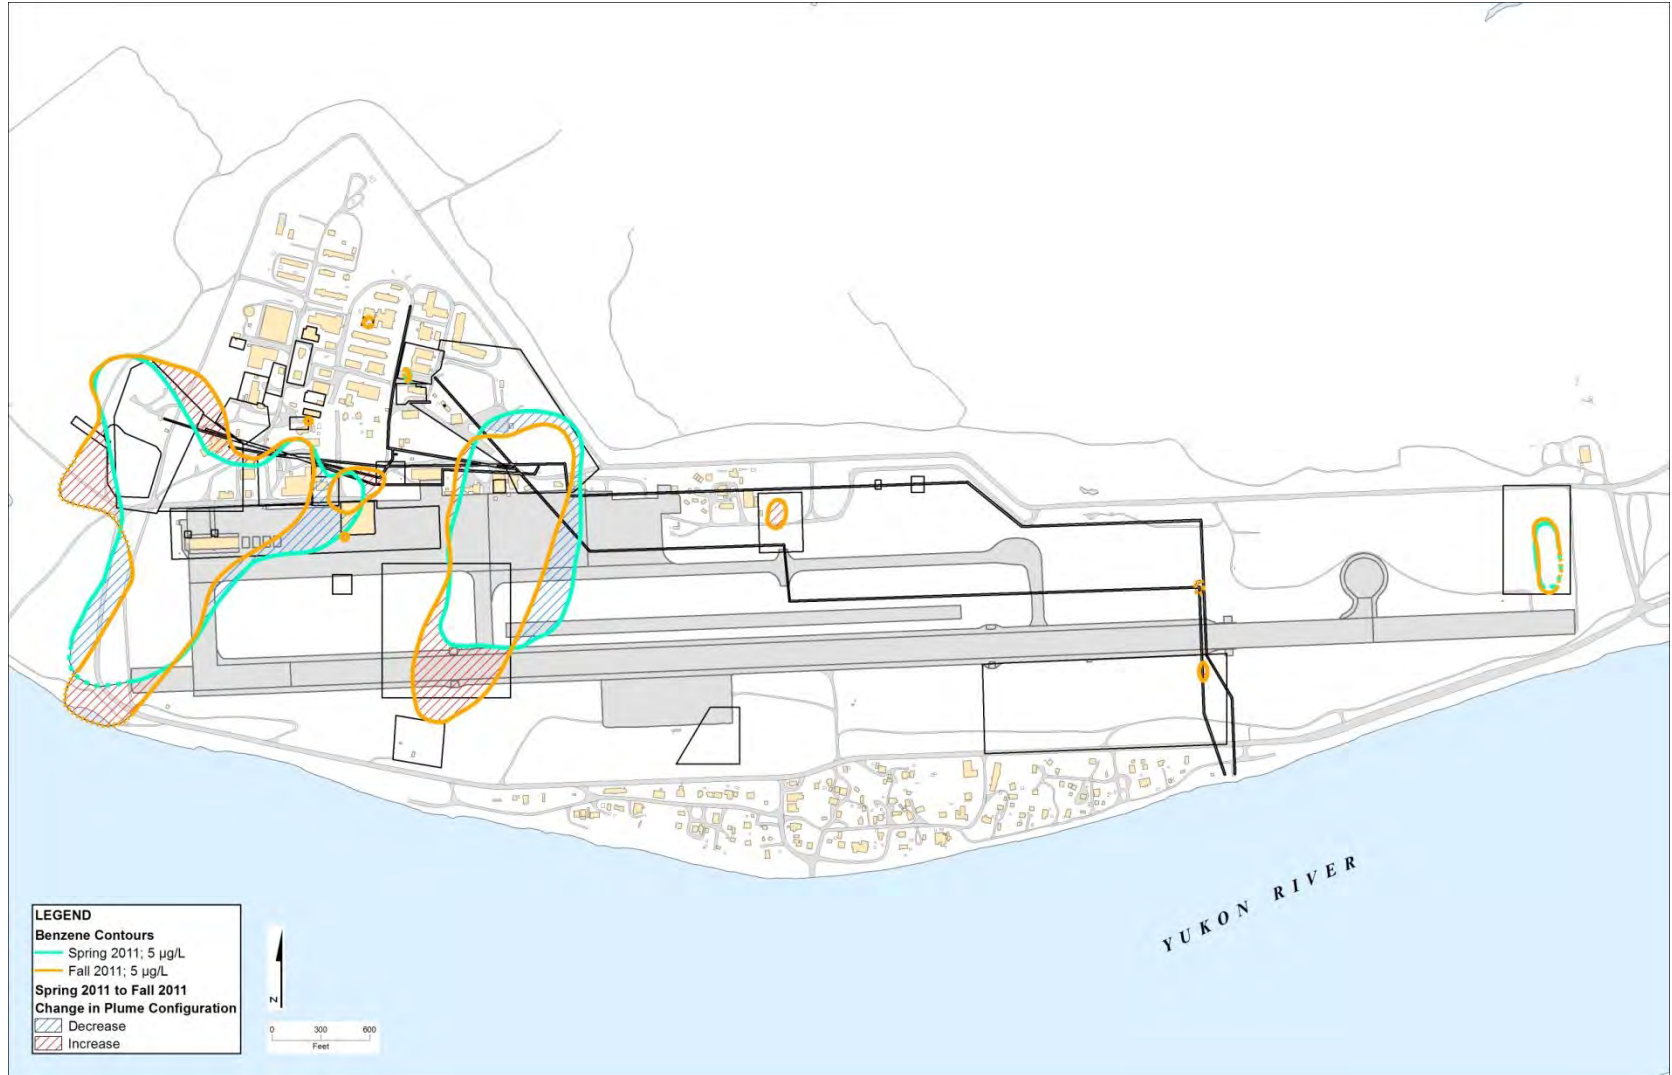
Change In Benzene Plume Configuration from Spring to Fall 2011

- Groundwater plumes were evaluated based on three rounds of sampling performed in Summer 2010, Spring 2011, and Fall 2011
- Benzene, DRO, and TCE plumes were evaluated
- Seasonal data suggests that concentrations increase from fall to spring as groundwater levels decline and decrease from spring to fall
- It is important to note that apparent changes to plume extents are often due to installation of new wells as opposed to changes in concentrations

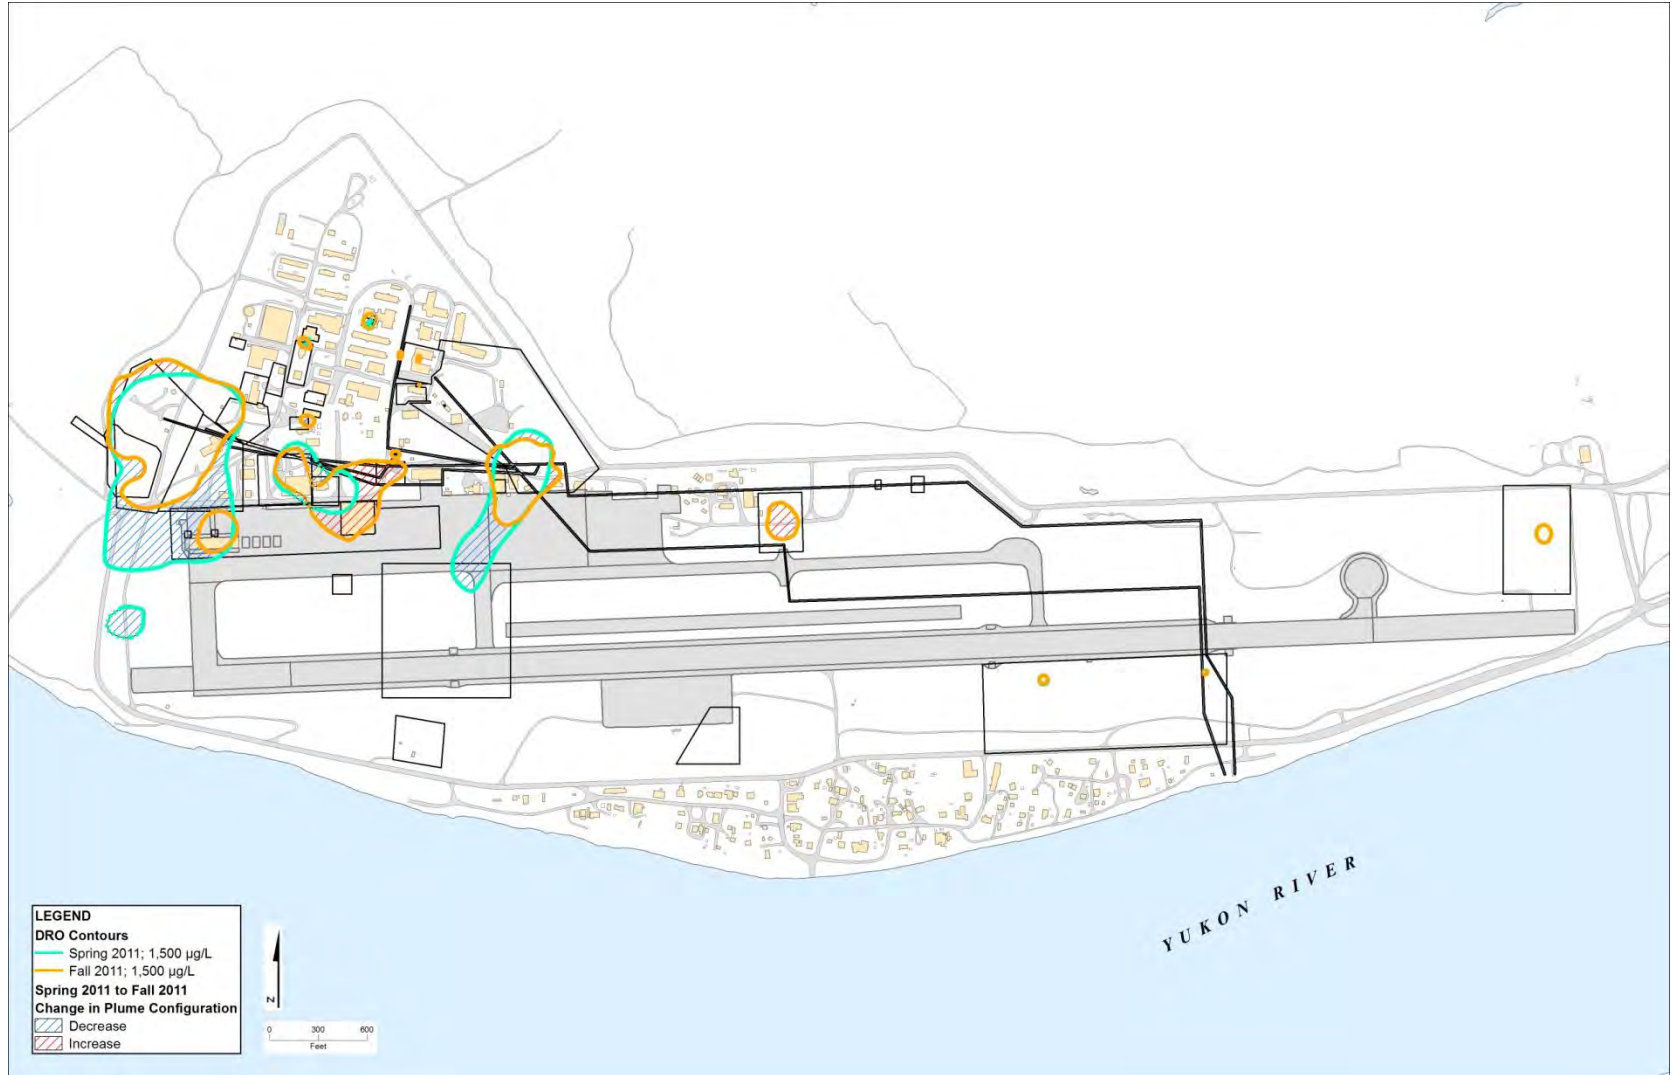
Change In DRO Plume Configuration from Spring to Fall 2011

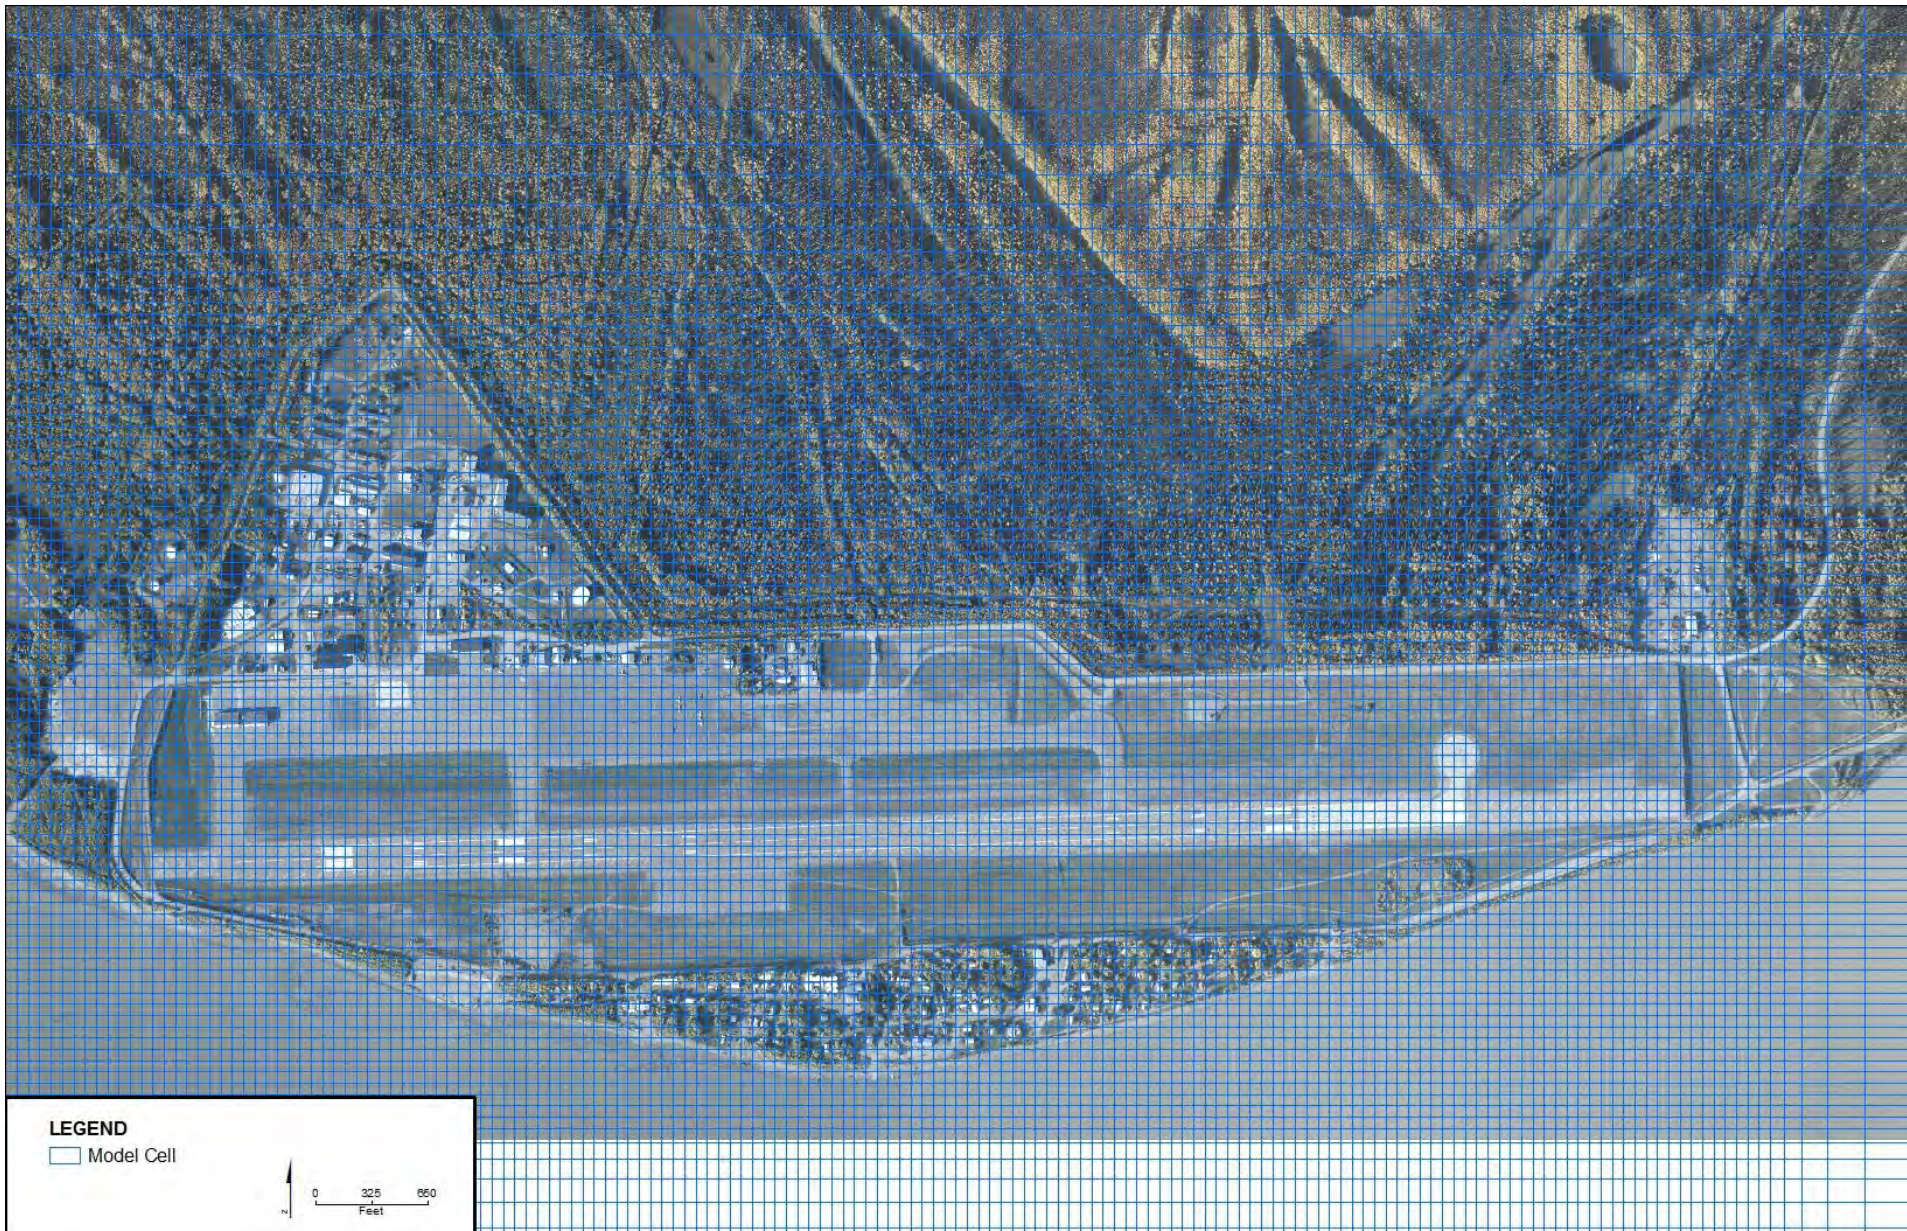
Flow Model Grid – Galena Area

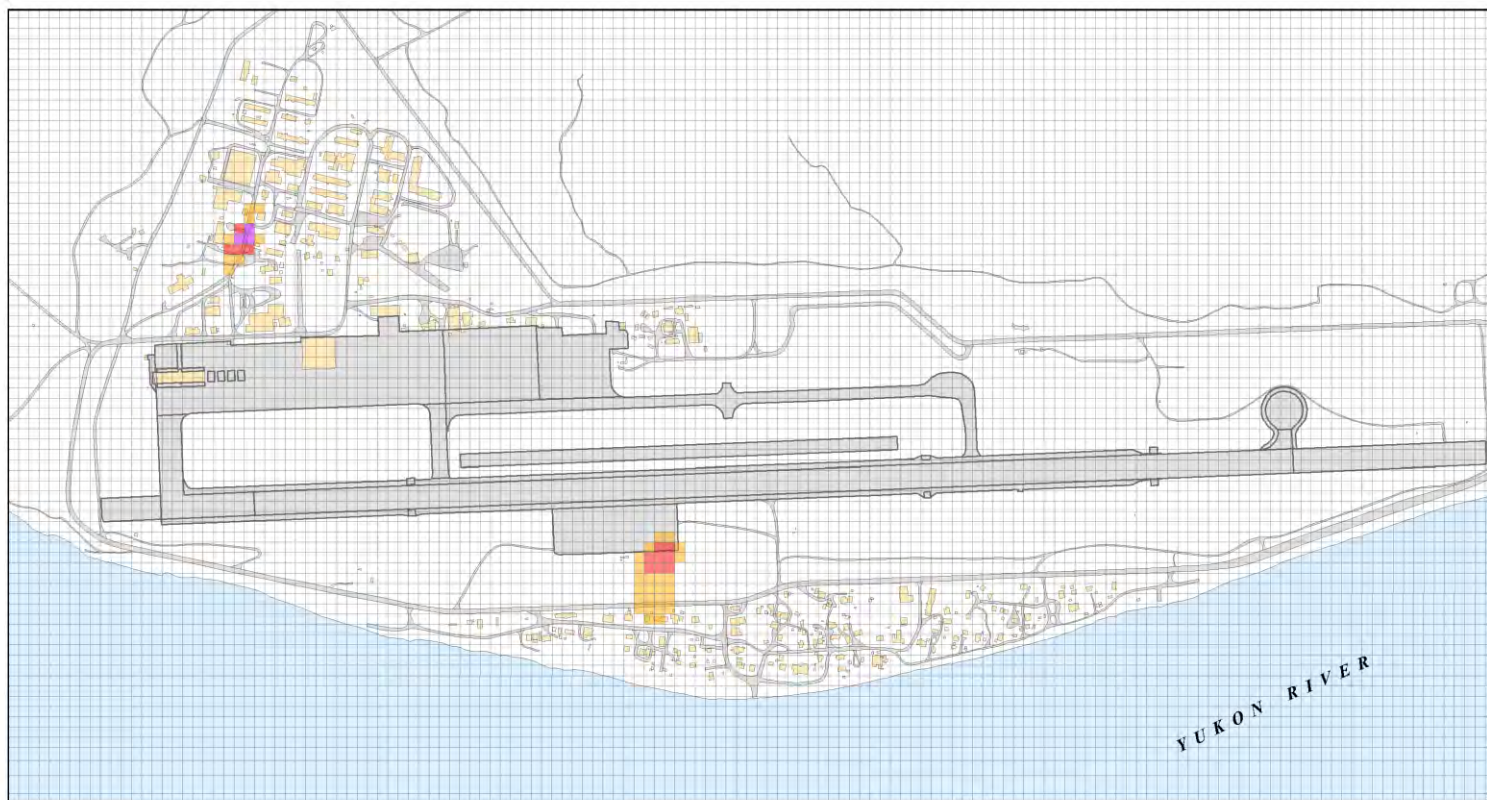
Initial Conditions – 40 to 70 feet

Note:
Mobile and immobile domain were set in equilibrium.

FIGURE 3-13
Initial TCE Concentrations
Layers 4 and 5
Groundwater Modeling Report
Former Galena Forward Operating Location, Alaska
