Galena Restoration Advisory Board

Mr. Greg Gangnuss
Strategic Communications Chief,
AFRPA/CIOC
26 Apr 2012

Overview of Environmental Restoration Strategy

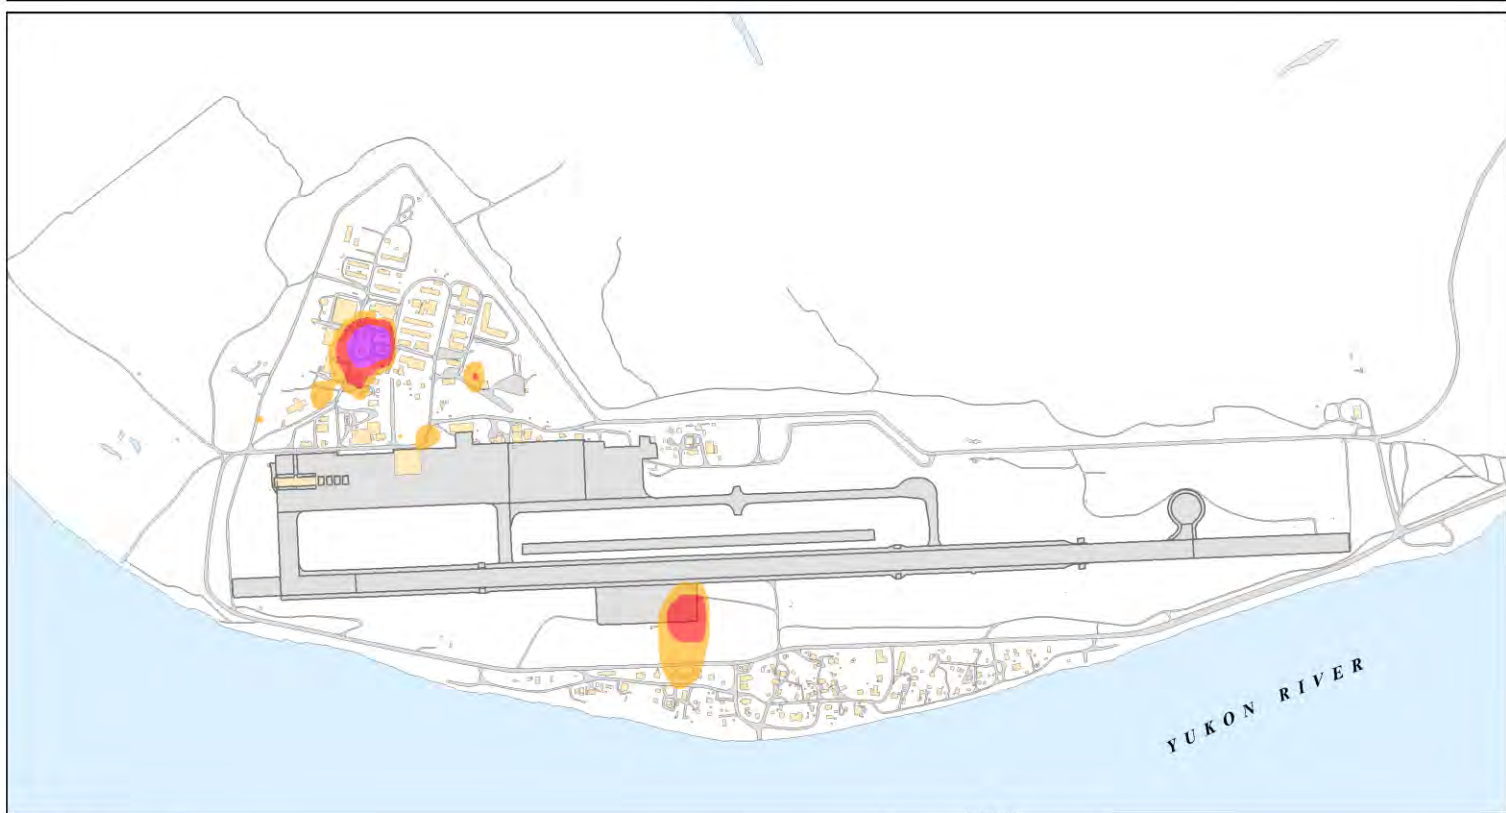
TCE 10 to 25 feet – 5 yrs

FIGURE 5-11
TCE Concentrations,
Layer 2, Year 5

- The transport model is in development and will benefit from future groundwater data collection
 - Model simulations suggest that the plumes are relatively stable; mass movement toward the river balanced by natural degradation
 - This implies very limited contaminant discharge to the Yukon River
-

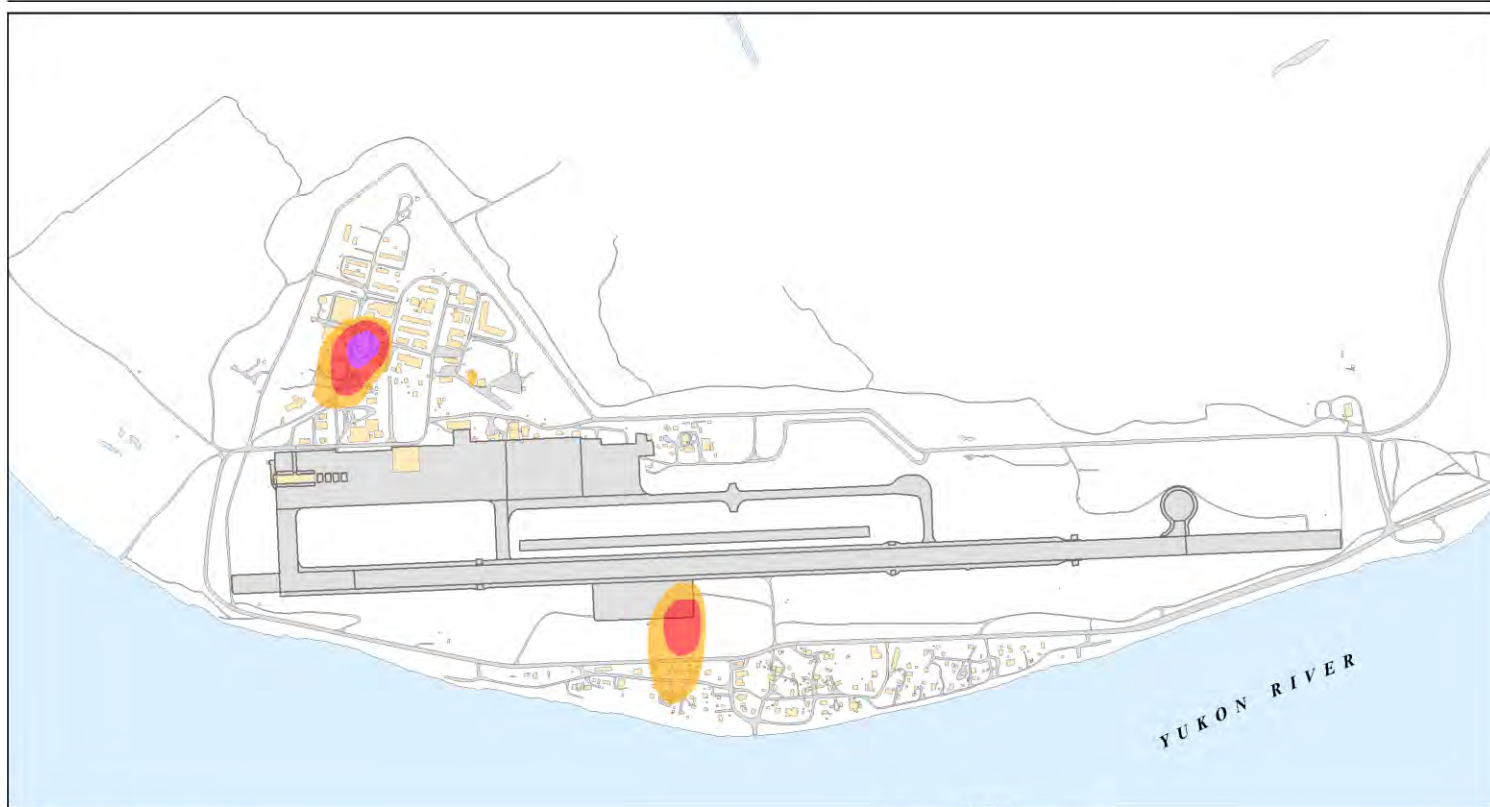
TCE 40 to 55 feet – 5 yrs

FIGURE 5-12
TCE Concentrations,
Layer 4, Year 5

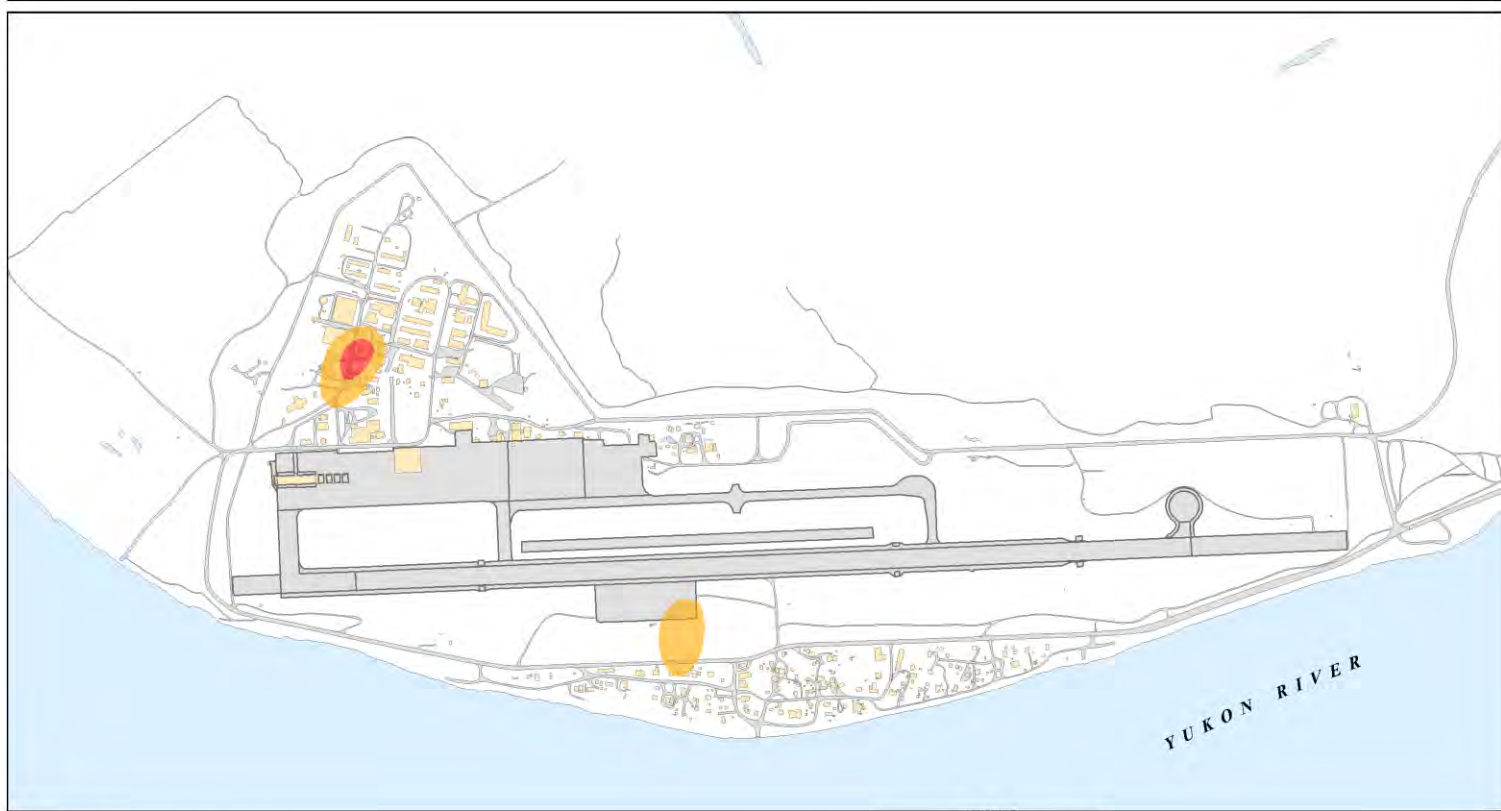
TCE 70 to 85 feet – 5 yrs

FIGURE 5-13
TCE Concentrations,
Layer 6, Year 5
Groundwater Modeling Report
Former Galena Forward Operating Location, Alaska

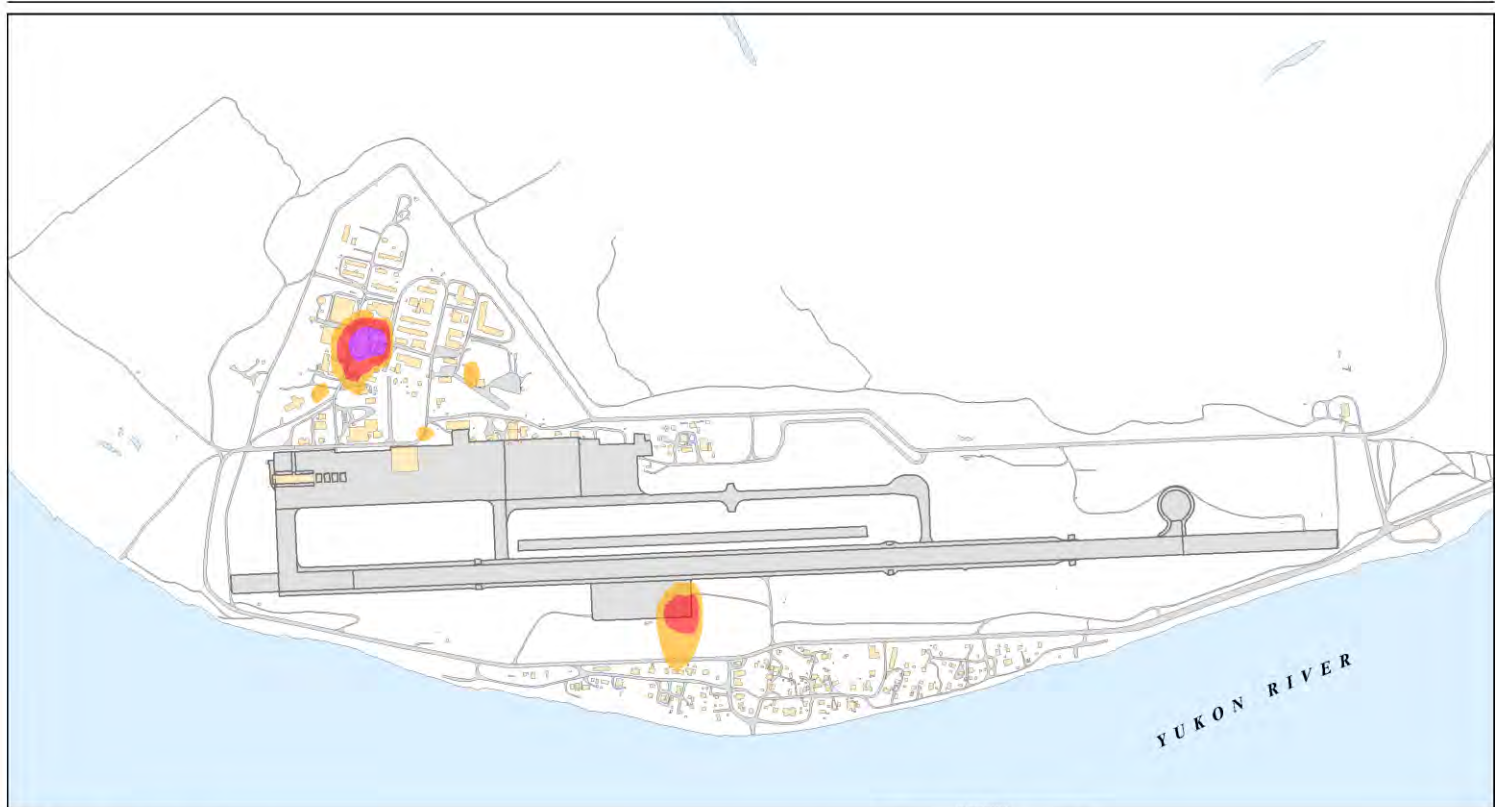
TCE 10 to 25 feet – 10 yrs

FIGURE 5-14
TCE Concentrations,
Layer 2, Year 10
Groundwater Modeling Report
Former Galena Forward Operating Location, Alaska

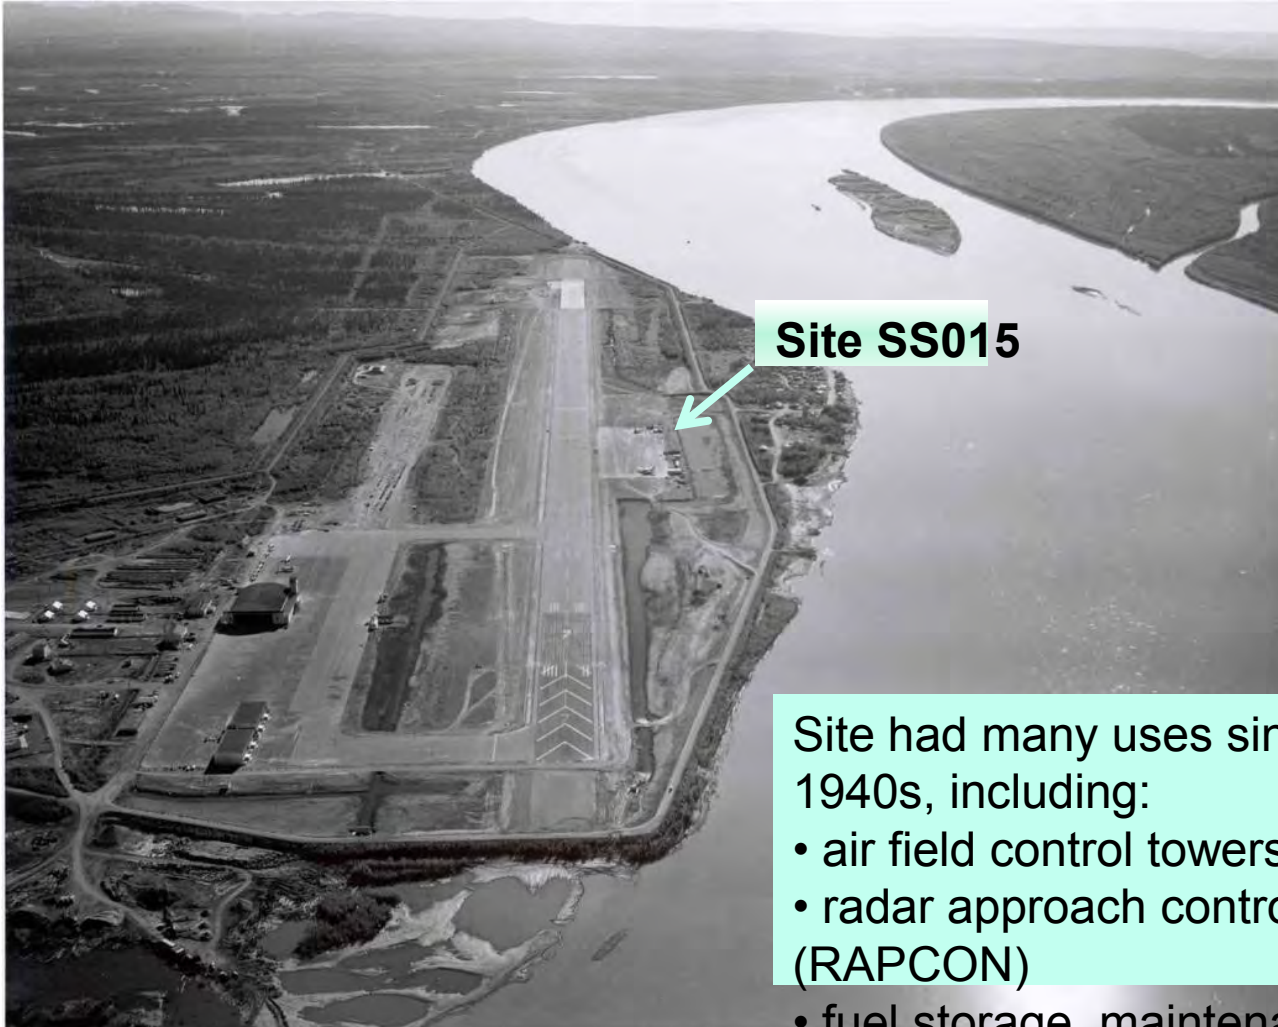
Bioreactor Location

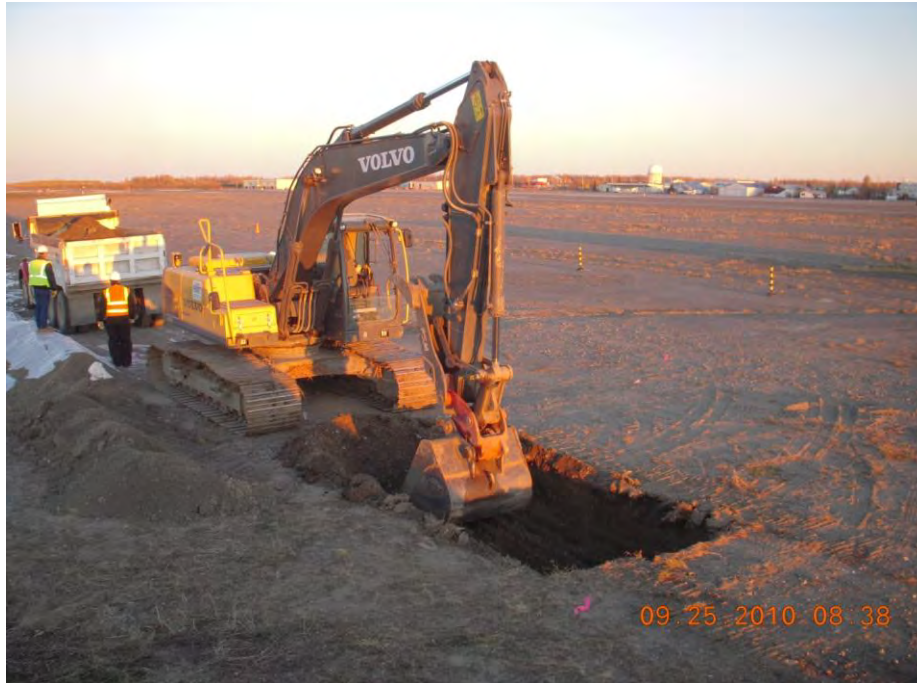
- The bioreactor was constructed in September 2010
- Excavated 200 cy of PCE and TCE-contaminated soil from the “hot spot” source area at the edge of the apron.

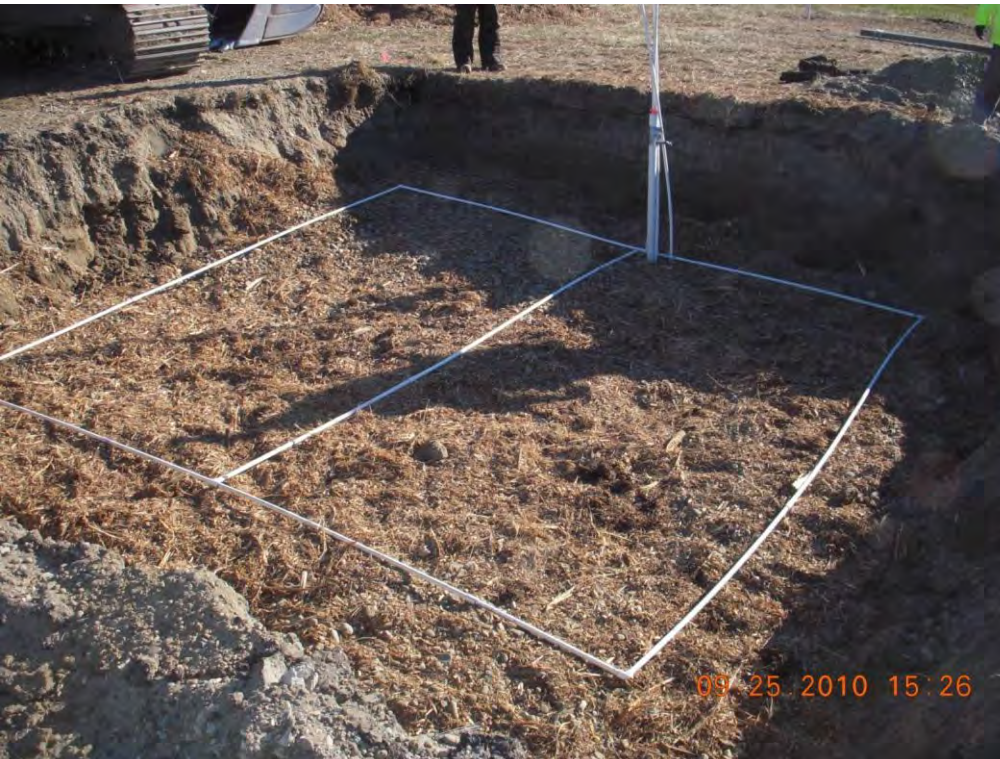
- The excavation was backfilled with wood chip mulch, vegetable oil, and gravel.
- Perforated piping allows the pumped groundwater to filter back through the top of the bioreactor.
- Some of the PCE/TCE-contaminated soil was put back on top of the bioreactor, the rest was moved to a lined

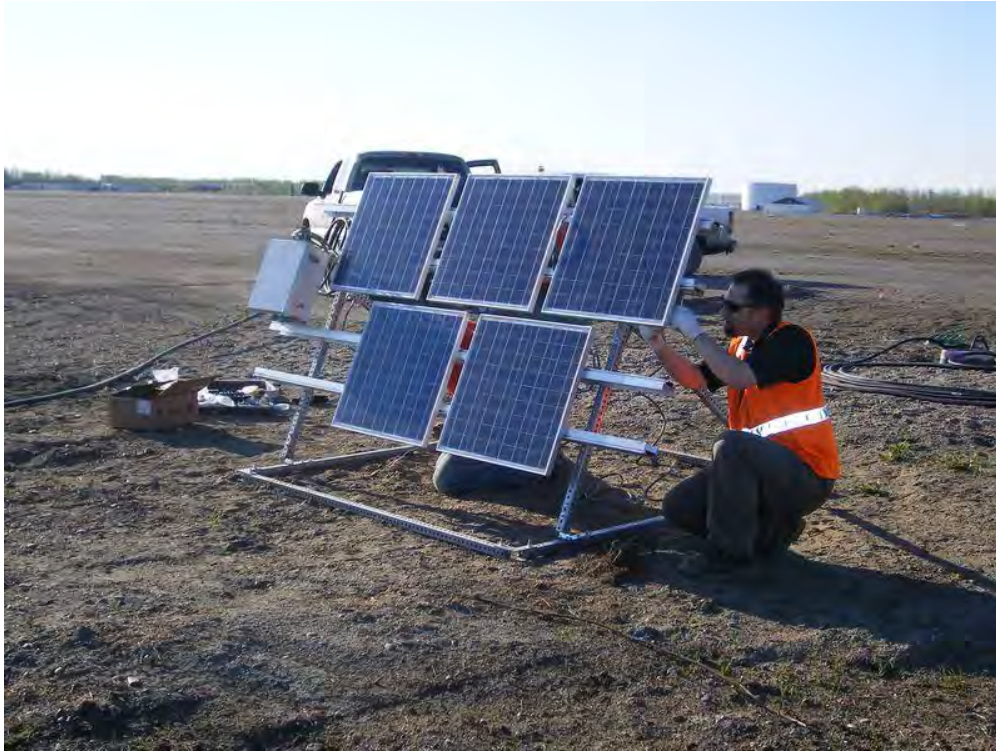
- Operation began in May 2011 by installing the solar panel and groundwater pump
- The system operated continuously to mid-October 2011, then was shutdown for the winter.

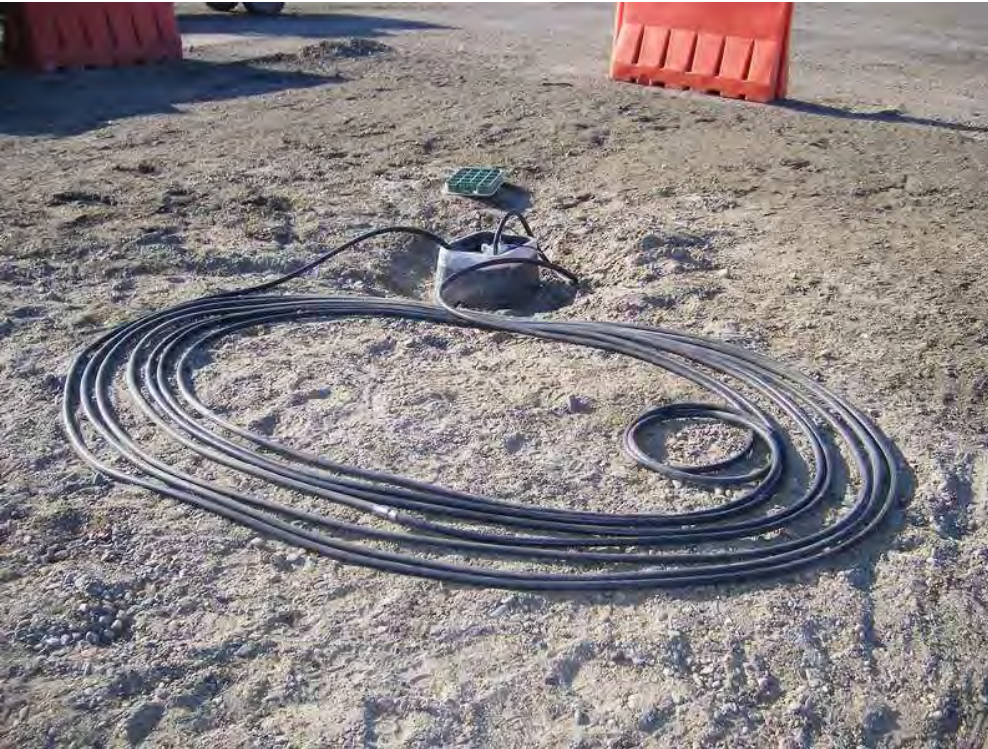
- A black hose passive heating coil is used to warm the groundwater before it is reinjected back into the bioreactor.
- Increased the water temperature by 5 °C at a flowrate of 1.5 gallons per minute.

- **Conclusions (Cont'd)**
 - The passive heating coil and heat from biodegradation raised the water temperature an average of 5°C in the bioreactor.
 - Total organic carbon (food source for microorganisms) was initially high in the bioreactor, but dropped to low levels after a month of operation, probably due to the vegetable oil flushing out of the bioreactor.
 - Oxidation-Reduction measurements in the groundwater indicated suitable conditions for biodegradation of chlorinated compounds.

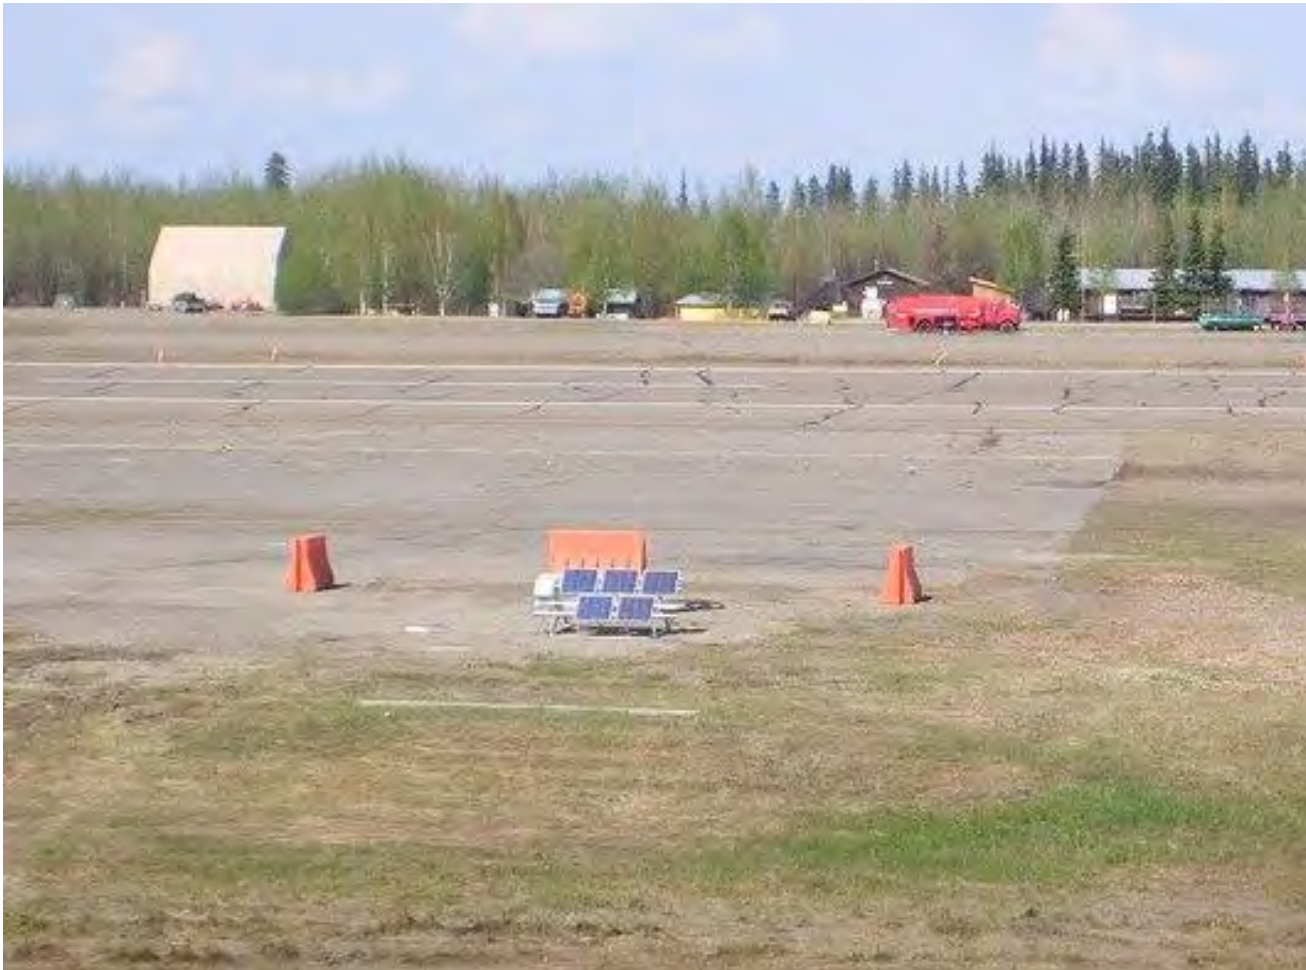
SS015 Bioreactor Pilot Study View from the South

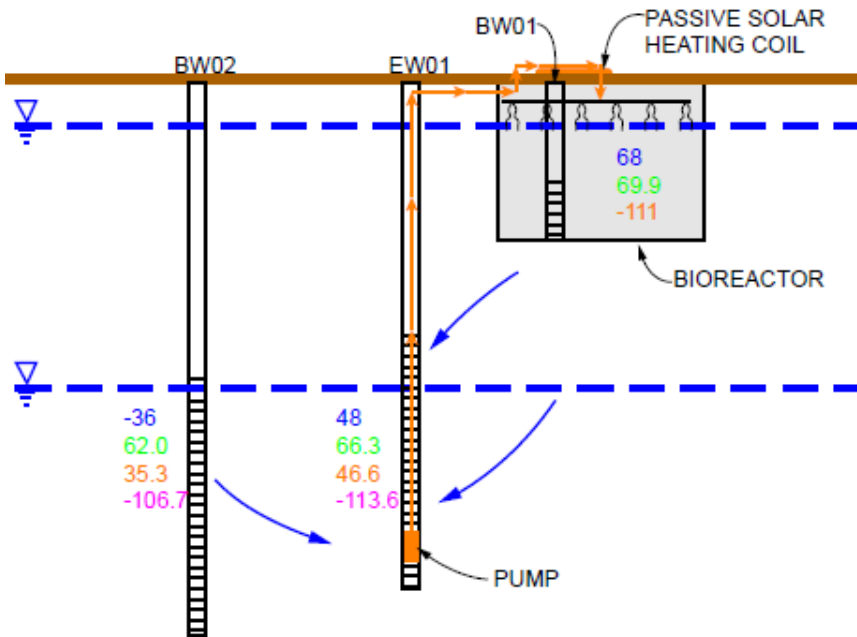
Groundwater Monitoring Results for Oxidation Reduction Potential

- ORP is an indication of conditions that are conducive to anaerobic biodegradation of CVOCs.
- ORP values less than 50 mV indicate good conditions for biodegradation of PCE and TCE.

— MAY 2011
— JUNE 2011
— JULY 2011
— SEPTEMBER 2011
