Air Force Civil Engineer Center
2261 Hughes Ave., Suite 163
JBSA Lackland, TX 78236

Figure 2
PFOA Overburden Groundwater Contour Map

Former Pease Air Force Base, Portsmouth, New Hampshire

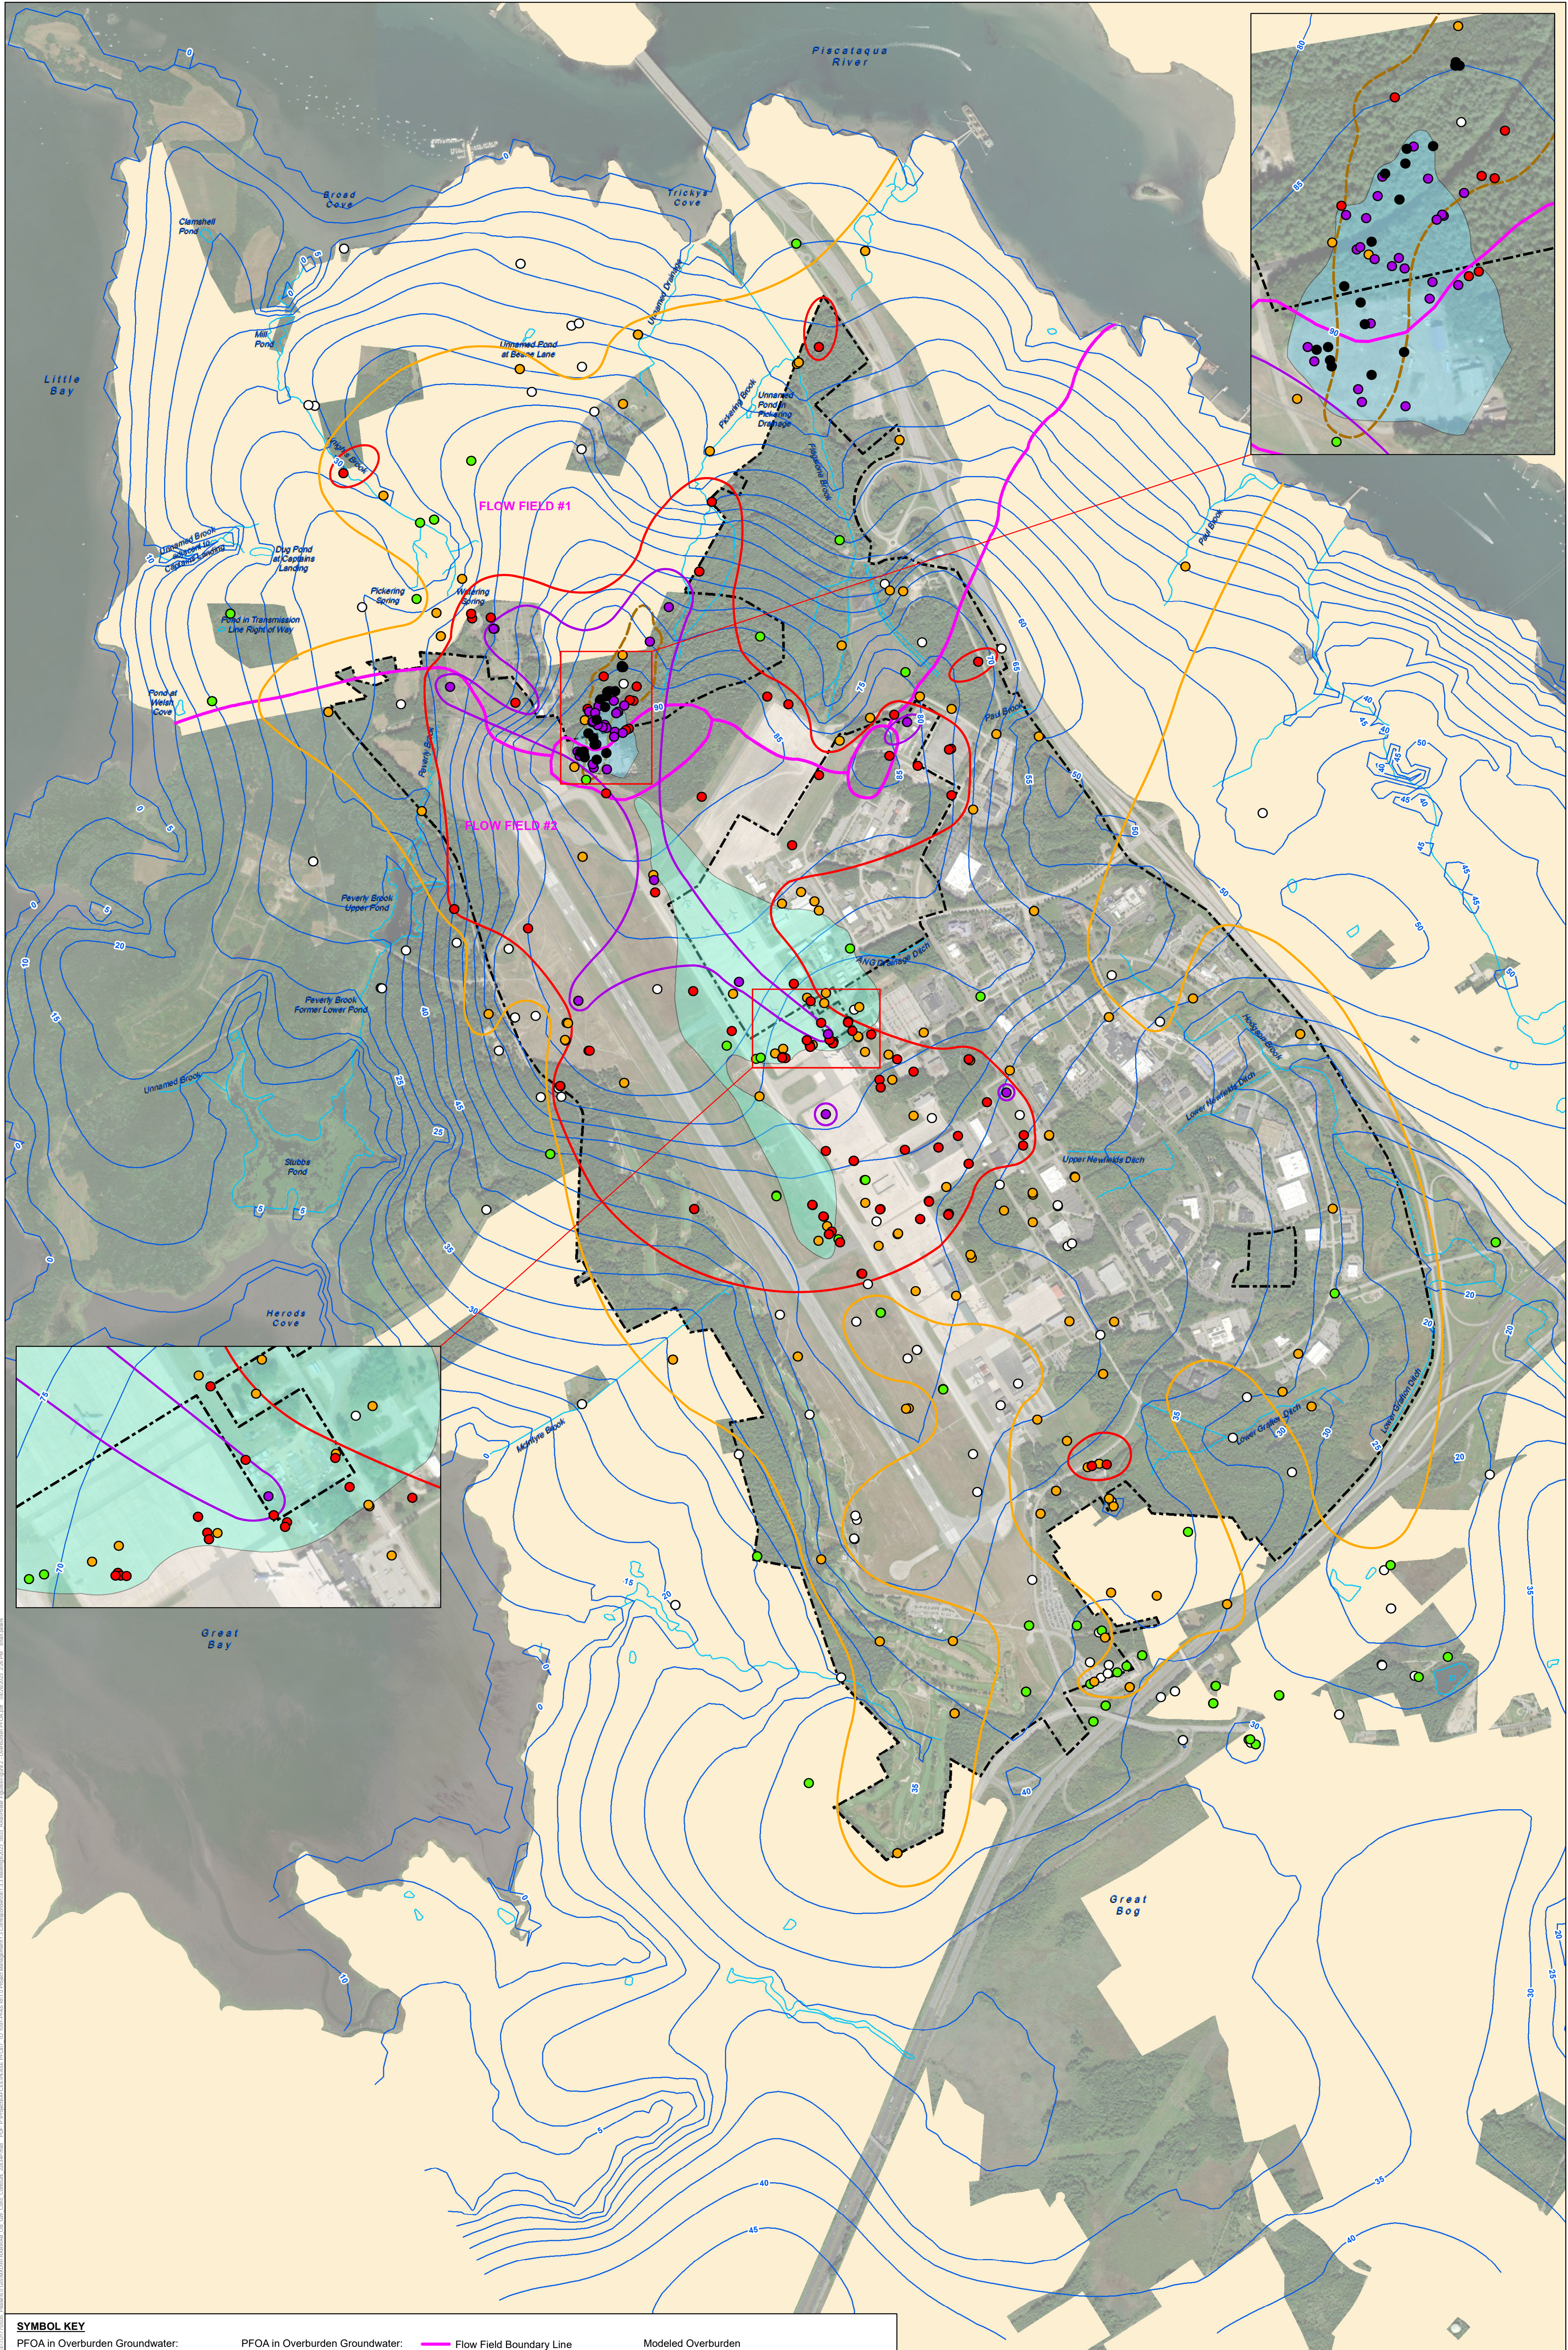
PFOA in Overburden Groundwater:

- Non-Detect
- Detected Below RSL (6 ng/L)
- Detected Above RSL (6 ng/L)
- Detected Above 10x RSL (60 ng/L)
- Detected Above 100x RSL (600 ng/L)
- Detected Above 1000x RSL (6000 ng/L)

- Site 8 Capture Zone - July 2022
- AIMS Capture Zone - July 2022
- Surface Water Bodies
- Interpreted Bedrock Trough
- Pease Development Authority (PDA) Property Boundary

Groundwater contours were generated using a (2022) revised Modflow Model. Peninsula-wide water levels gauged in June 2022 were used as targets for model calibration.
